## ACOUSTICAL PERFORMANCE TEST REPORT

ASTM E90 SOUND TRANSMISSION LOSS TESTING ON A 3252, CURTAIN WALL

K0598.01-303-11-R1

SERIES 3252  
EXTERIOR GLAZED  
CURTAIN WALL SYSTEM

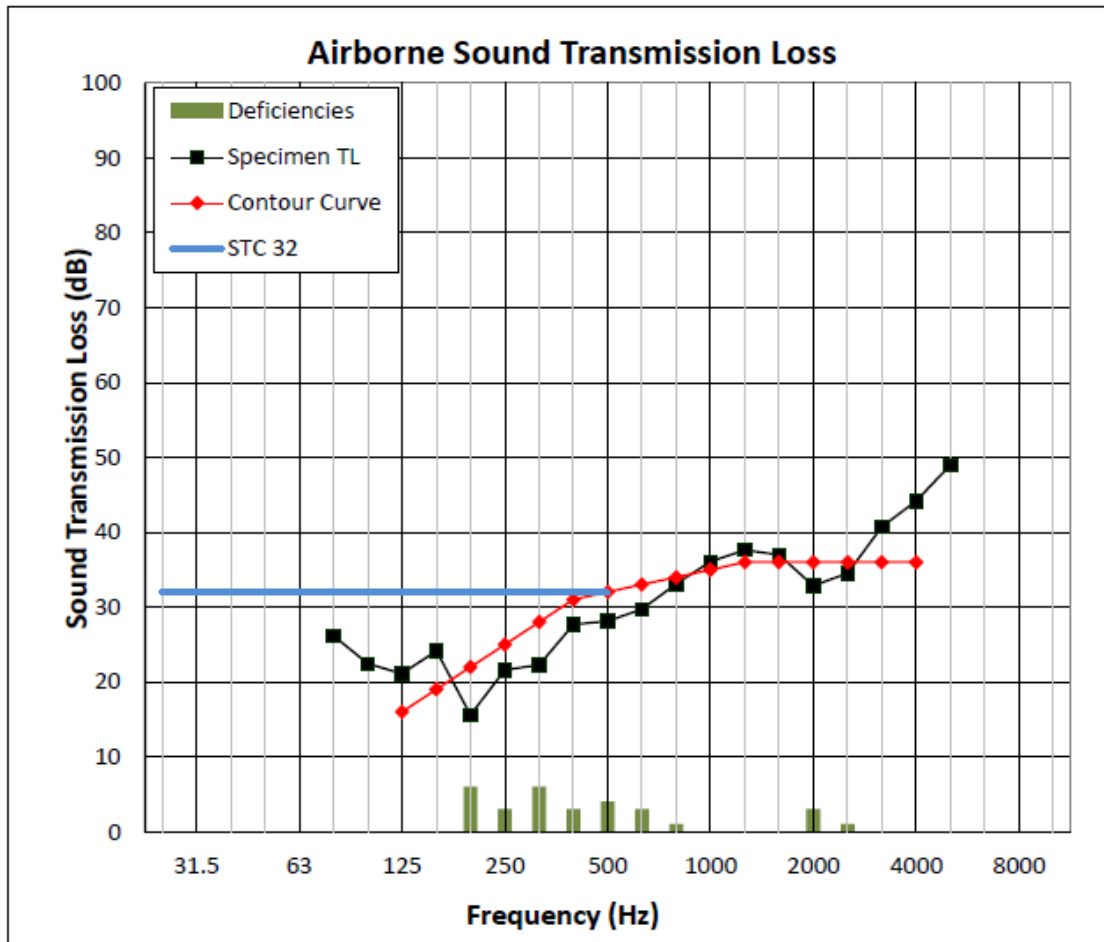
### ASTM E90 AIRBORNE SOUND TRANSMISSION LOSS

FREQ (Hz)	BACKGROUND SPL (dB)	ABSORPTION (m <sup>2</sup> )	SOURCE SPL (dB)	RECEIVE SPL (dB)	SPECIMEN TL (dB)	95% CONFIDENCE LIMIT	NUMBER OF DEFICIENCIES
80	41.4	4.6	103	77	26	1.78	-
100	35.6	4.9	102	79	22	1.00	-
125	42.0	5.2	102	80	21	1.16	0
160	42.7	5.2	103	78	24	0.97	0
200	36.1	6.6	106	88	16	0.90	6
250	26.4	7.2	107	82	22	0.59	3
315	27.9	7.1	106	81	22	0.38	6
400	32.8	6.2	105	75	28	0.33	3
500	21.0	5.5	106	76	28	0.50	4
630	17.6	6.1	106	75	30	0.21	3
800	20.5	5.9	105	70	33	0.34	1
1000	13.9	5.8	106	69	36	0.20	0
1250	11.8	6.0	105	65	38	0.19	0
1600	5.5	6.7	103	64	37	0.21	0
2000	3.9	8.0	101	65	33	0.21	3
2500	3.7	9.0	101	63	35	0.31	1
3150	4.2	10.4	100	55	41	0.20	0
4000	4.8	12.9	97	47	44	0.25	0
5000	5.4	16.9	92	37	49	0.62	-
<b>STC RATING</b>	32 (Sound Transmission Class)						
<b>DEFICIENCIES</b>	30 (Sum of Deficiencies)						
<b>OITC RATING</b>	26 (Outdoor-Indoor Transmission Class)

<b>TEST DATE</b>	11/20/19				
<b>DATA FILE NO.</b>	K0598.01A				
<b>CLIENT</b>	CR Laurence Co. Inc.				
<b>DESCRIPTION</b>	Series/Model: 3252 Curtain Wall With 1" IG (1/4" Tempered Exterior, 1/2" Air Space, 1/4" Tempered Interior)				
<b>SPECIMEN AREA</b>	4.00 m <sup>2</sup>	<b>RECEIVE TEMP.</b>	20.4 °C	<b>SOURCE TEMP</b>	20.0 °C
<b>TECHNICIAN</b>	Marco T Sant	<b>RECEIVE HUMIDITY</b>	42%	<b>SOURCE HUMIDIT</b>	43%

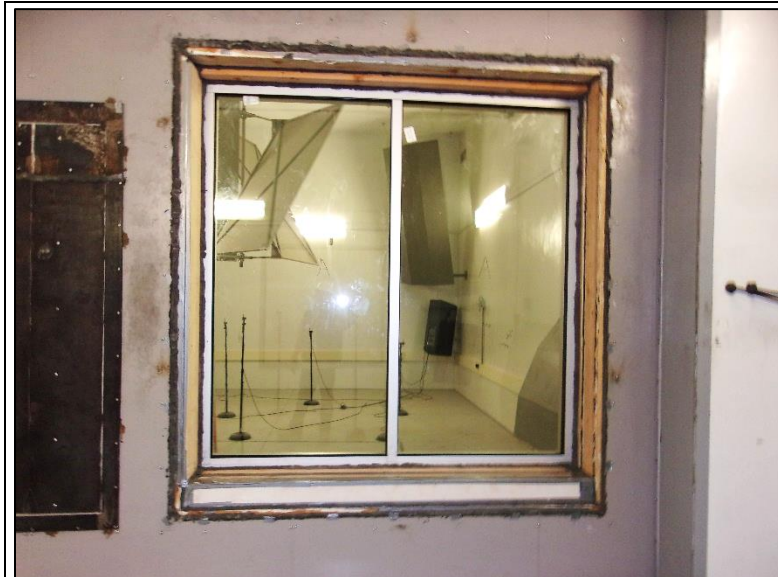
**Photo No. 1**  
**Source Room View of Test Specimen**

Photographs are included in Section 11.

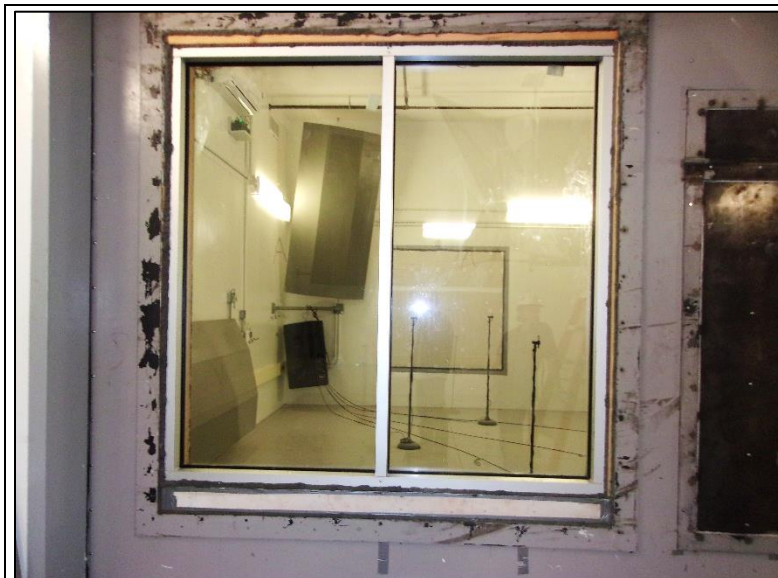
**Photo No. 2**  
**Receive Room View of Test Specimen**

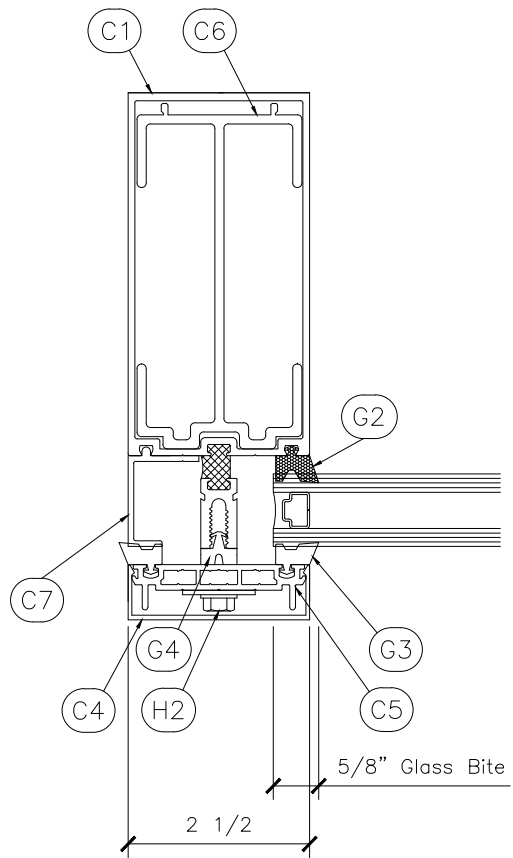
① SECTION DETAIL – JAMB

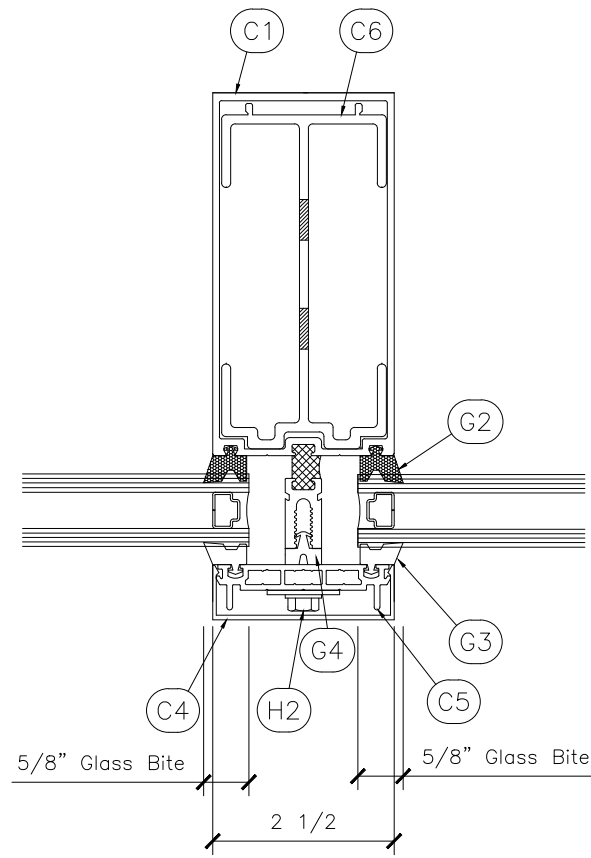
② SECTION DETAIL – VERT. MULL.

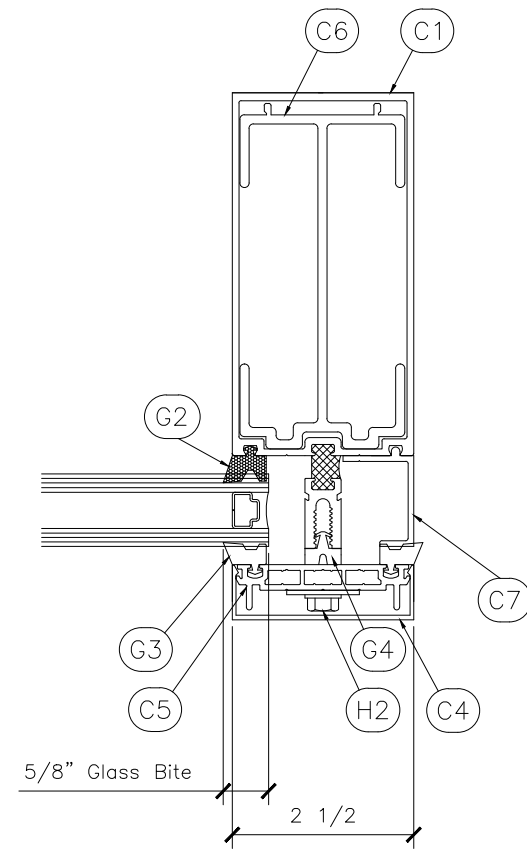
③ SECTION DETAIL – JAMB

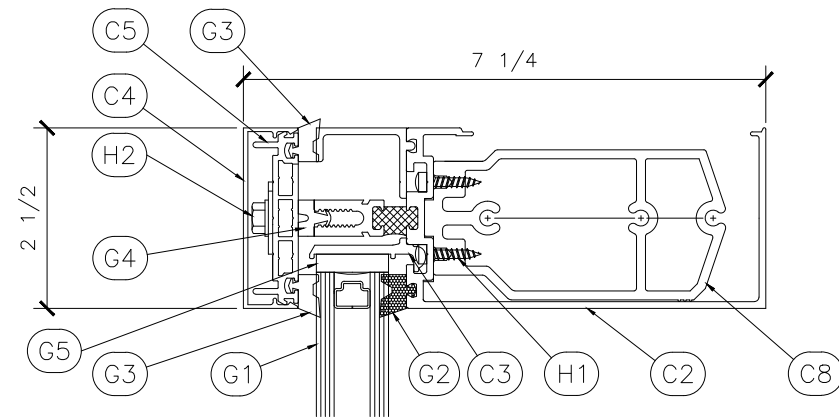
④ SECTION DETAIL – UPPER HORIZONTAL

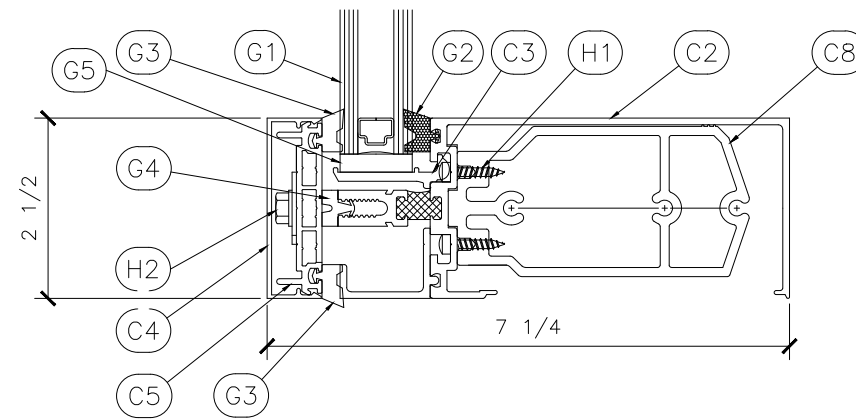
⑤ SECTION DETAIL – LOWER HORIZONTAL
