ACOUSTICAL PERFORMANCE TEST REPORT

ASTM E90 SOUND TRANSMISSION LOSS TESTING ON A 3252, CURTAIN WALL

K0598.02-303-11-R1

SERIES 3252
EXTERIOR GLAZED
CURTAIN WALL SYSTEM

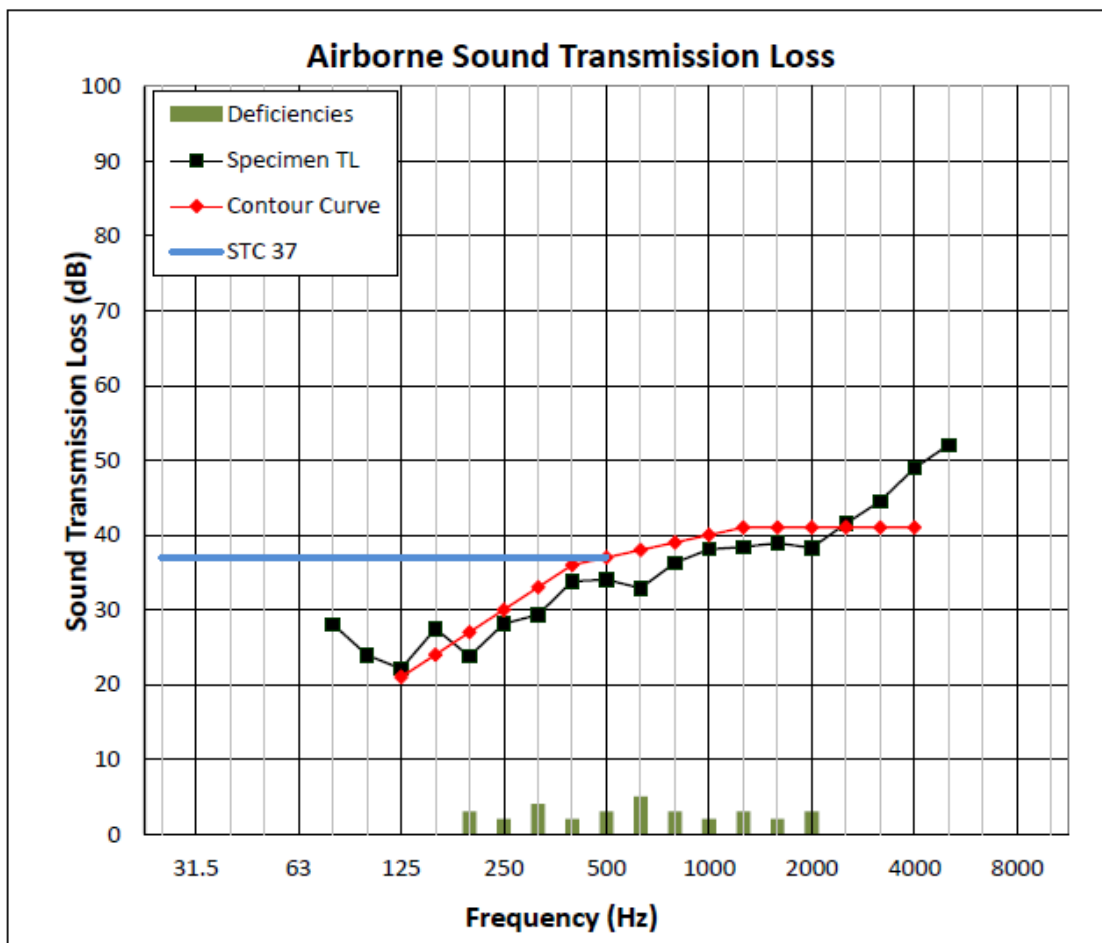
ASTM E90 AIRBORNE SOUND TRANSMISSION LOSS

TEST DATE	11/20/19				
DATA FILE NO.	K0598.01B				
CLIENT	CR Laurence Co. Inc.				
DESCRIPTION	Series/Model: 3252 Curtain Wall With 1-1/8" IG (1/4" Tempered Exterior, 1/2" Air Space, 3/8" Laminated Interior) Glass temperature 75F				
SPECIMEN AREA	4.00 m ²	RECEIVE TEMP.	21.3 °C	SOURCE TEMP	20.8 °C
TECHNICIAN	Marco T Sant	RECEIVE HUMIDITY	44%	SOURCE HUMIDIT	46%

FREQ (Hz)	BACKGROUND SPL (dB)	ABSORPTION (m ²)	SOURCE SPL (dB)	RECEIVE SPL (dB)	SPECIMEN TL (dB)	95% CONFIDENCE LIMIT	NUMBER OF DEFICIENCIES
80	39.9	4.6	103	75	28	1.85	-
100	33.5	4.9	102	77	24	1.31	-
125	39.9	5.1	102	79	22	0.94	0
160	42.5	5.0	102	74	27	0.93	0
200	35.7	6.3	105	80	24	0.78	3
250	25.0	7.0	106	76	28	0.64	2
315	26.0	7.1	106	74	29	0.49	4
400	31.1	6.0	105	70	34	0.33	2
500	20.5	5.4	106	70	34	0.44	3
630	17.0	5.9	106	72	33	0.33	5
800	20.6	5.9	105	67	36	0.34	3
1000	12.9	5.9	106	67	38	0.24	2
1250	10.8	6.0	105	65	38	0.27	3
1600	5.4	6.6	103	62	39	0.26	2
2000	3.6	7.8	101	60	38	0.24	3
2500	3.8	8.8	101	56	42	0.16	0
3150	4.2	10.2	100	52	45	0.17	0
4000	4.8	12.4	97	43	49	0.18	0
5000	5.4	16.1	93	34	52	0.45	-
STC RATING	37 (Sound Transmission Class)						
DEFICIENCIES	32 (Sum of Deficiencies)						
OITC RATING	31 (Outdoor-Indoor Transmission Class)

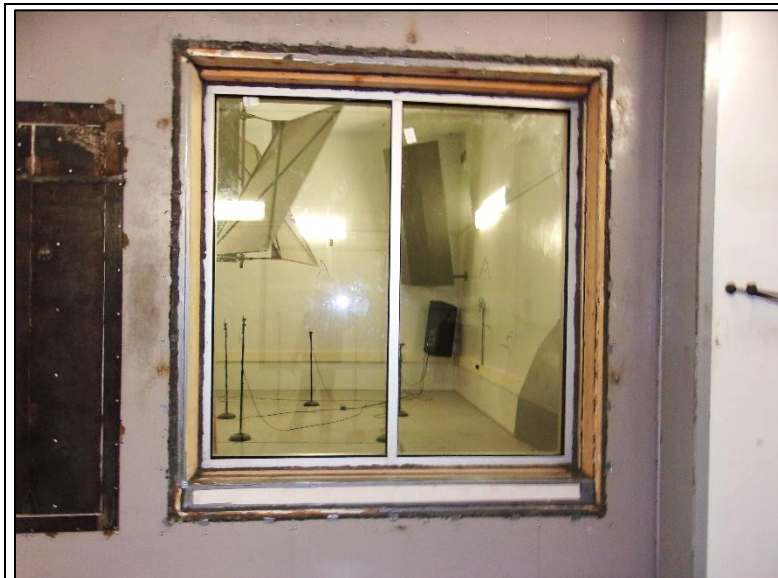
Photo No. 1
Source Room View of Test Specimen

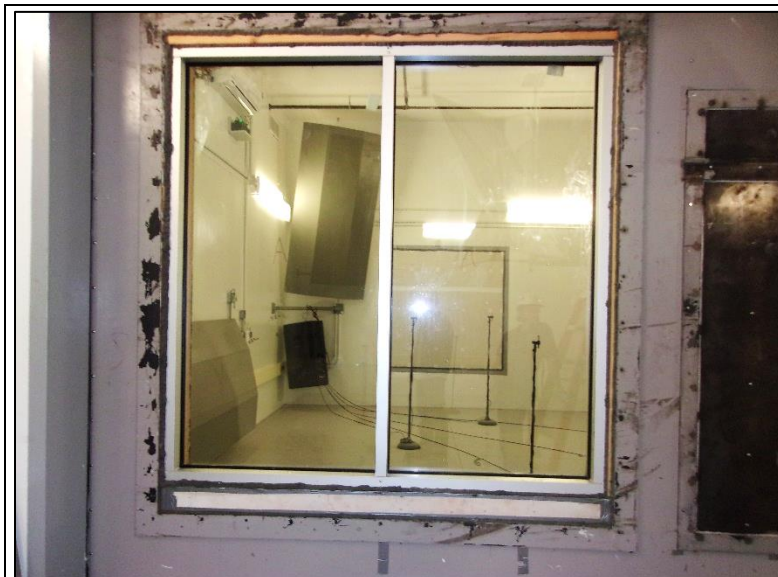
Photo No. 2
Receive Room View of Test Specimen

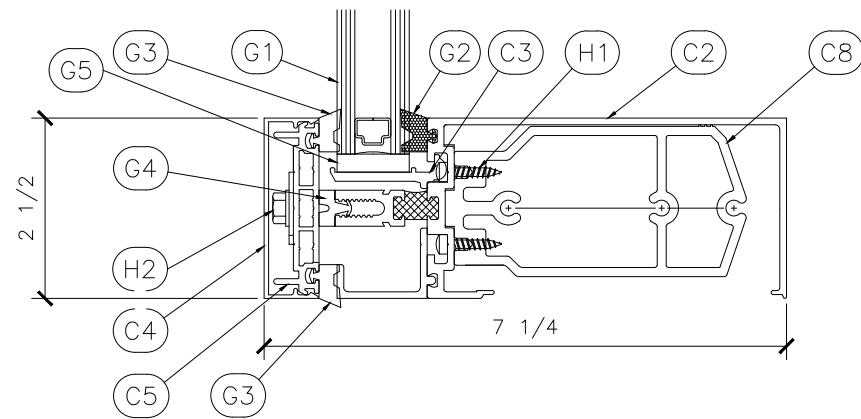
⑤ SECTION DETAIL – LOWER HORIZONTAL
