**ASTM F 1642-04/GSA TS01
TEST REPORT**

**INTERNATIONAL ARCHITECTURAL PRODUCTS, INC.
DBA: UNITED STATES ALUMINUM**

**SERIES/MODEL: BT601
PRODUCT TYPE: Aluminum Storefront with Vertical Mullion**

Report No.: A1225.01-122-12
Revision 1: 06/09/10
Test Date: 05/28/10
Report Date: 06/04/10
Expiration Date: 05/28/14

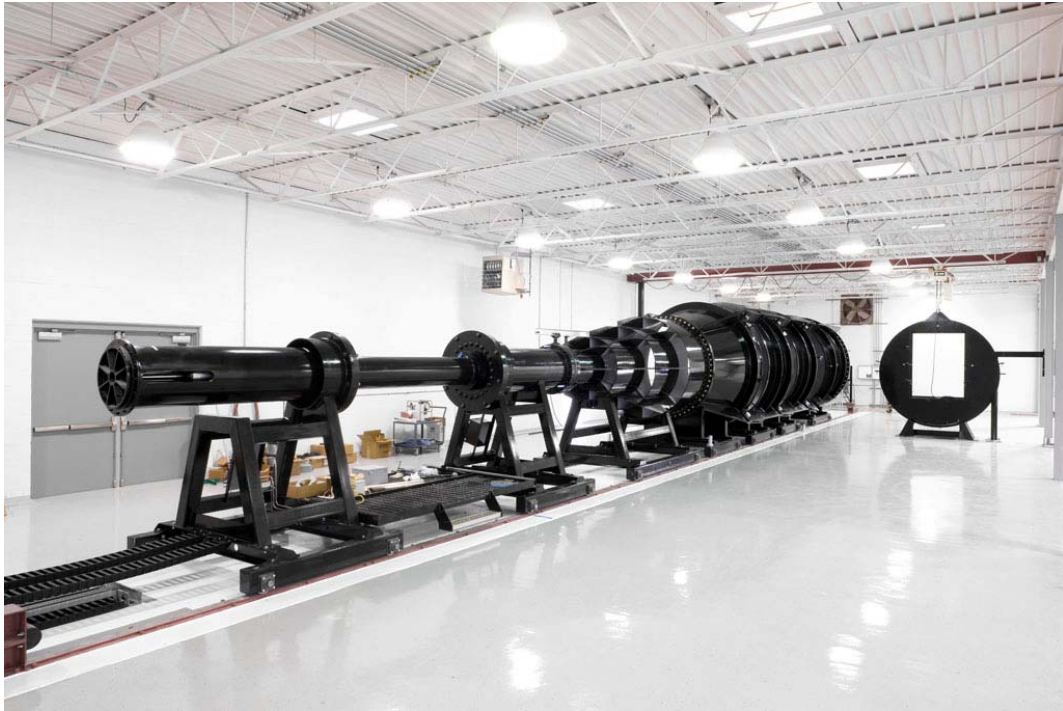
Figure #1
Shock Tube and Test Facility

Test Facility: Architectural Testing, Inc.'s shock tube is housed in a 10,000 square foot state-of-the-art test facility located in York, Pennsylvania. Blast loadings are produced on the specimen to simulate the effects of a high explosive charge at a specified standoff distance. Shock waves are generated by the sudden rupturing of a thin aluminum membrane. The shock wave expands as it travels down the tube, and impacts the target with a specific positive pressure and impulse. A photograph of the shock tube is provided in Figure #1 of Appendix A.

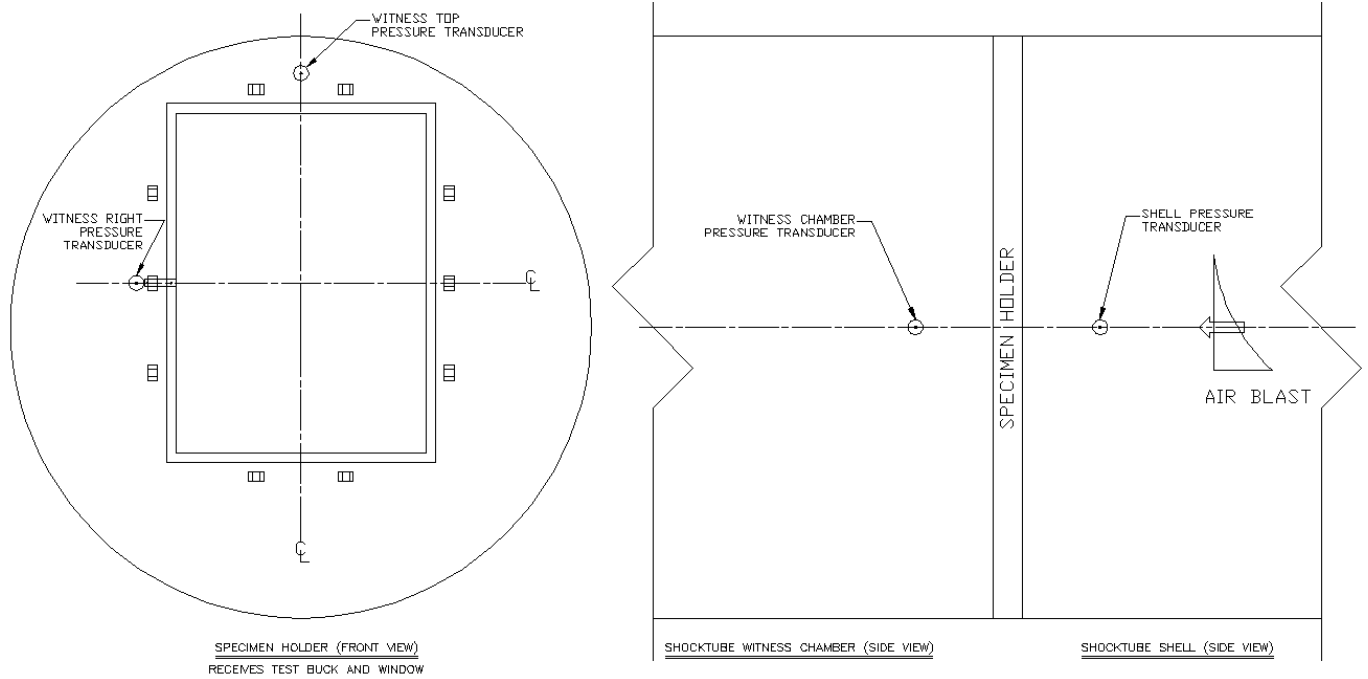
Figure #2
Pressure Sensor Locations

Data Acquisition: In accordance with ASTM F 1642-04 and GSA TS01, four reflective pressure transducers are utilized to record data at a 1MHz sample rate. Two reflective pressure transducers are located on the specimen holder at the top and right side (when viewed from the interior). A third pressure transducer is located on the shell to the exterior of the specimen, and a fourth is located in the witness chamber, directly to the interior of the specimen holder. A sketch of the specimen holder and corresponding reflective pressure sensor locations are provided in Figure #2 of Appendix A.

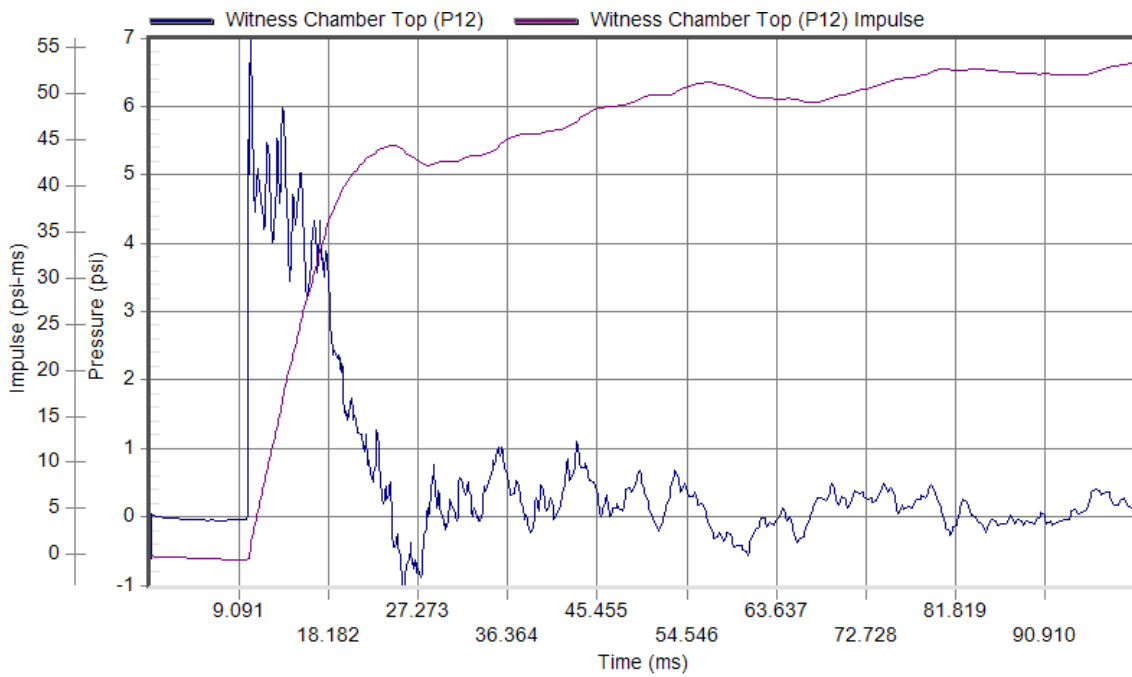
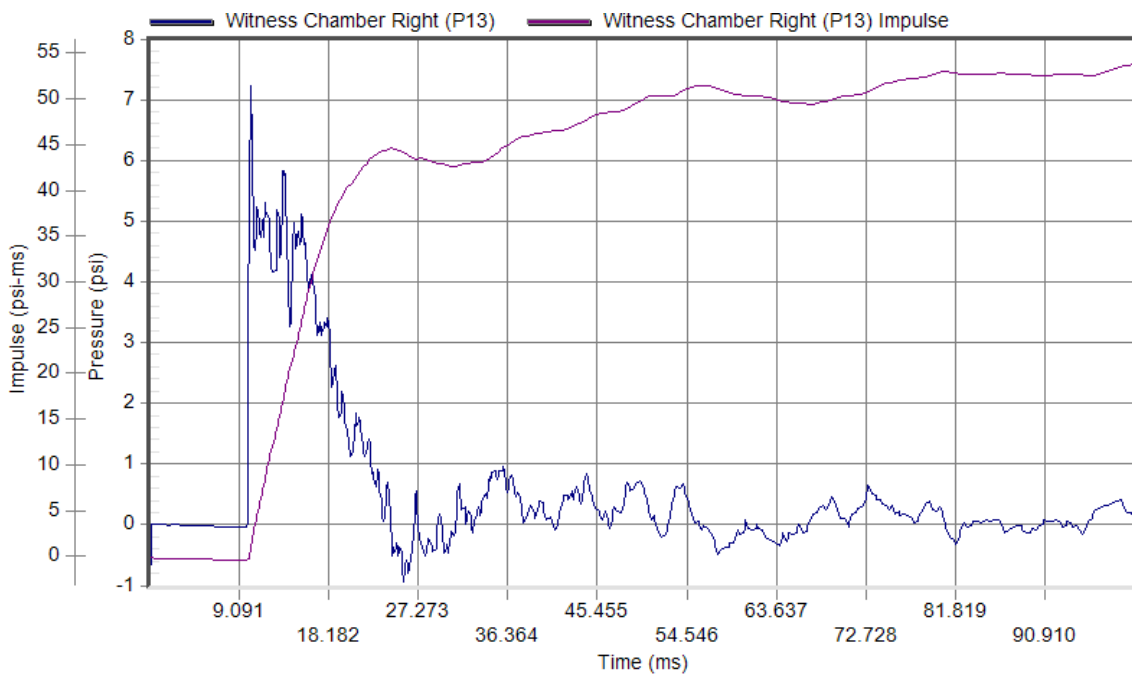
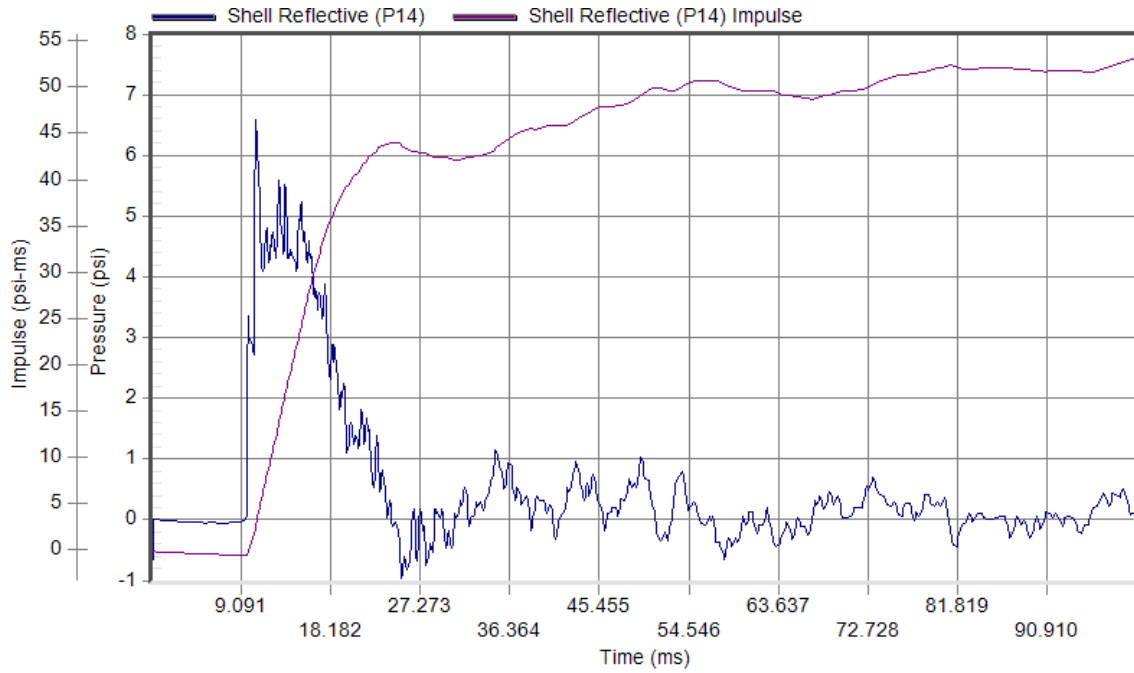
Specimen #1

<u>Description</u>	<u>Results</u>
Ambient Temperature	75°F
Glazing Temperature	75°F
Peak Positive Pressure	
Top Pressure	7.1 psi
Right Pressure	7.3 psi
Shell Pressure	6.6 psi
Average Pressure	7.0 psi
Positive Phase Duration	
Top Duration	14 msec
Right Duration	13 msec
Shell Duration	13 msec
Average Duration	13 msec
Positive Phase Impulse	
Top Impulse	44 psi-msec
Right Impulse	45 psi-msec
Shell Impulse	44 psi-msec
Average Impulse	44 psi-msec

Peak Pressure: 7.09 psi at 10.30 ms
Duration: 14.32 ms

Peak Pressure: 7.26 psi at 10.32 ms
Duration: 13.40 ms

Peak Pressure: 6.60 psi at 10.62 ms
Duration: 13.31 ms

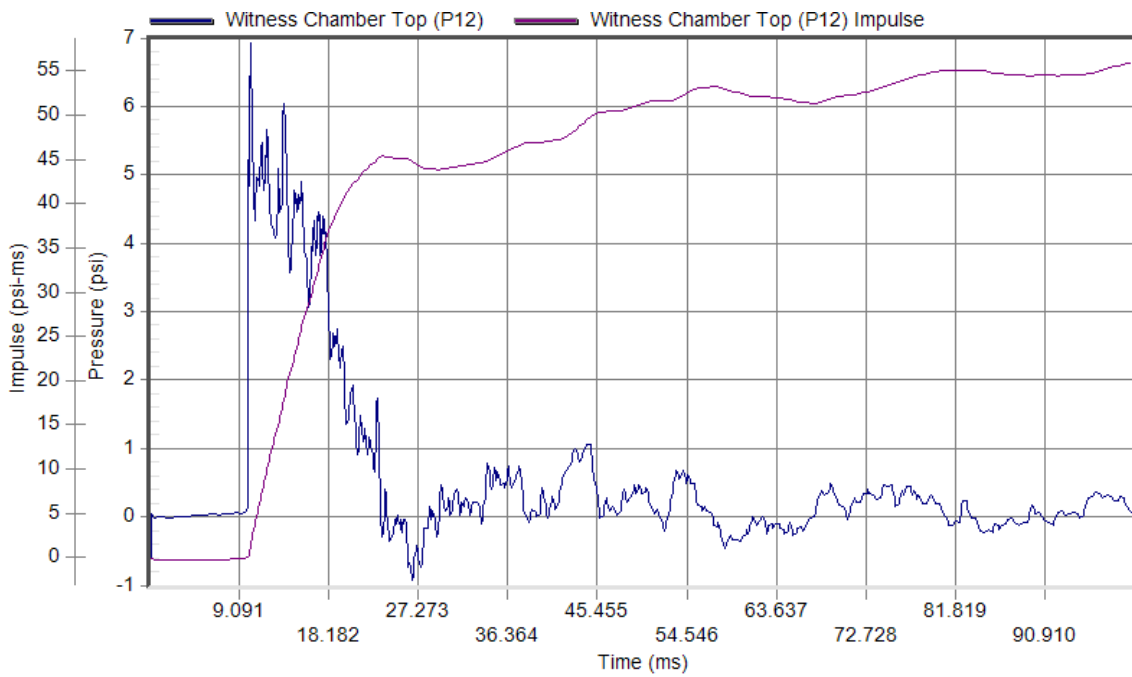
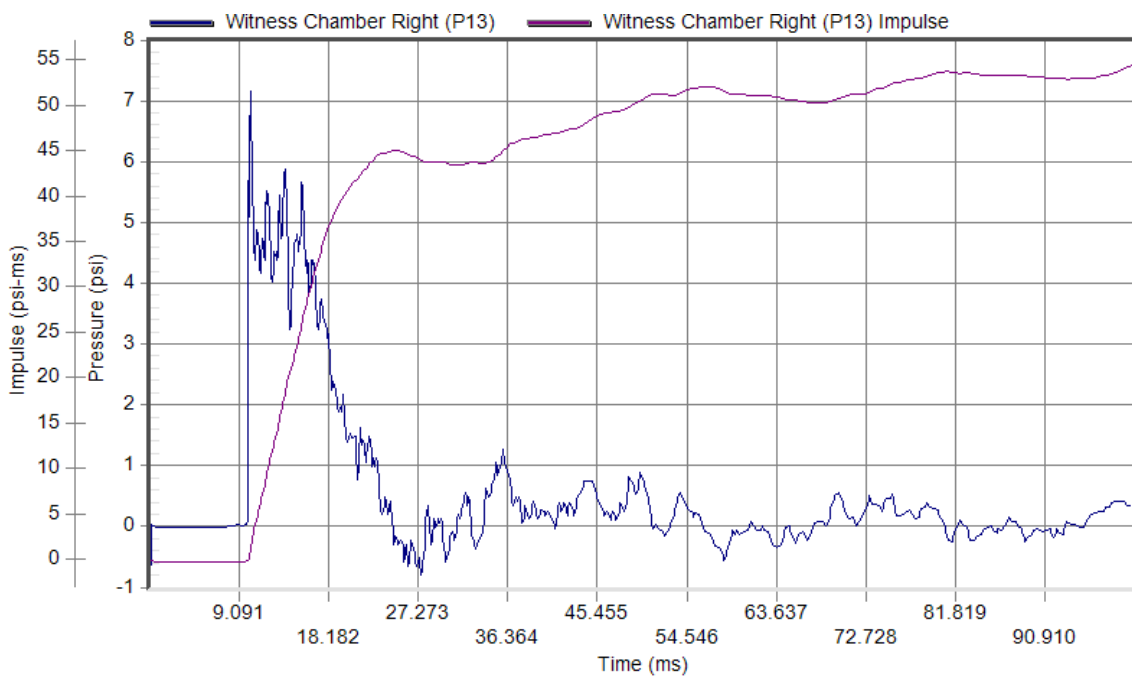
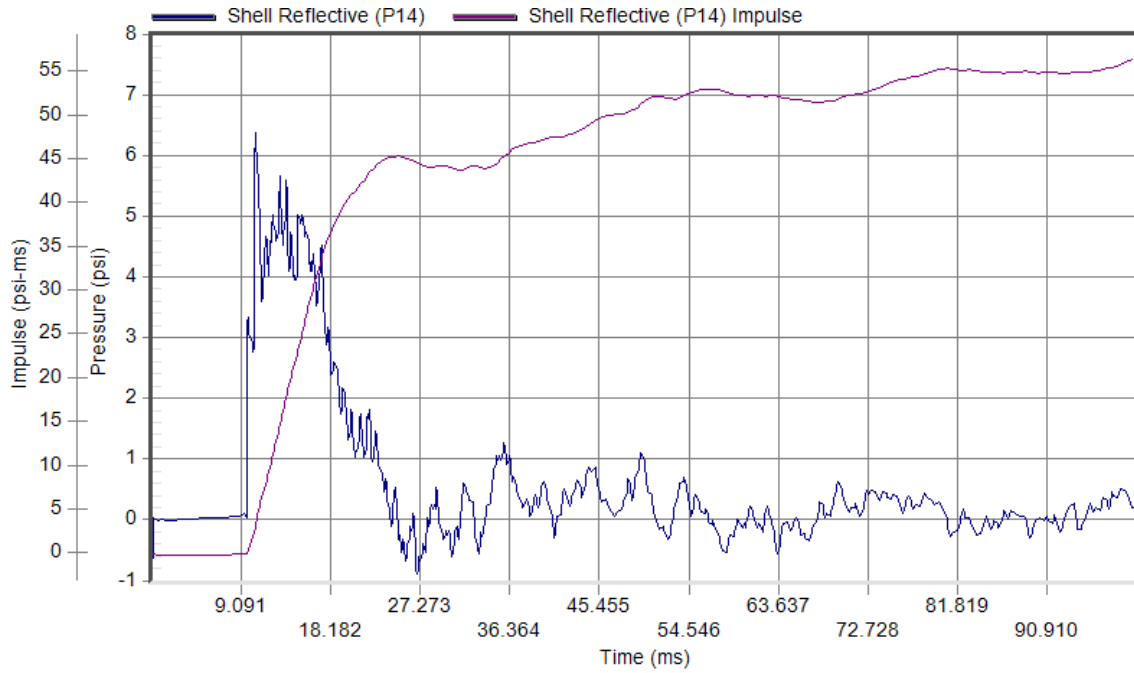
Specimen #2

<u>Description</u>	<u>Results</u>
Ambient Temperature	77°F
Glazing Temperature	76°F
Peak Positive Pressure	
Top Pressure	6.9 psi
Right Pressure	7.2 psi
Shell Pressure	6.4 psi
Average Pressure	6.8 psi
Positive Phase Duration	
Top Duration	13 msec
Right Duration	14 msec
Shell Duration	14 msec
Average Duration	14 msec
Positive Phase Impulse	
Top Impulse	45 psi-msec
Right Impulse	44 psi-msec
Shell Impulse	45 psi-msec
Average Impulse	45 psi-msec

Peak Pressure: 6.94 psi at 10.30 ms
Duration: 13.20 ms

Peak Pressure: 7.17 psi at 10.29 ms
Duration: 14.40 ms

Peak Pressure: 6.39 psi at 10.59 ms
Duration: 13.66 ms

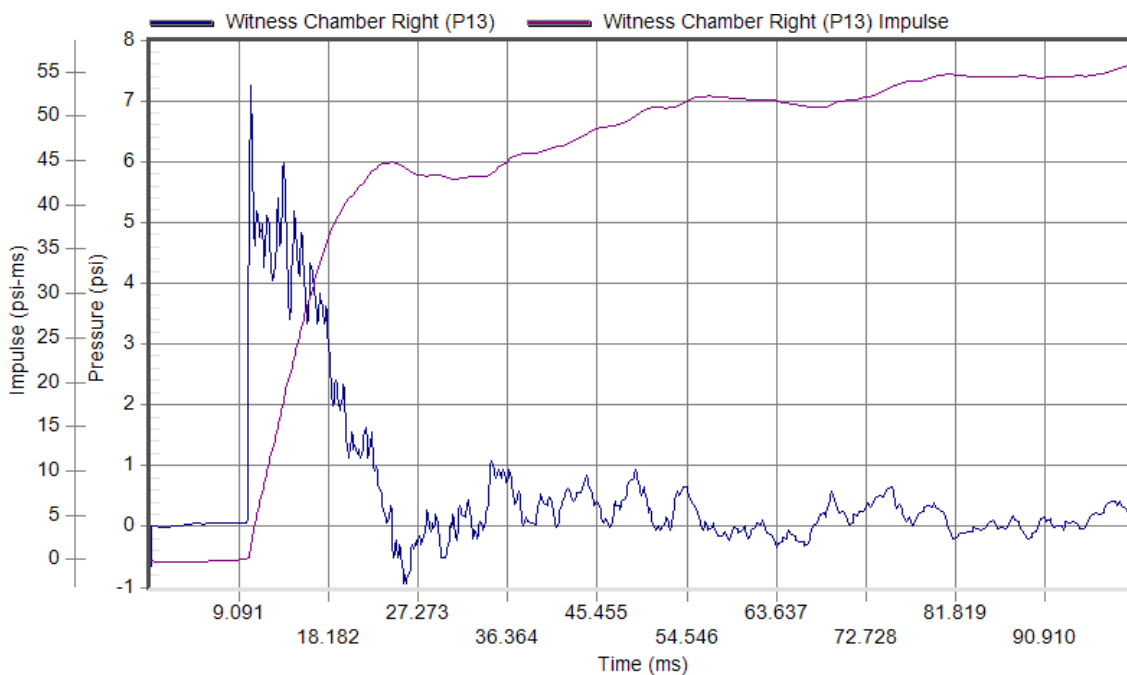
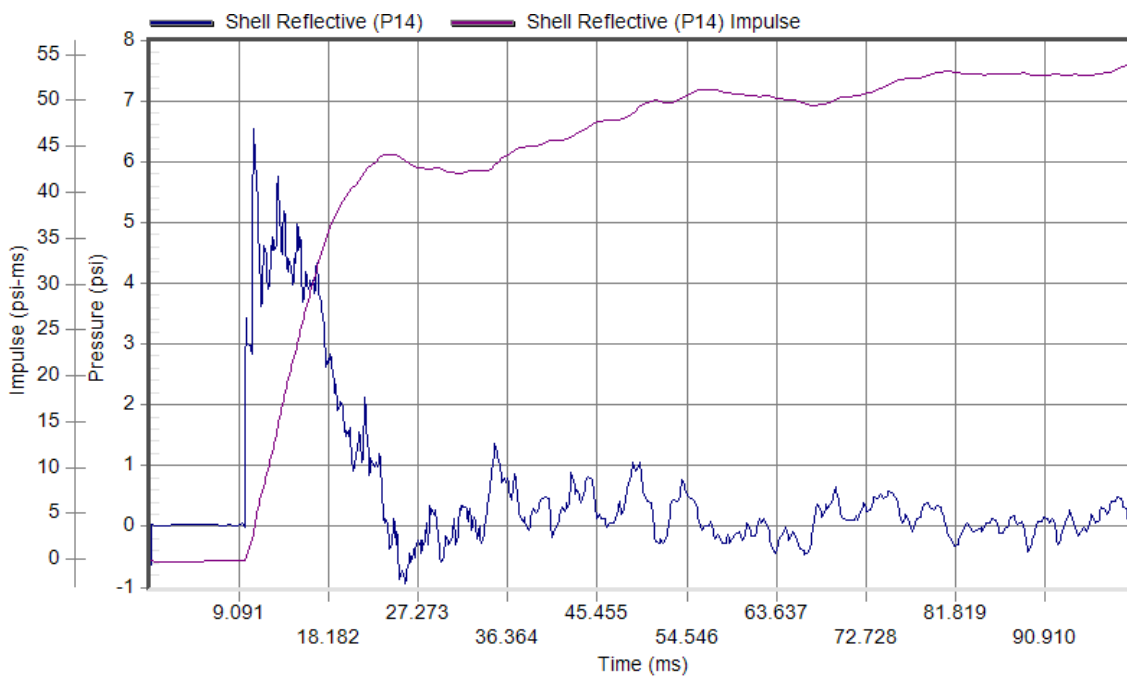
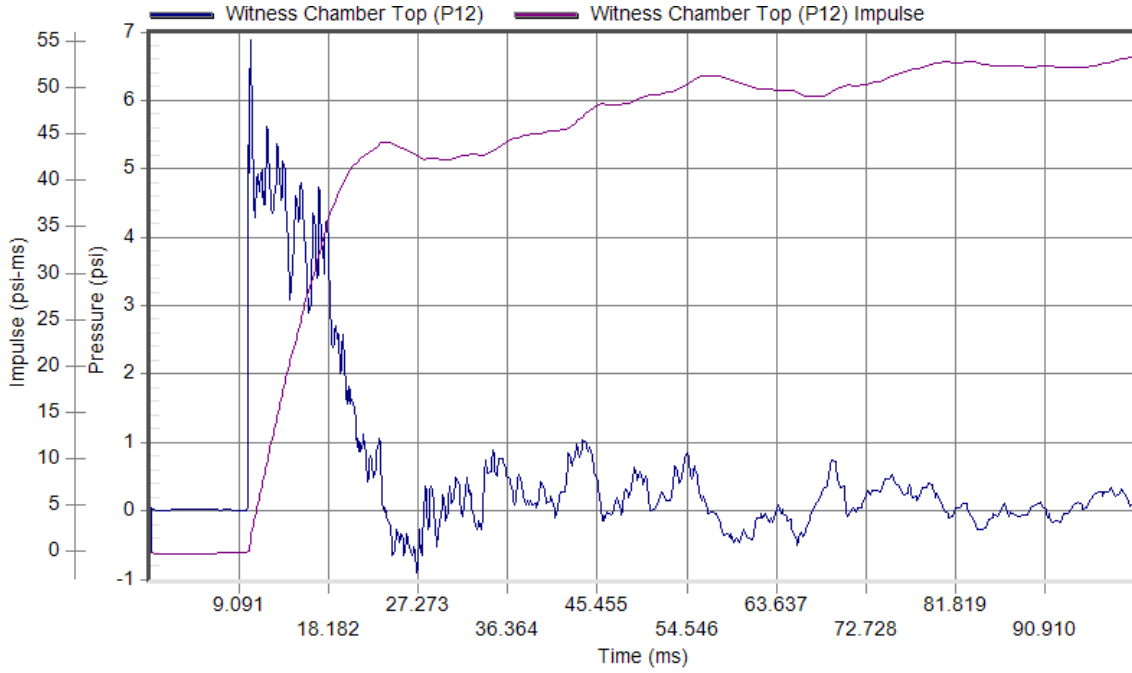
Specimen #3

<u>Description</u>	<u>Results</u>
Ambient Temperature	76°F
Glazing Temperature	75°F
Peak Positive Pressure	
Top Pressure	6.9 psi
Right Pressure	7.3 psi
Shell Pressure	6.6 psi
Average Pressure	6.9 psi
Positive Phase Duration	
Top Duration	13 msec
Right Duration	14 msec
Shell Duration	13 msec
Average Duration	13 msec
Positive Phase Impulse	
Top Impulse	44 psi-msec
Right Impulse	45 psi-msec
Shell Impulse	44 psi-msec
Average Impulse	44 psi-msec

Peak Pressure: 7.28 psi at 10.32 ms
Duration: 13.76 ms

Peak Pressure: 6.56 psi at 10.61 ms
Duration: 13.23 ms

Peak Pressure: 6.92 psi at 10.29 ms
Duration: 13.48 ms

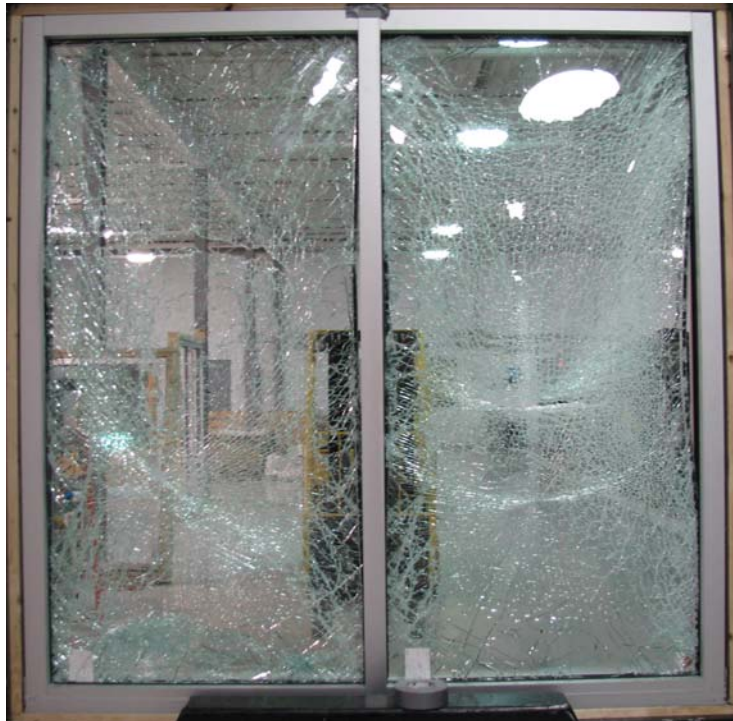
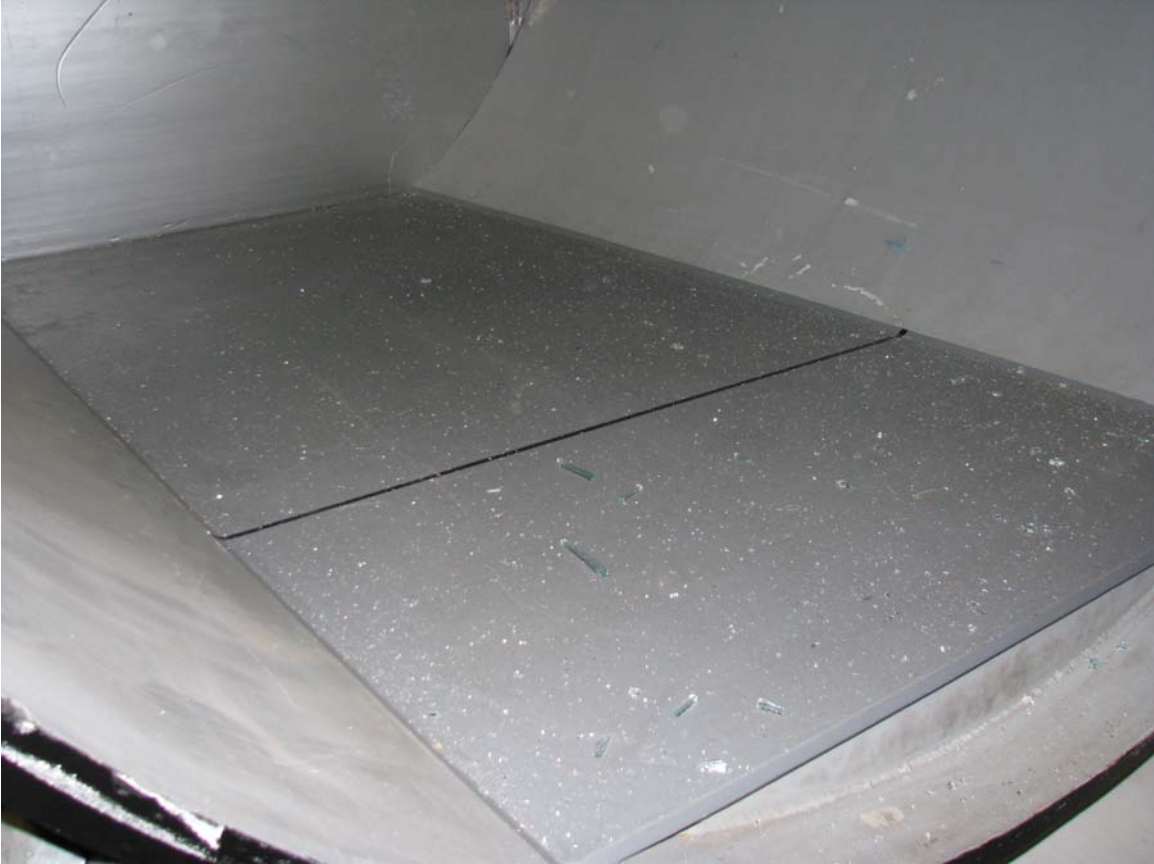
- No pressure rise was measured on the protected side of the specimen.
- The exterior lite fractured and fell to the unprotected side of the window. Both layers of the interior laminated lite were observed to fracture. The PVB laminate tore horizontally near the center of both lites. Glazing pull-out measured approximately 47" at the left jamb and 42" on the left side vertical. Total pull-out was 39%.
- Fragments of glass were located 42" behind the 1m line. No impacts or punctures were observed on the vertical witness panel.

ASTM Hazard Rating: Very Low Hazard

GSA Performance Condition: 3b

Photo No. 2
Post-test Specimen #1, Interior

Photo No. 3
Post-test Specimen #1, Witness Chamber

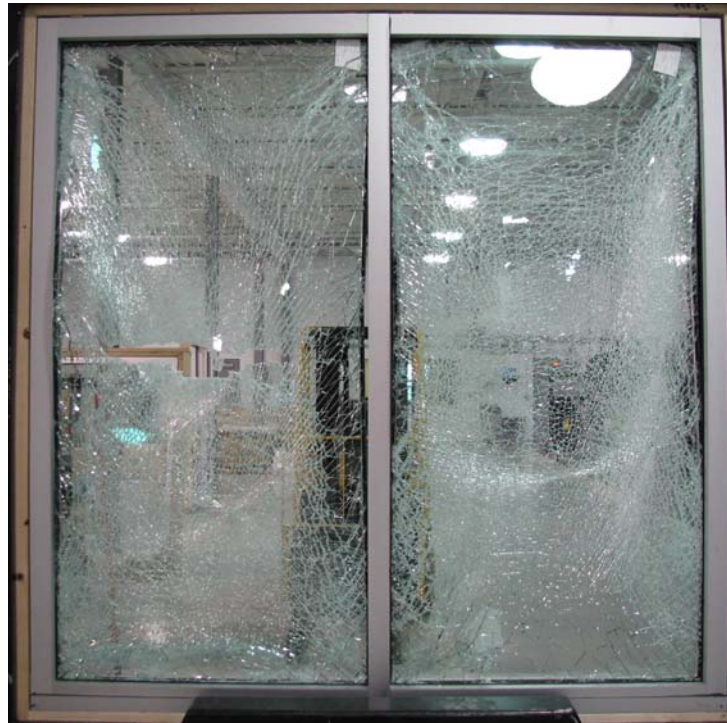
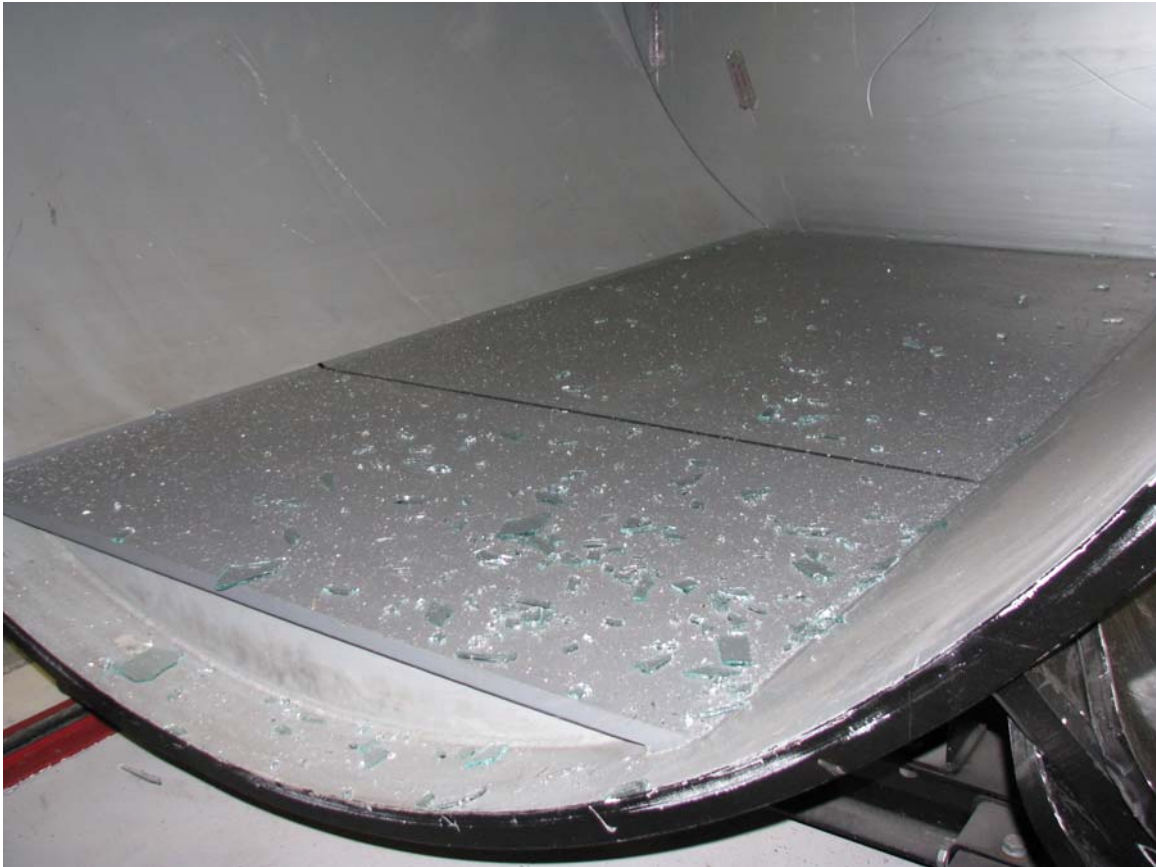
- No pressure rise was measured on the protected side of the specimen.
- The exterior lite fractured and fell to the unprotected side of the window. Both layers of the interior laminated lite were observed to fracture. The PVB laminate tore horizontally near the center of the left side lite. Glazing pull-out measured approximately 53" at the left jamb, 46" on the left side vertical, 23" on the right side vertical and 34" on the right jamb. Total pull-out was 43%.
- Fragments of glass were located 10" in front of the vertical witness panel. No impacts or punctures were observed on the vertical witness panel.

ASTM Hazard Rating: Very Low Hazard

GSA Performance Condition: 3b

Photo No. 5
Post-test Specimen #2, Interior

Photo No. 6
Post-test Specimen #2, Witness Chamber

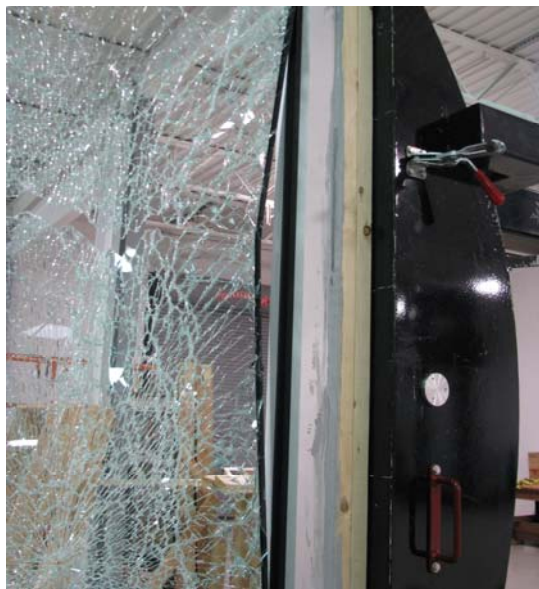
Photo No. 7
Post-test Specimen #1 and #2, Typical Tearing and Pull-out

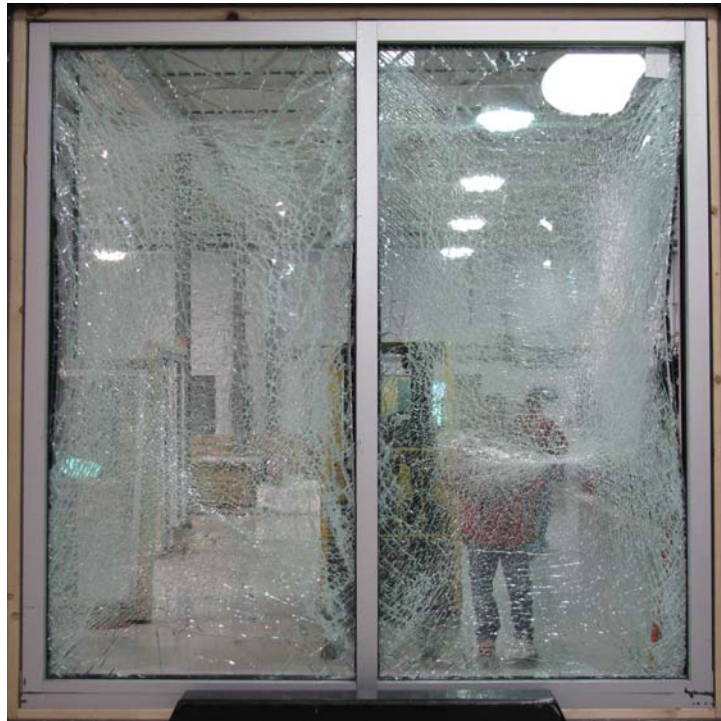
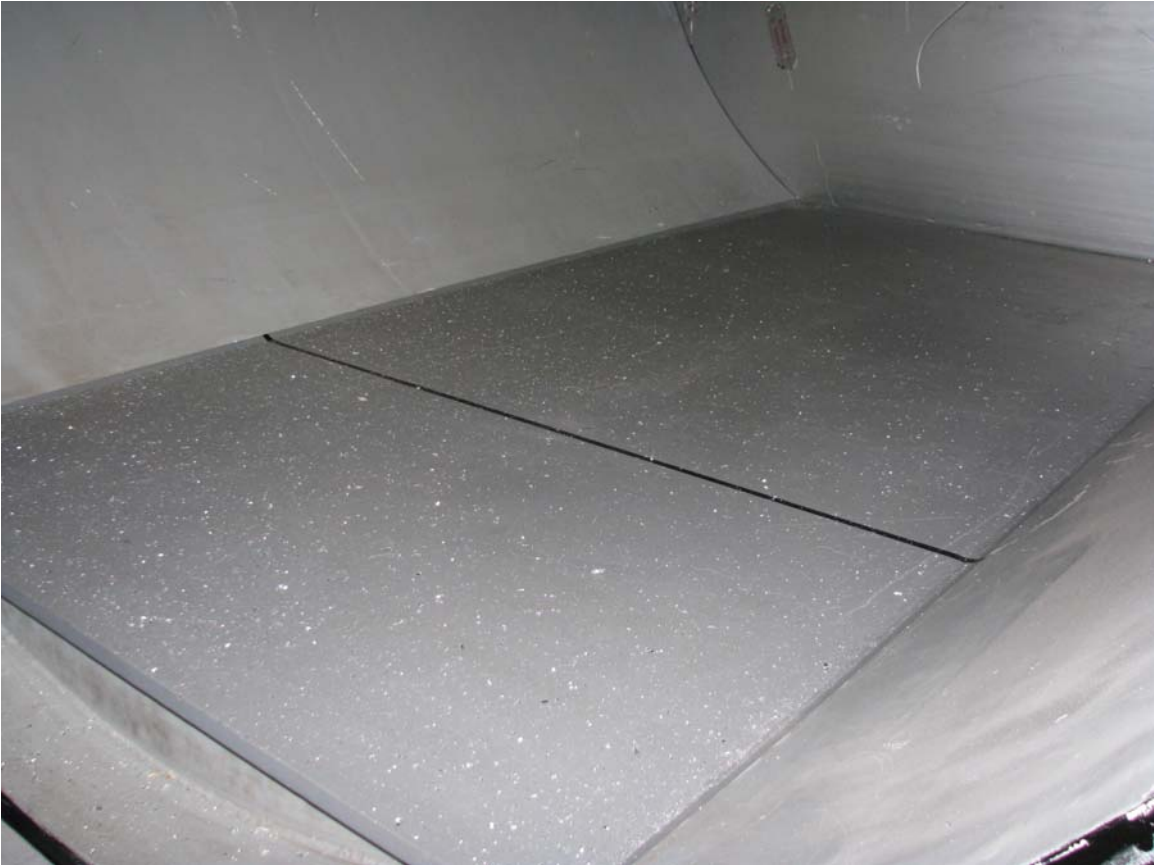
- No pressure rise was measured on the protected side of the specimen.
- The exterior lite fractured and fell to the unprotected side of the window. Both layers of the interior laminated lite were observed to fracture. Pull-out measured 24" at the left jamb, 17" on the left side vertical and 32" at the right jamb. Total pull-out was 18%.
- A dusting of glass was deposited on the floor of the witness area, with no impacts or punctures observed in the witness panel.

ASTM Hazard Rating: Minimal Hazard

GSA Performance Condition: 2

Photo No. 9
Post-test Specimen #3, Interior

Photo No. 10
Post-test Specimen #3, Witness Chamber

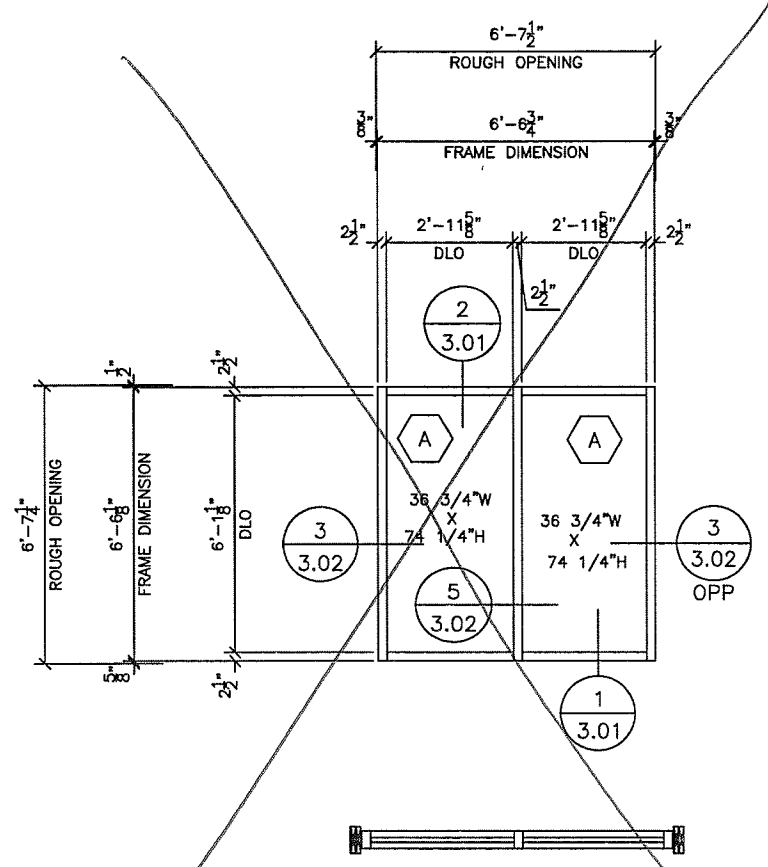
1 SYSTEM: BT601 (2 1/2" X 5")
 SCALE: 1/2" = 1'-0"
 QTY: 1
 ARCH REF: STC TEST ELEVATION

2 SYSTEM: BT601 (2 1/2" X 5")
 SCALE: 1/2" = 1'-0"
 QTY: 4
 ARCH REF: 1PSI RATING

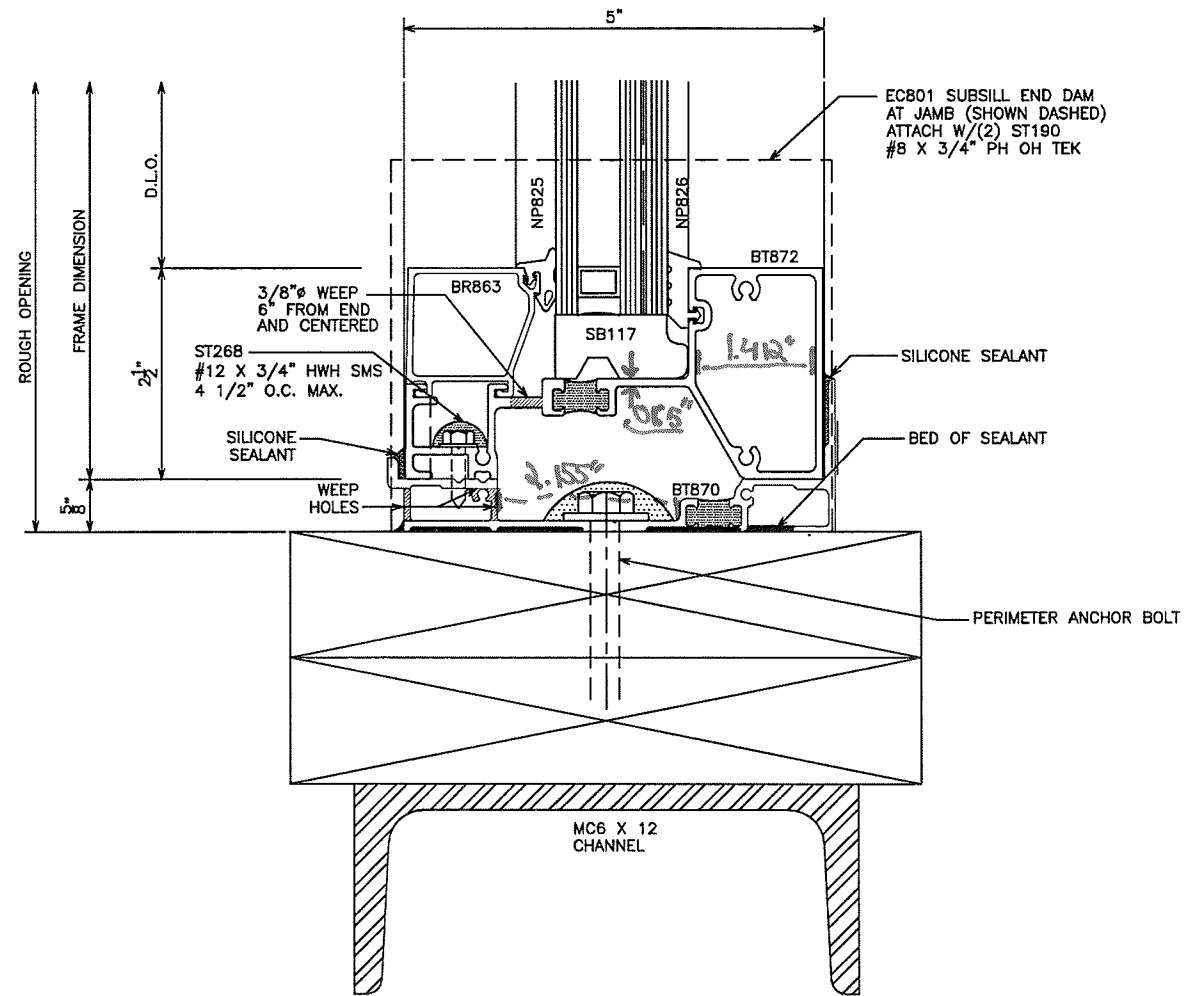
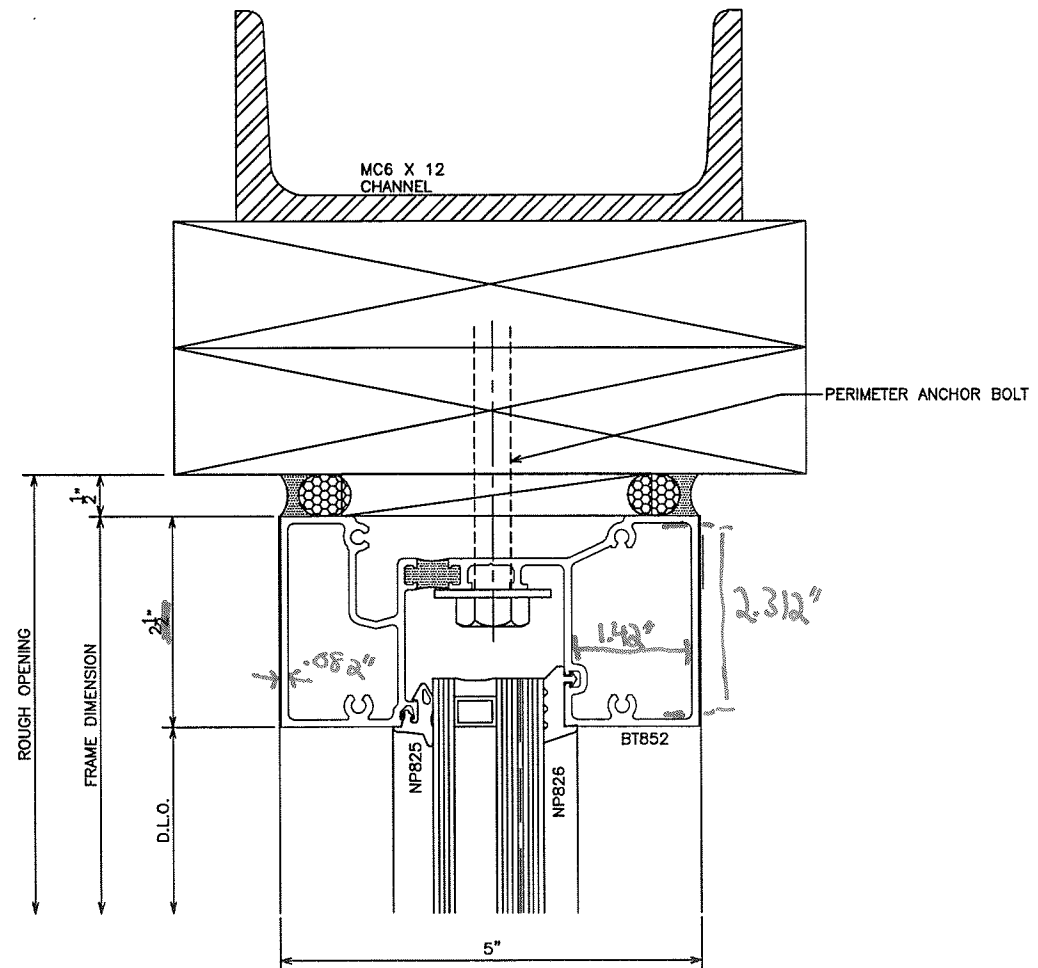
Glazing Details: The window was glazed with a 1-1/4" thick insulating glass unit constructed of an exterior sheet of 1/4" thick annealed glass and an interior sheet of 1/2" thick laminated glass with a 1/2" thick aluminum spacer system. The laminated glass was constructed of two sheets of 1/4" thick annealed glass and a 0.030" thick PVB interlayer. The glass was set from the exterior against a neoprene gasket and secured with a snap-fit glazing clip at the sill and a perimeter rubber wedge gasket. Glazing bite measured 5/8".

1 SILL DETAIL
BT601 (DEFENDER SERIES)
DRY GLAZE

2 HEAD DETAIL
BT601 (DEFENDER SERIES)
DRY GLAZE

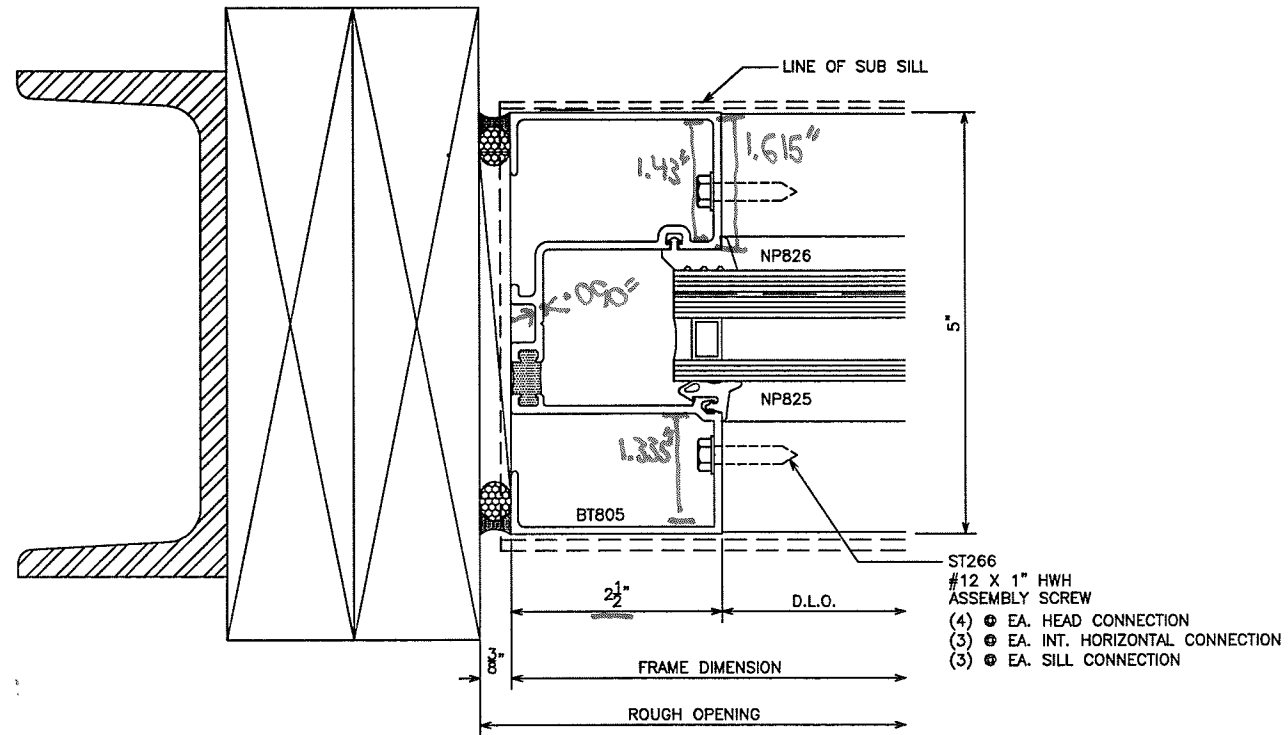
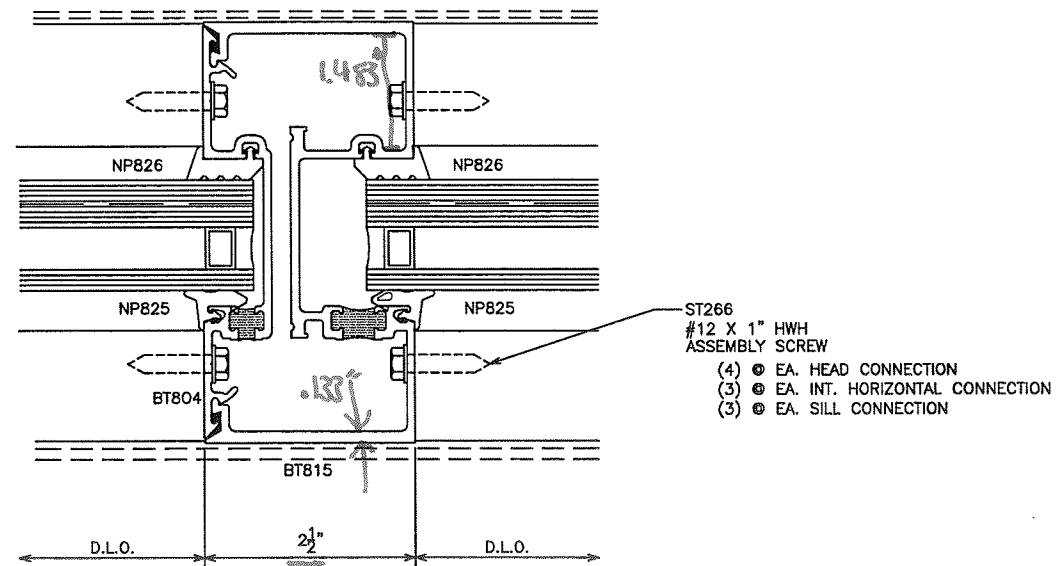
Frame Construction: Frame members were constructed of poured-in-place and debridged thermally improved aluminum with butted corners. The corners were fastened with three #12 x 1" long screws at the jamb/sill connection and four #12 x 1" long screws at the jamb/head connection. The vertical mullion was attached to the frame with three #12 x 1" long screws at the vertical/sill connection and four #12 x 1" long screws at the vertical/head connection.

3 JAMB DETAIL
BT601 (DEFENDER SERIES)
DRY GLAZE

5 VERTICAL DETAIL
BT601 (DEFENDER SERIES)
DRY GLAZE

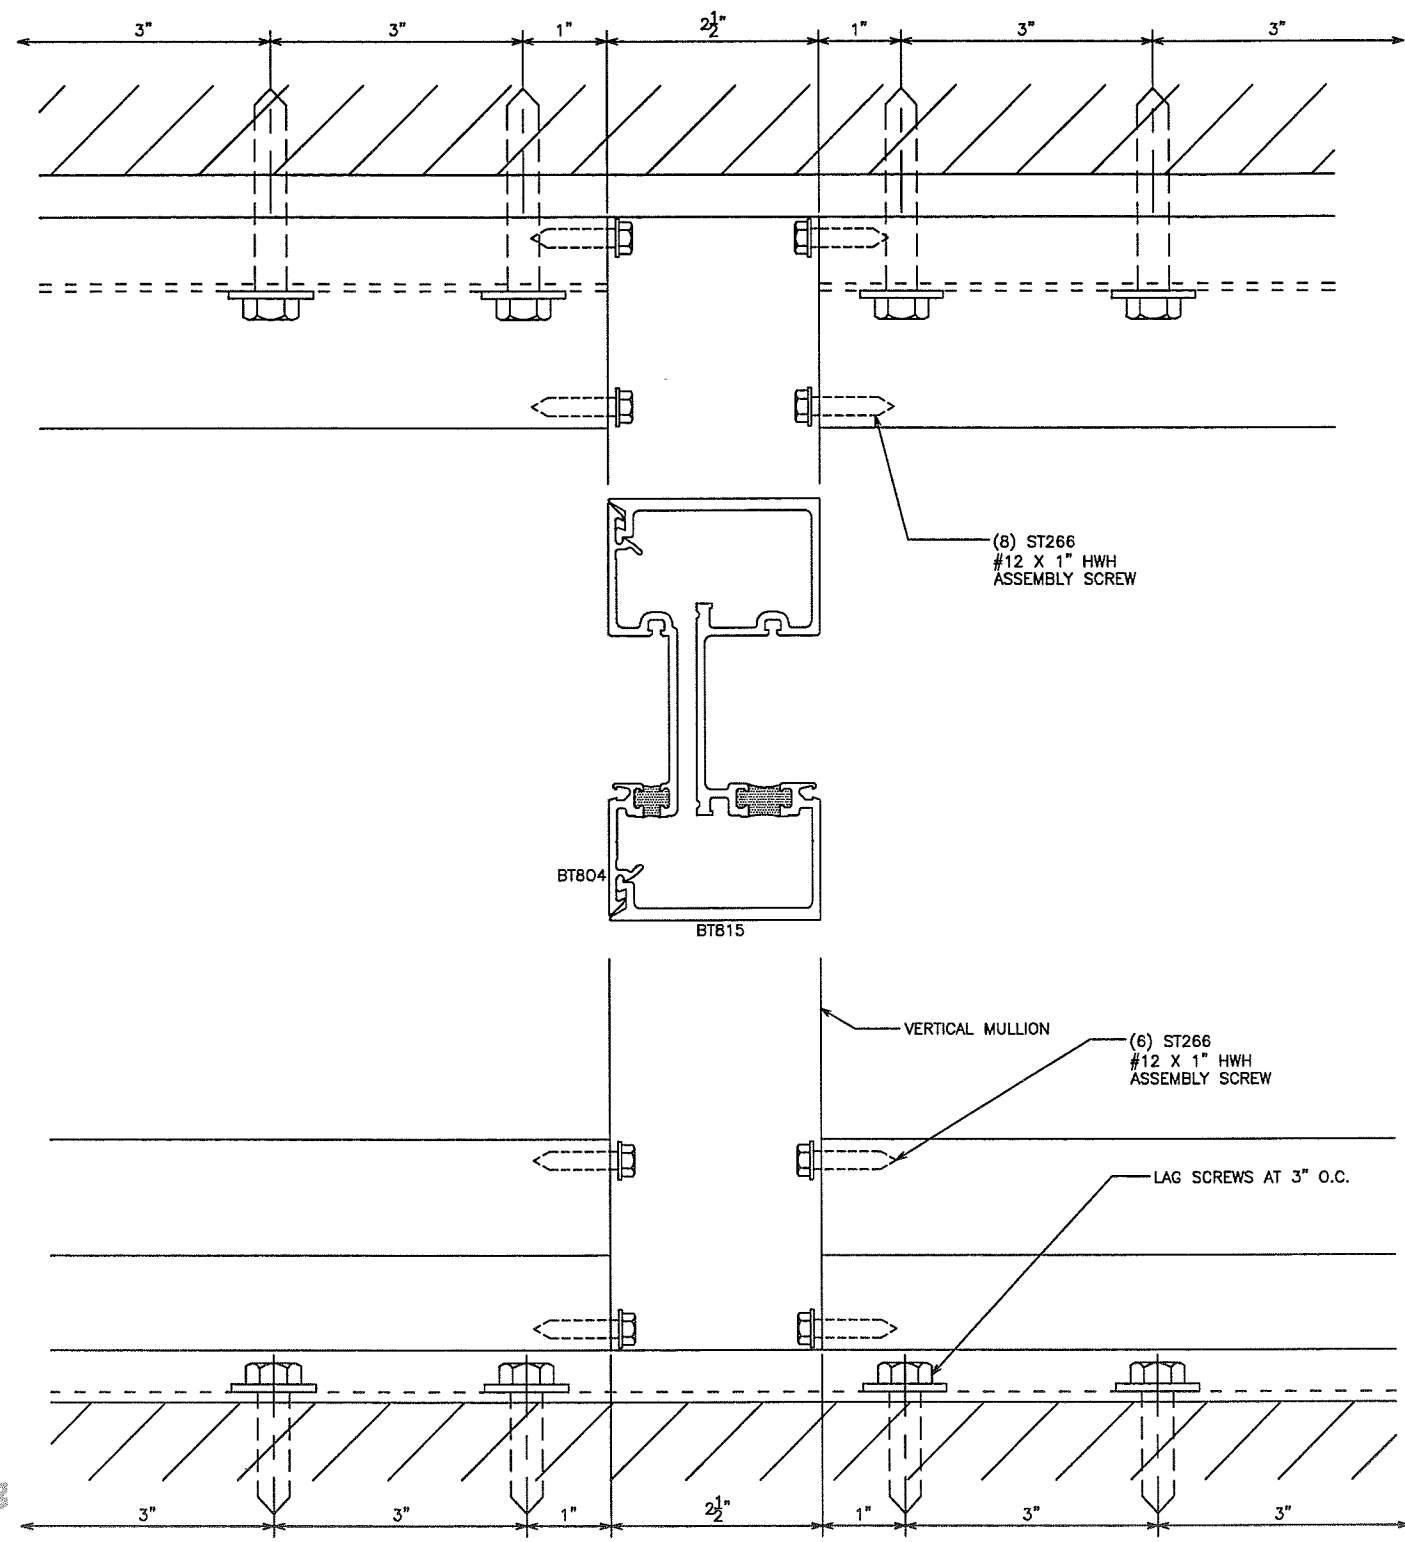
SILL ANCHOR VIEW

Installation: The frame was anchored to a double 2x6 Spruce-Pine-Fir test buck using 1/4" x 4" long Spax® hex head lag screws. Screws were grouped near the jambs and vertical mullion at the head and sill only. Four anchors were grouped near each jamb vertical, spaced 3-1/2" from the end and 3" on center. Four anchors were also grouped on either side of the vertical mullion, located 1" away from the mullion and spaced at 3" on center.
