ACOUSTICAL PERFORMANCE TEST REPORT

ASTM E90 SOUND TRANSMISSION LOSS TESTING ON A IW8100, FIXED WINDOW

I0167.01-303-11 R0

CR LAURENCE CO, INC.

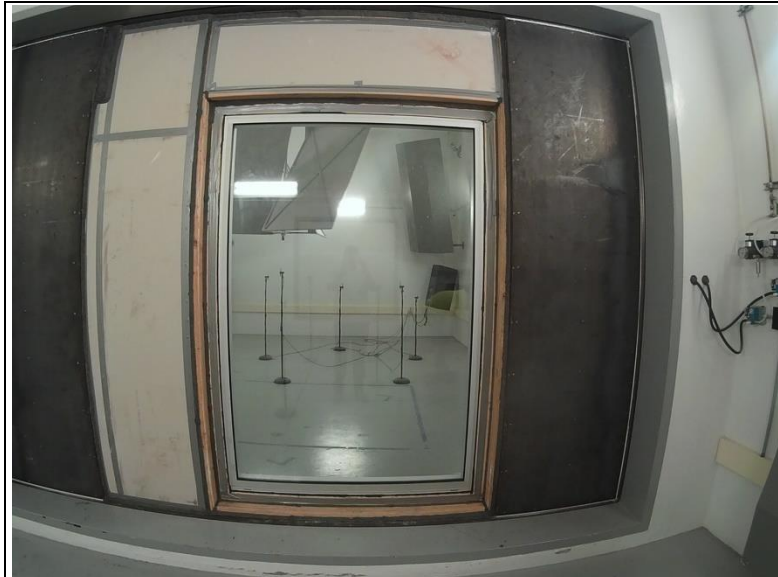
Photo No. 1
Source Room View of Test Specimen

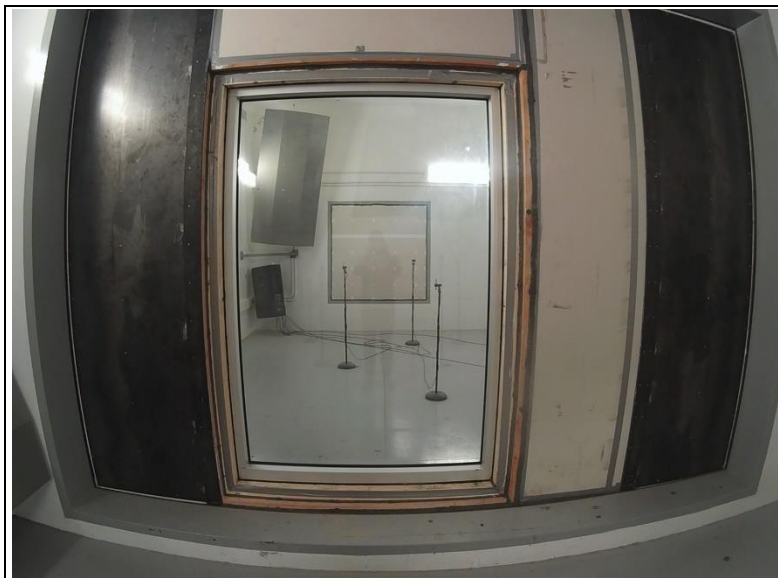
Photo No. 2
Receive Room View of Test Specimen
