PERFORMANCE TEST REPORT

Report No.: A8744.04-801-18

C.R. Laurence Co., INC.
Los Angeles, California

PRODUCT TYPE: Curtain Wall Systems
SERIES/MODEL: StormWall®XL

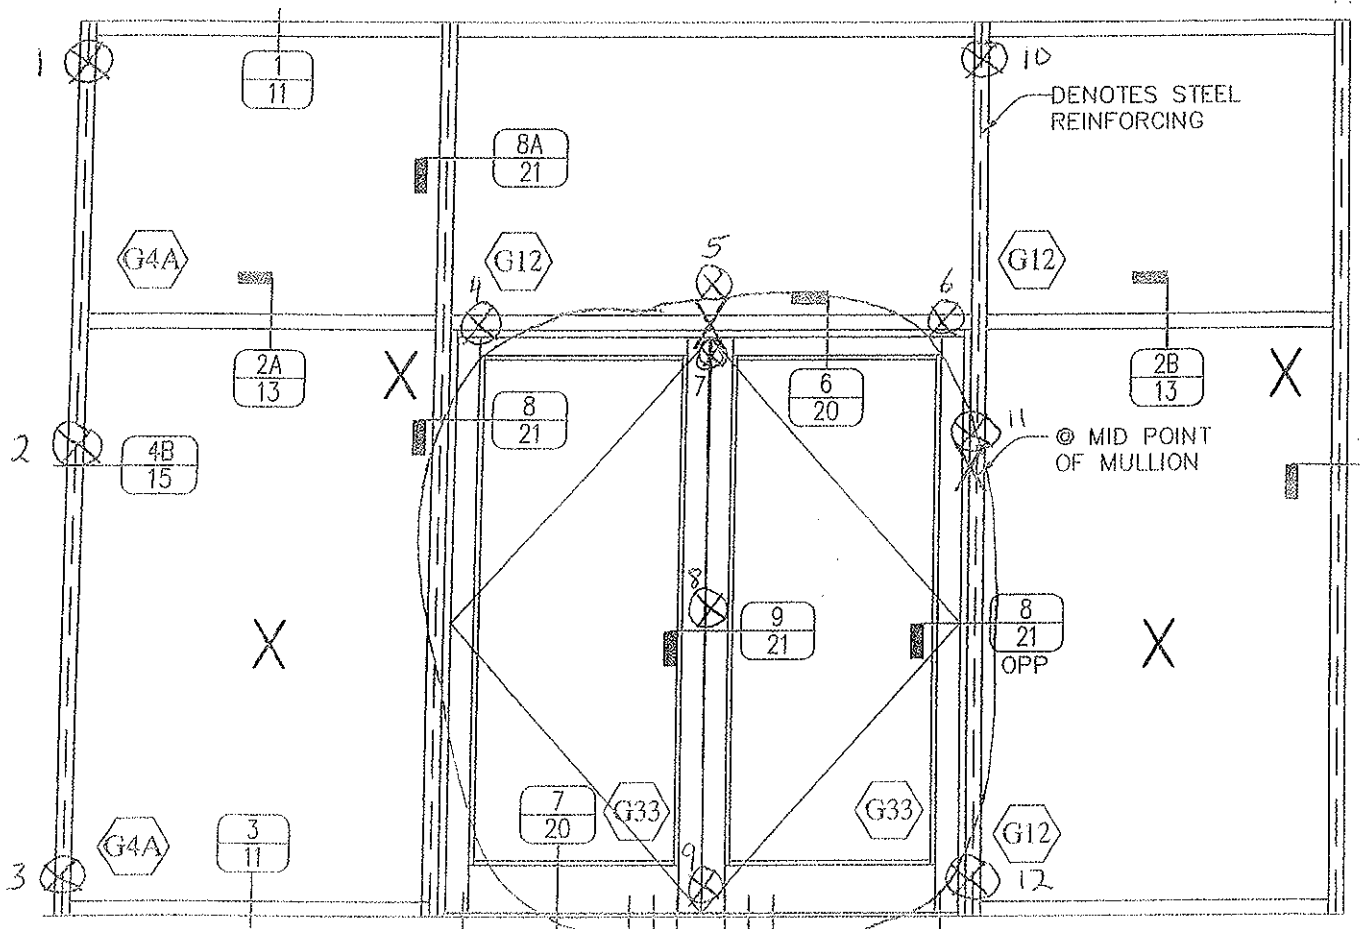
Sketch #1

TEST UNIT E1

⊗ = Indicator Locations

× = Impact Locations

Impact #1: Missile Velocity: 15.3 m/s (50.1 fps)	
Impact Area:	Bottom left lite, center of glass
Observations:	No rupture, no penetration in excess of allowable, sacrificial lite broke
Results:	Pass

Impact #2: Missile Velocity: 15.2 m/s (50.0 fps)	
Impact Area:	Bottom left lite, top right corner of glass
Observations:	No rupture, no penetration in excess of allowable, sacrificial lite broke
Results:	Pass

Impact #3: Missile Velocity: 15.3 m/s (50.2 fps)	
Impact Area:	Bottom right lite, top right corner of glass
Observations:	No rupture, no penetration in excess of allowable, sacrificial lite broke
Results:	Pass

Impact #4: Missile Velocity: 15.3 m/s (50.2 fps)	
Impact Area:	Bottom right lite, center of glass
Observations:	No rupture, no penetration in excess of allowable, sacrificial lite broke
Results:	Pass

Impact #5: Missile Velocity: 15.3 m/s (50.3 fps)	
Impact Area:	Right vertical mullion, midpoint
Observations:	No rupture, no penetration in excess of allowable
Results:	Pass

Impact #6: Missile Velocity: 15.3 m/s (50.2 fps)	
Impact Area:	Center horizontal mullion, midpoint
Observations:	No rupture, no penetration in excess of allowable
Results:	Pass

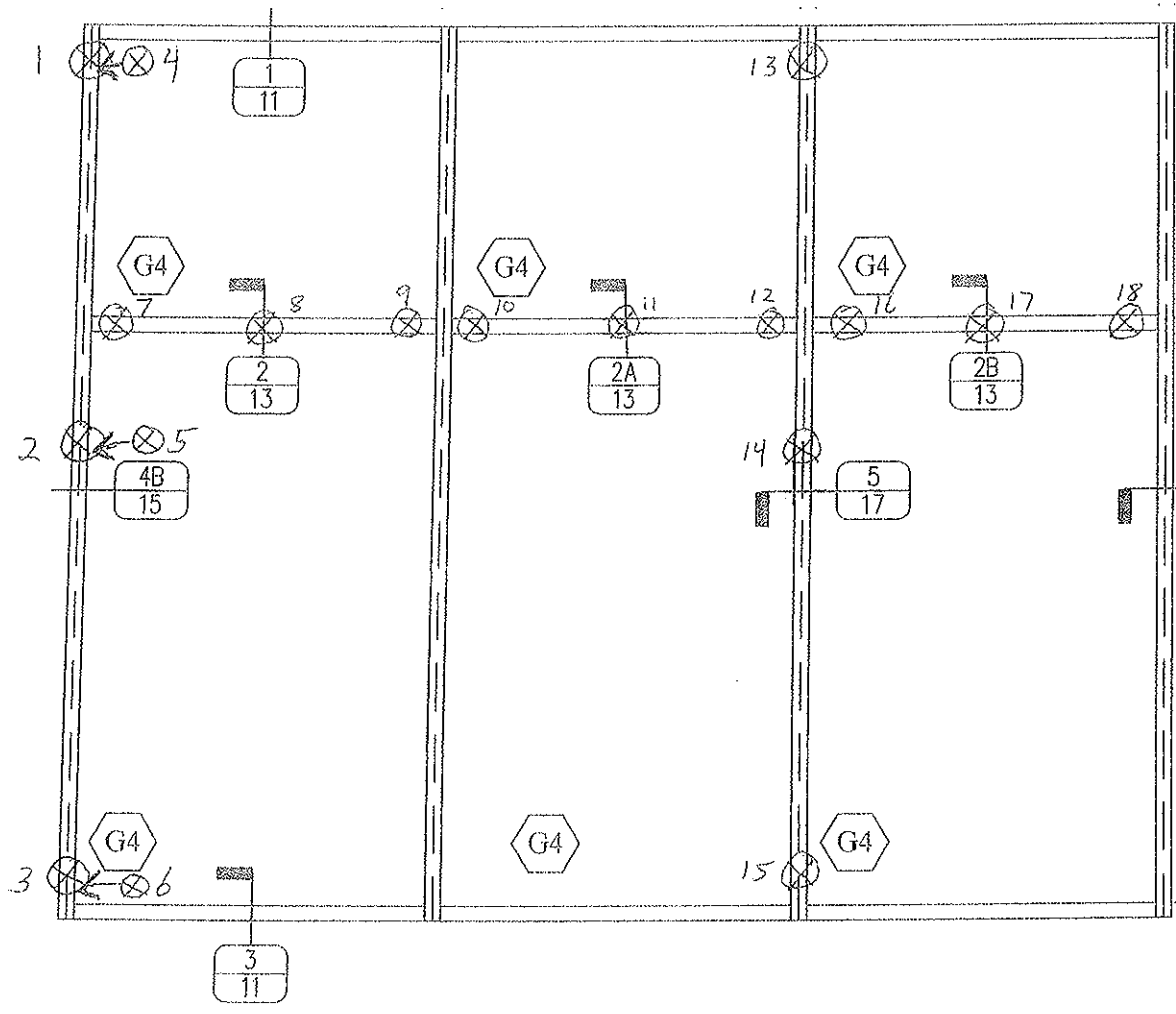
Sketch #2

TEST UNIT E2

Note: Indicator readings 4-6 were taken on the lateral face of the jamb

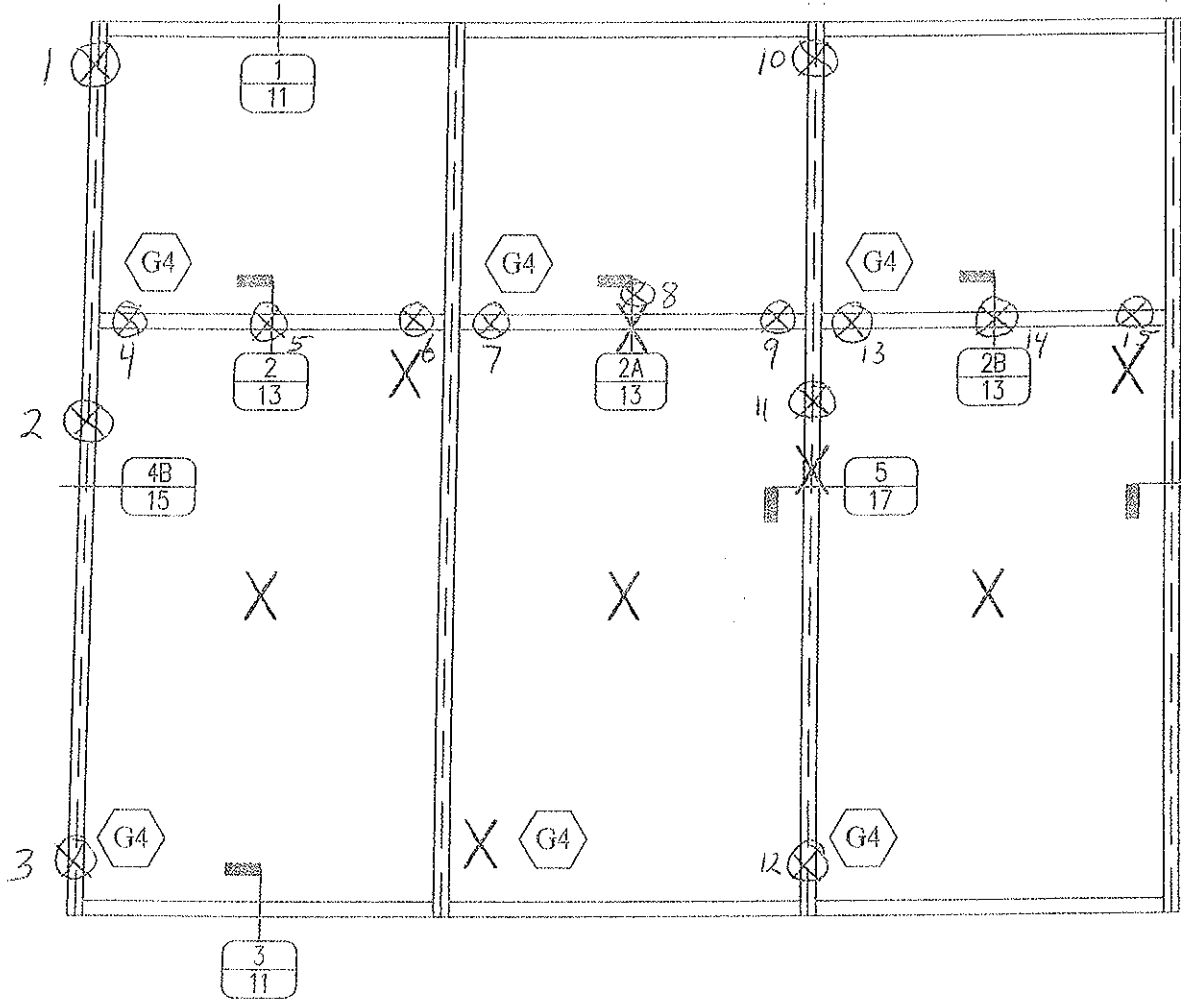
Sketch #3

TEST UNIT E2

⊗ = Indicator Locations

⊗ = Impact Locations

Impact #1: Missile Velocity: 15.5 m/s (50.7 fps)	
Impact Area:	Bottom left lite, center of glass
Observations:	No rupture, no penetration in excess of allowable, sacrificial lite broke
Results:	Pass

Impact #2: Missile Velocity: 15.5 m/s (50.9 fps)	
Impact Area:	Bottom left lite, top right corner of glass
Observations:	No rupture, no penetration in excess of allowable, sacrificial lite broke
Results:	Pass

Impact #3: Missile Velocity: 15.4 m/s (50.6 fps)	
Impact Area:	Bottom center lite, bottom left corner of glass
Observations:	No rupture, no penetration in excess of allowable, sacrificial lite broke
Results:	Pass

Impact #4: Missile Velocity: 15.4 m/s (50.6 fps)	
Impact Area:	Bottom center lite, center of glass
Observations:	No rupture, no penetration in excess of allowable, sacrificial lite broke
Results:	Pass

Impact #5: Missile Velocity: 15.5 m/s (50.7 fps)	
Impact Area:	Center horizontal mullion, midpoint
Observations:	No rupture, no penetration in excess of allowable
Results:	Pass

Impact #6: Missile Velocity: 15.3 m/s (50.2 fps)	
Impact Area:	Bottom right lite, top right corner of glass
Observations:	No rupture, no penetration in excess of allowable, sacrificial lite broke
Results:	Pass

Impact #7: Missile Velocity: 15.5 m/s (50.8 fps)	
Impact Area:	Bottom right lite, center of glass
Observations:	No rupture, no penetration in excess of allowable, sacrificial lite broke
Results:	Pass

Impact #8: Missile Velocity: 15.3 m/s (50.1 fps)	
Impact Area:	Right vertical mullion, midpoint
Observations:	No rupture, no penetration in excess of allowable
Results:	Pass

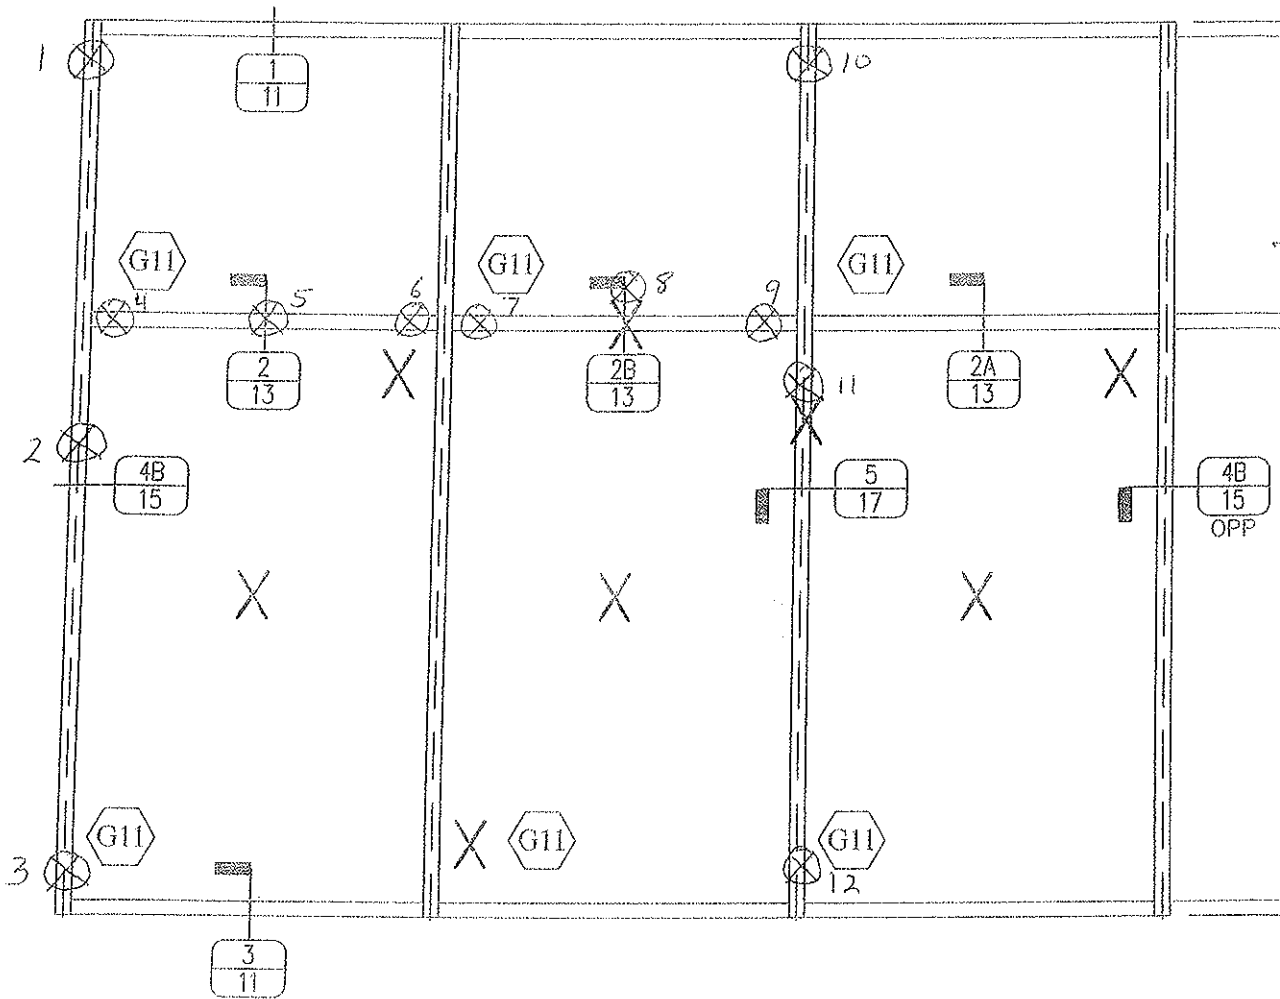
Sketch #4

TEST UNIT E3

⊗ = Indicator Locations

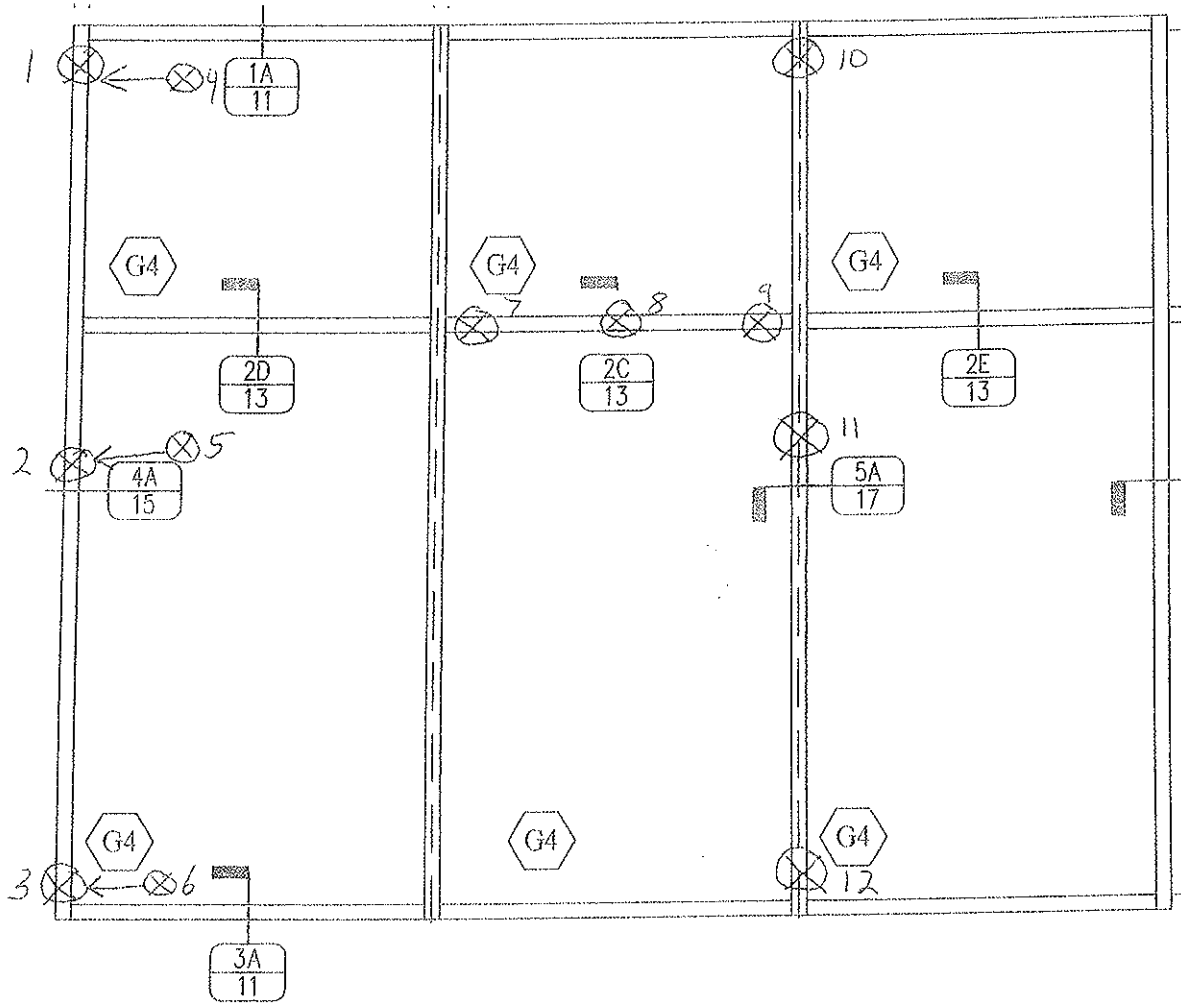
Sketch #8

TEST UNIT E6

⊗ = Indicator Locations

Note: Indicator readings 4-6 were taken on the lateral face of the jamb

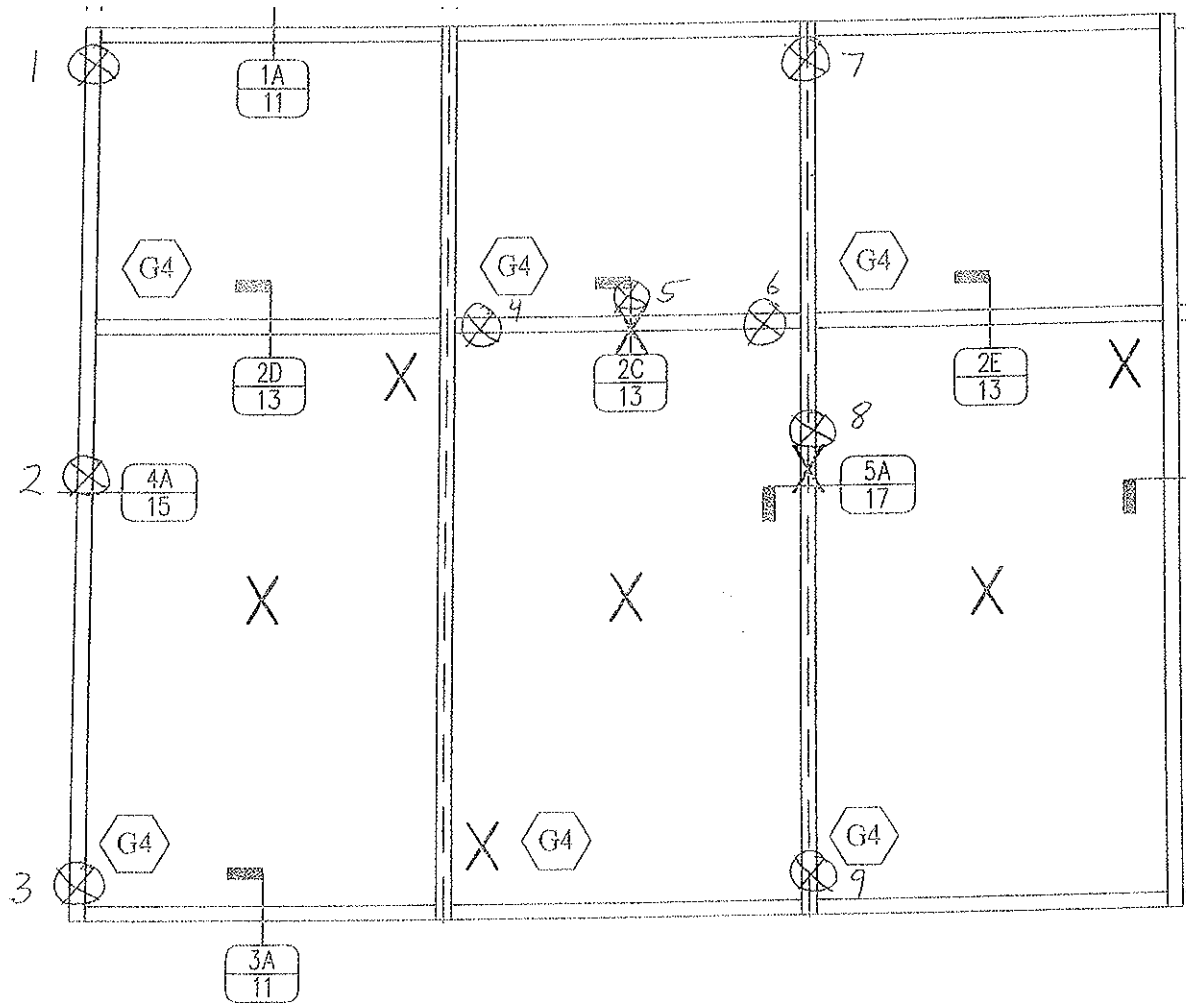
Sketch #9

TEST UNIT E6

⊗ = Indicator Locations

× = Impact Locations

Impact #1: Missile Velocity: 15.3 m/s (50.2 fps)	
Impact Area:	Bottom left lite, center of glass
Observations:	No rupture, no penetration in excess of allowable, sacrificial lite broke
Results:	Pass

Impact #2: Missile Velocity: 15.5 m/s (50.8 fps)	
Impact Area:	Bottom left lite, top right corner of glass
Observations:	No rupture, no penetration in excess of allowable, sacrificial lite broke
Results:	Pass

Impact #3: Missile Velocity: 15.4 m/s (50.6 fps)	
Impact Area:	Bottom center lite, bottom left corner of glass
Observations:	No rupture, no penetration in excess of allowable, sacrificial lite broke
Results:	Pass

Impact #4: Missile Velocity: 15.4 m/s (50.5 fps)	
Impact Area:	Bottom center lite, center of glass
Observations:	No rupture, no penetration in excess of allowable, sacrificial lite broke
Results:	Pass

Impact #5: Missile Velocity: 15.5 m/s (50.8 fps)	
Impact Area:	Center horizontal mullion, midpoint
Observations:	No rupture, no penetration in excess of allowable
Results:	Pass

Impact #6: Missile Velocity: 15.5 m/s (51.0 fps)	
Impact Area:	Right vertical mullion, midpoint
Observations:	No rupture, no penetration in excess of allowable
Results:	Pass

Impact #7: Missile Velocity: 15.5 m/s (50.8 fps)	
Impact Area:	Bottom right lite, top right corner of glass
Observations:	No rupture, no penetration in excess of allowable, sacrificial lite broke
Results:	Pass

Impact #8: Missile Velocity: 15.5 m/s (50.7 fps)	
Impact Area:	Bottom right lite, center of glass
Observations:	No rupture, no penetration in excess of allowable, sacrificial lite broke
Results:	Pass

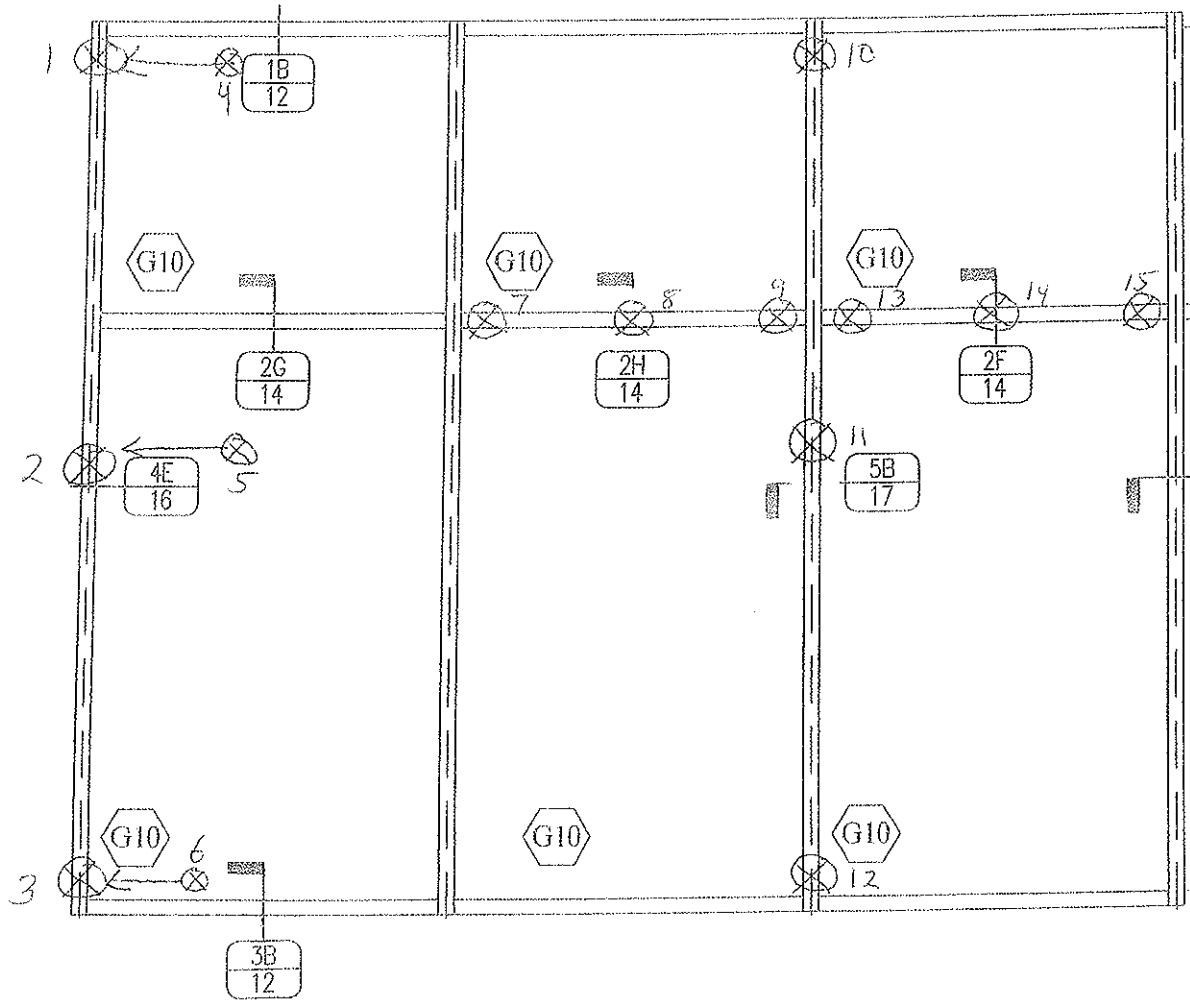
Sketch #10

TEST UNIT E7

⊗ = Indicator Locations

Note: Indicator readings 4-6 were taken on the lateral face of the jamb

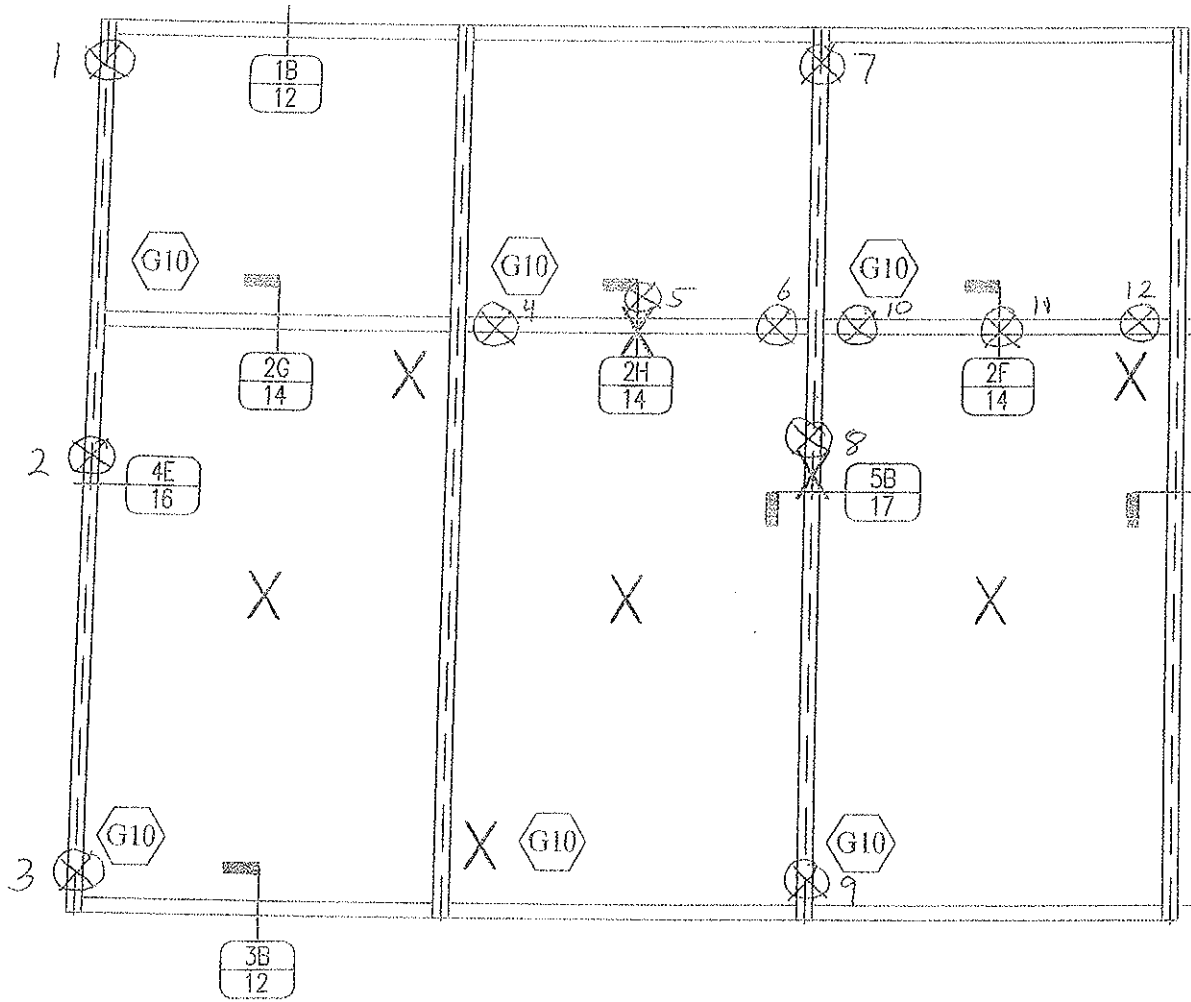
Sketch #11

TEST UNIT E7

⊗ = Indicator Locations

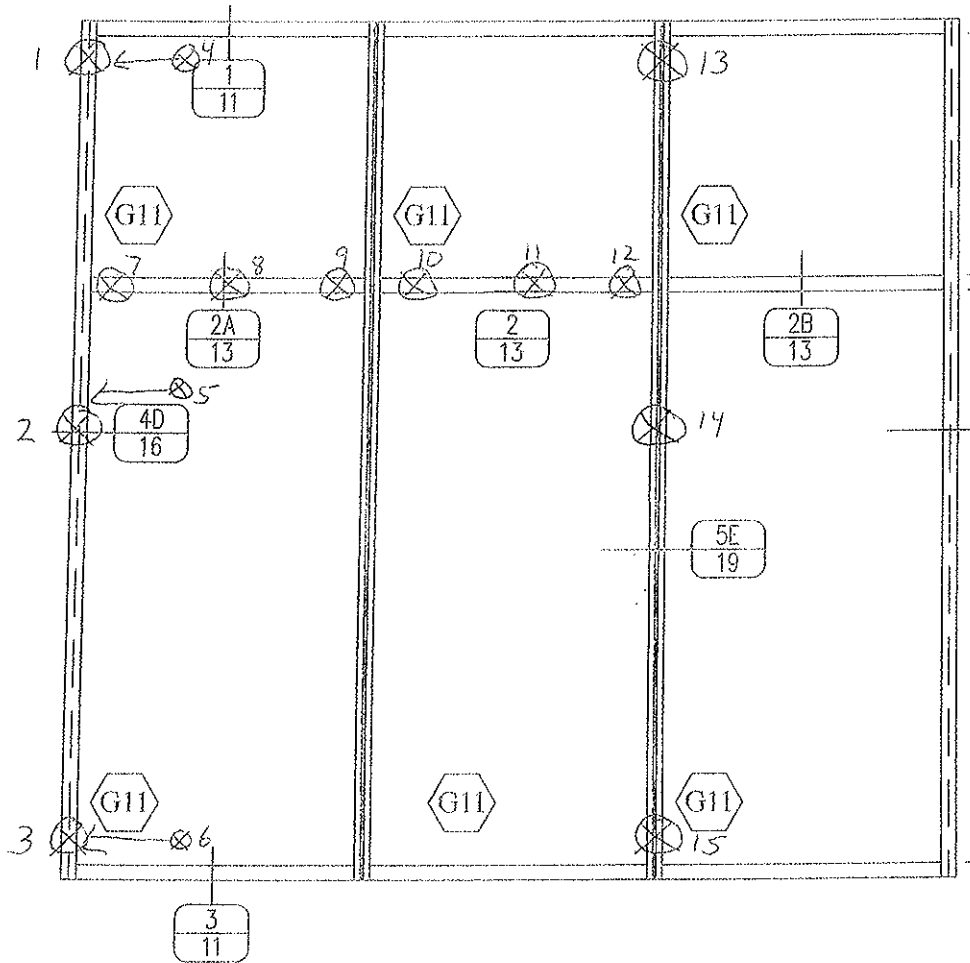
Sketch #14

TEST UNIT E9

Note: Indicator readings 4-6 were taken on the lateral face of the jamb

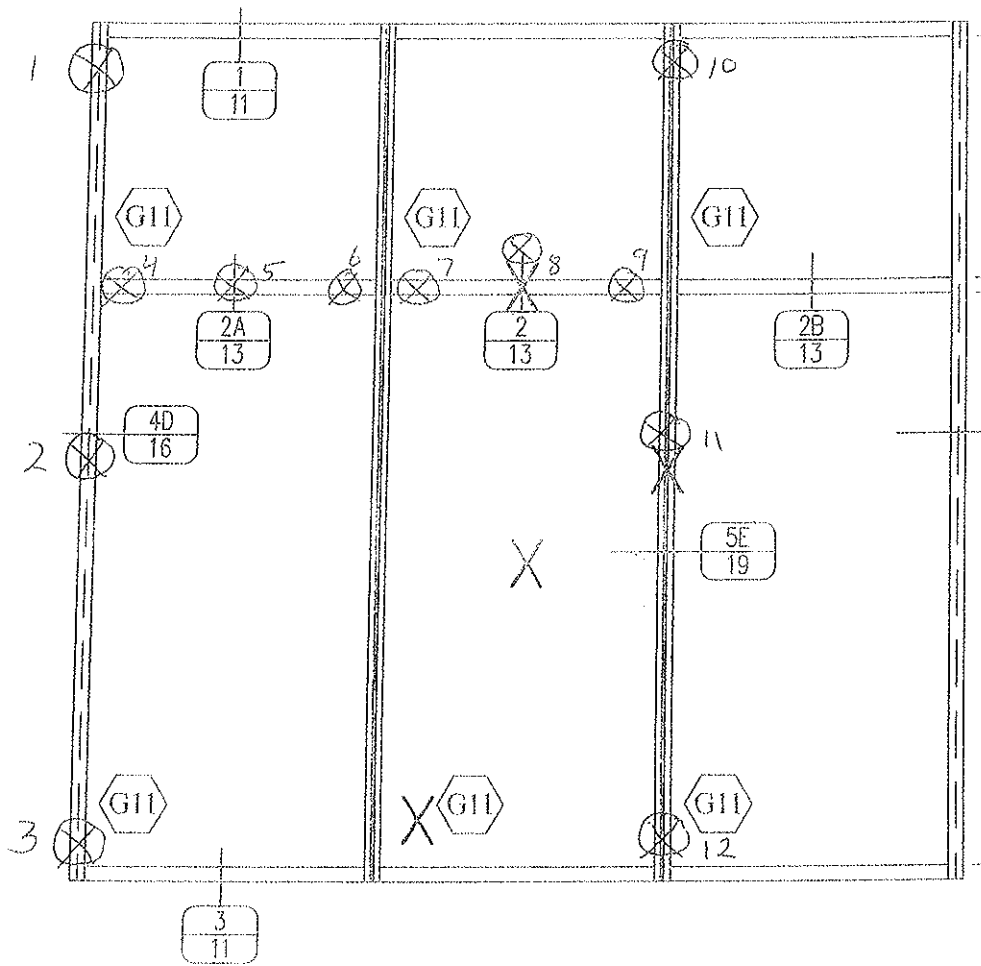
Sketch #15

TEST UNIT E9

⊗ = Indicator Locations

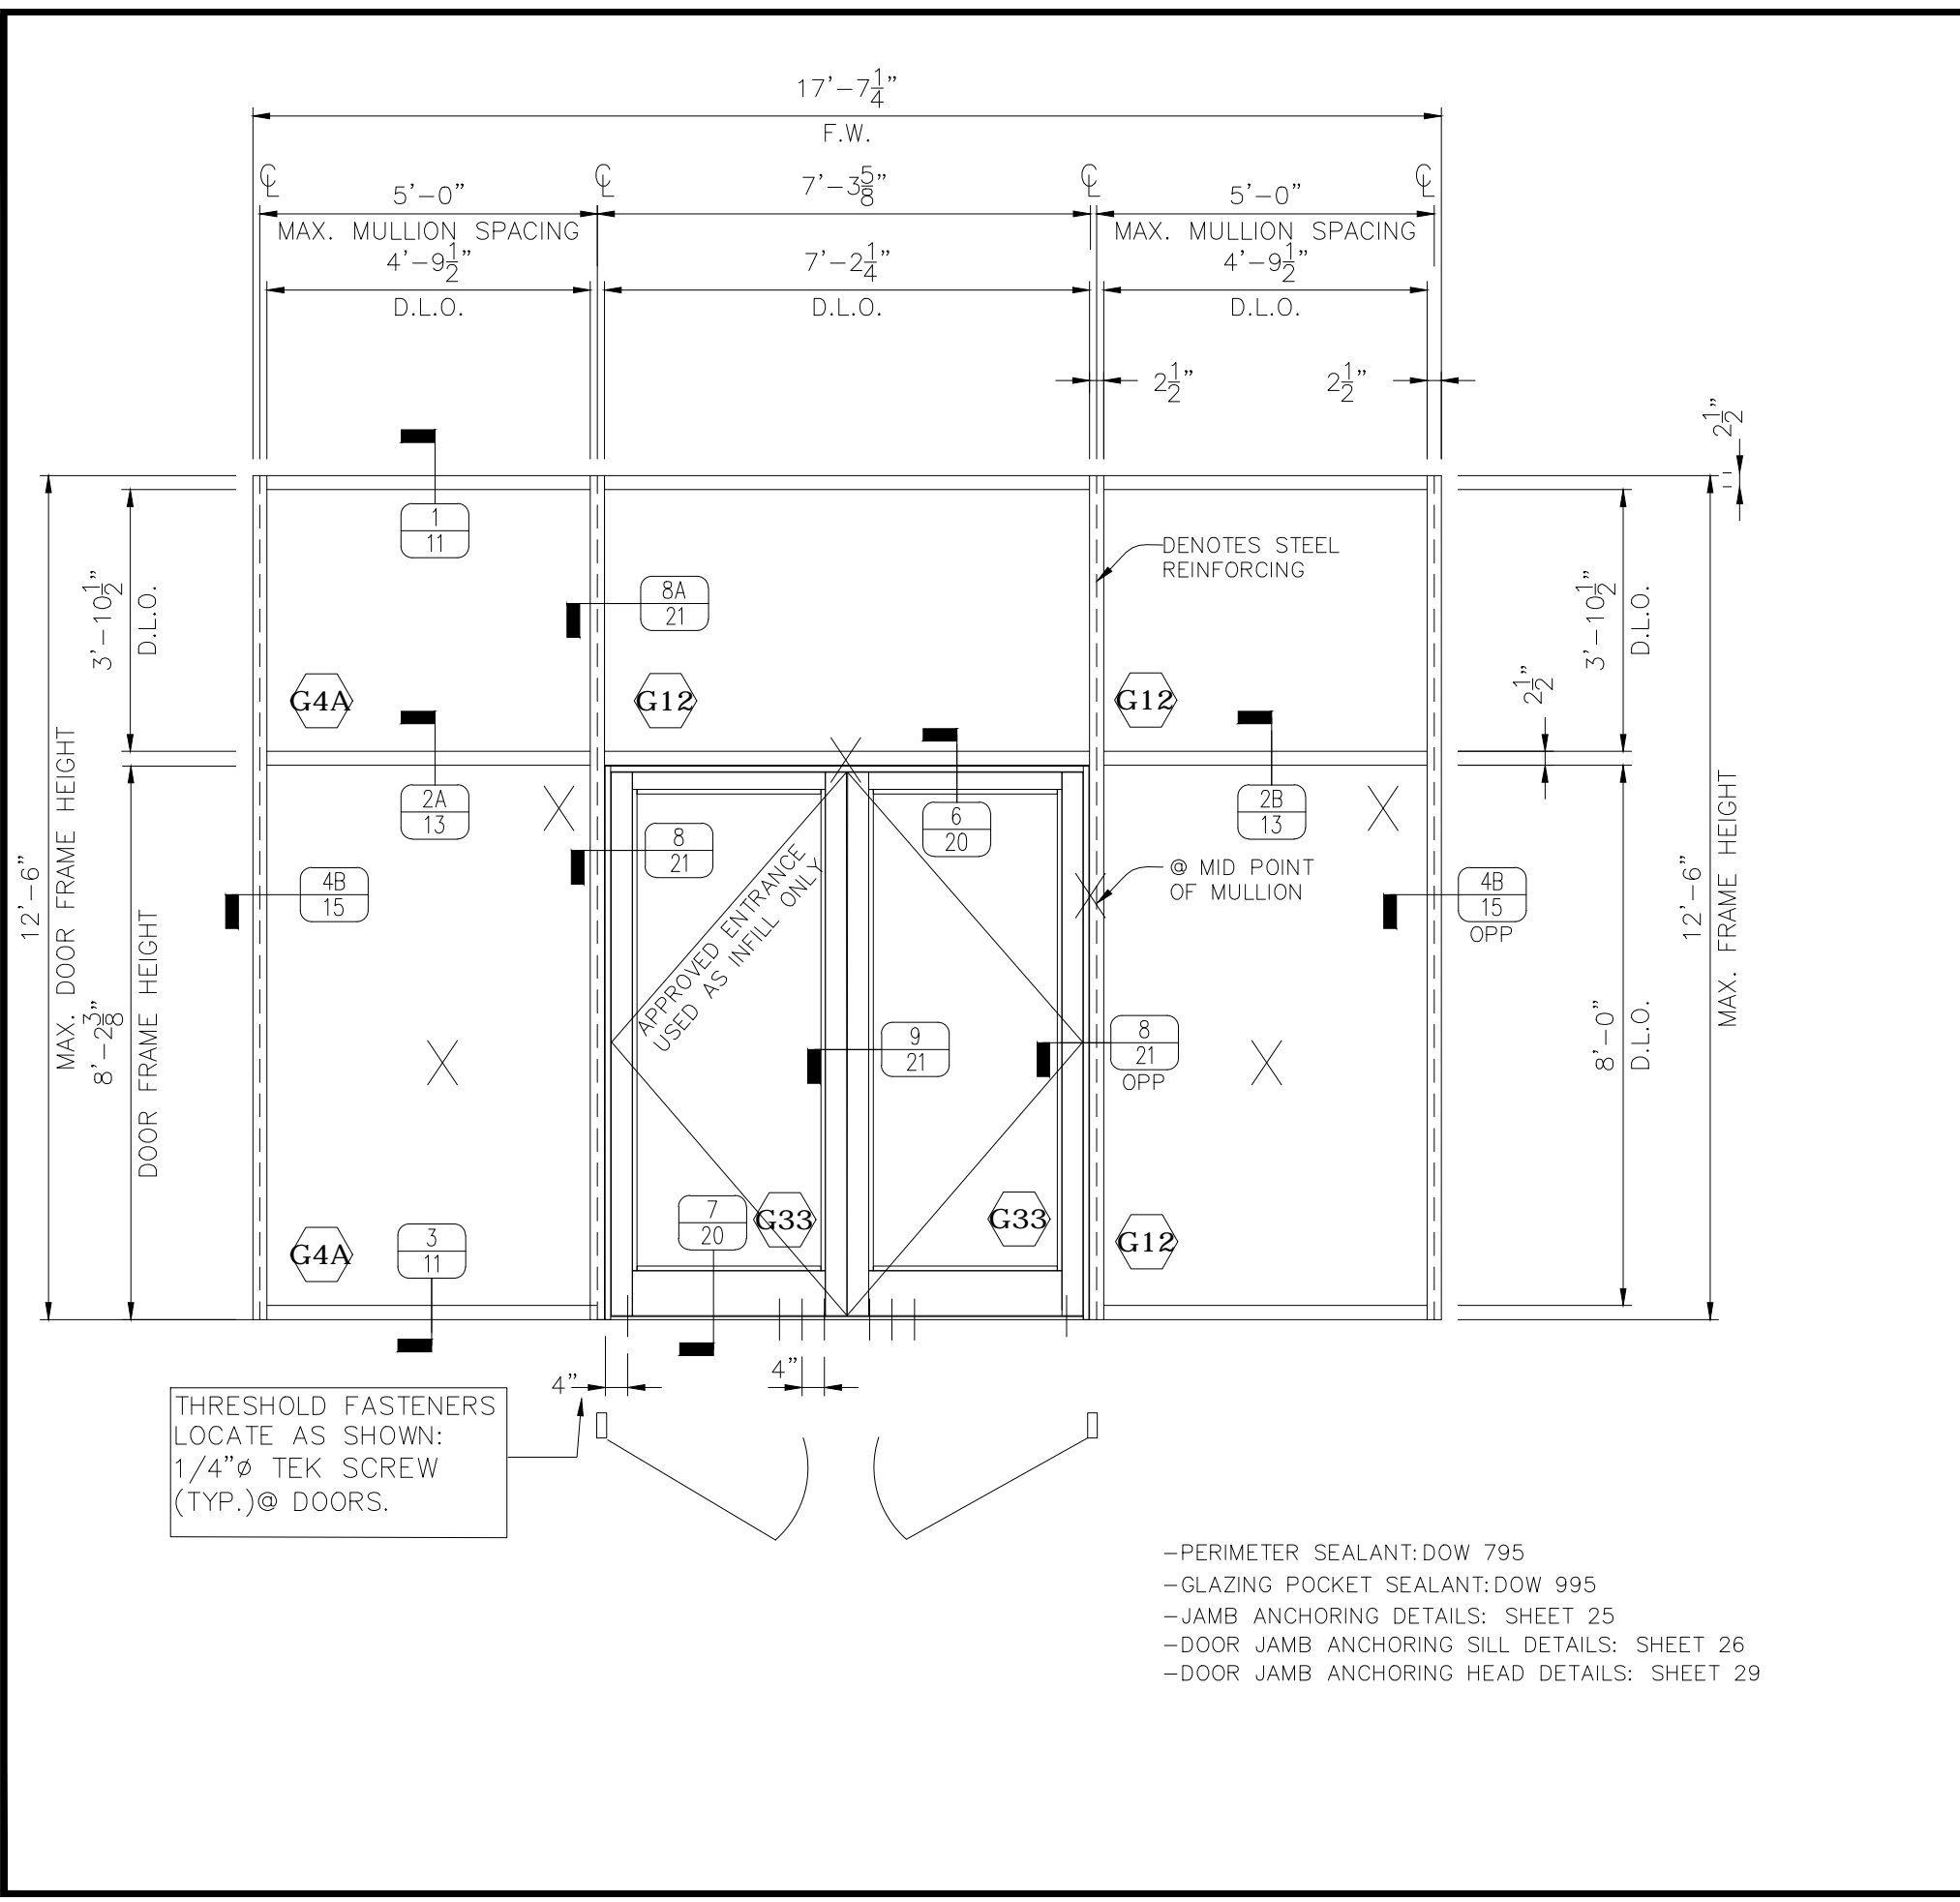
SHT 1 OF 39

ELEVATION E1 CAPTURED MULLION -ENTRANCE- WITH STEEL FOR ENTRANCE DOORS, IN STEEL BUCK FRAME.

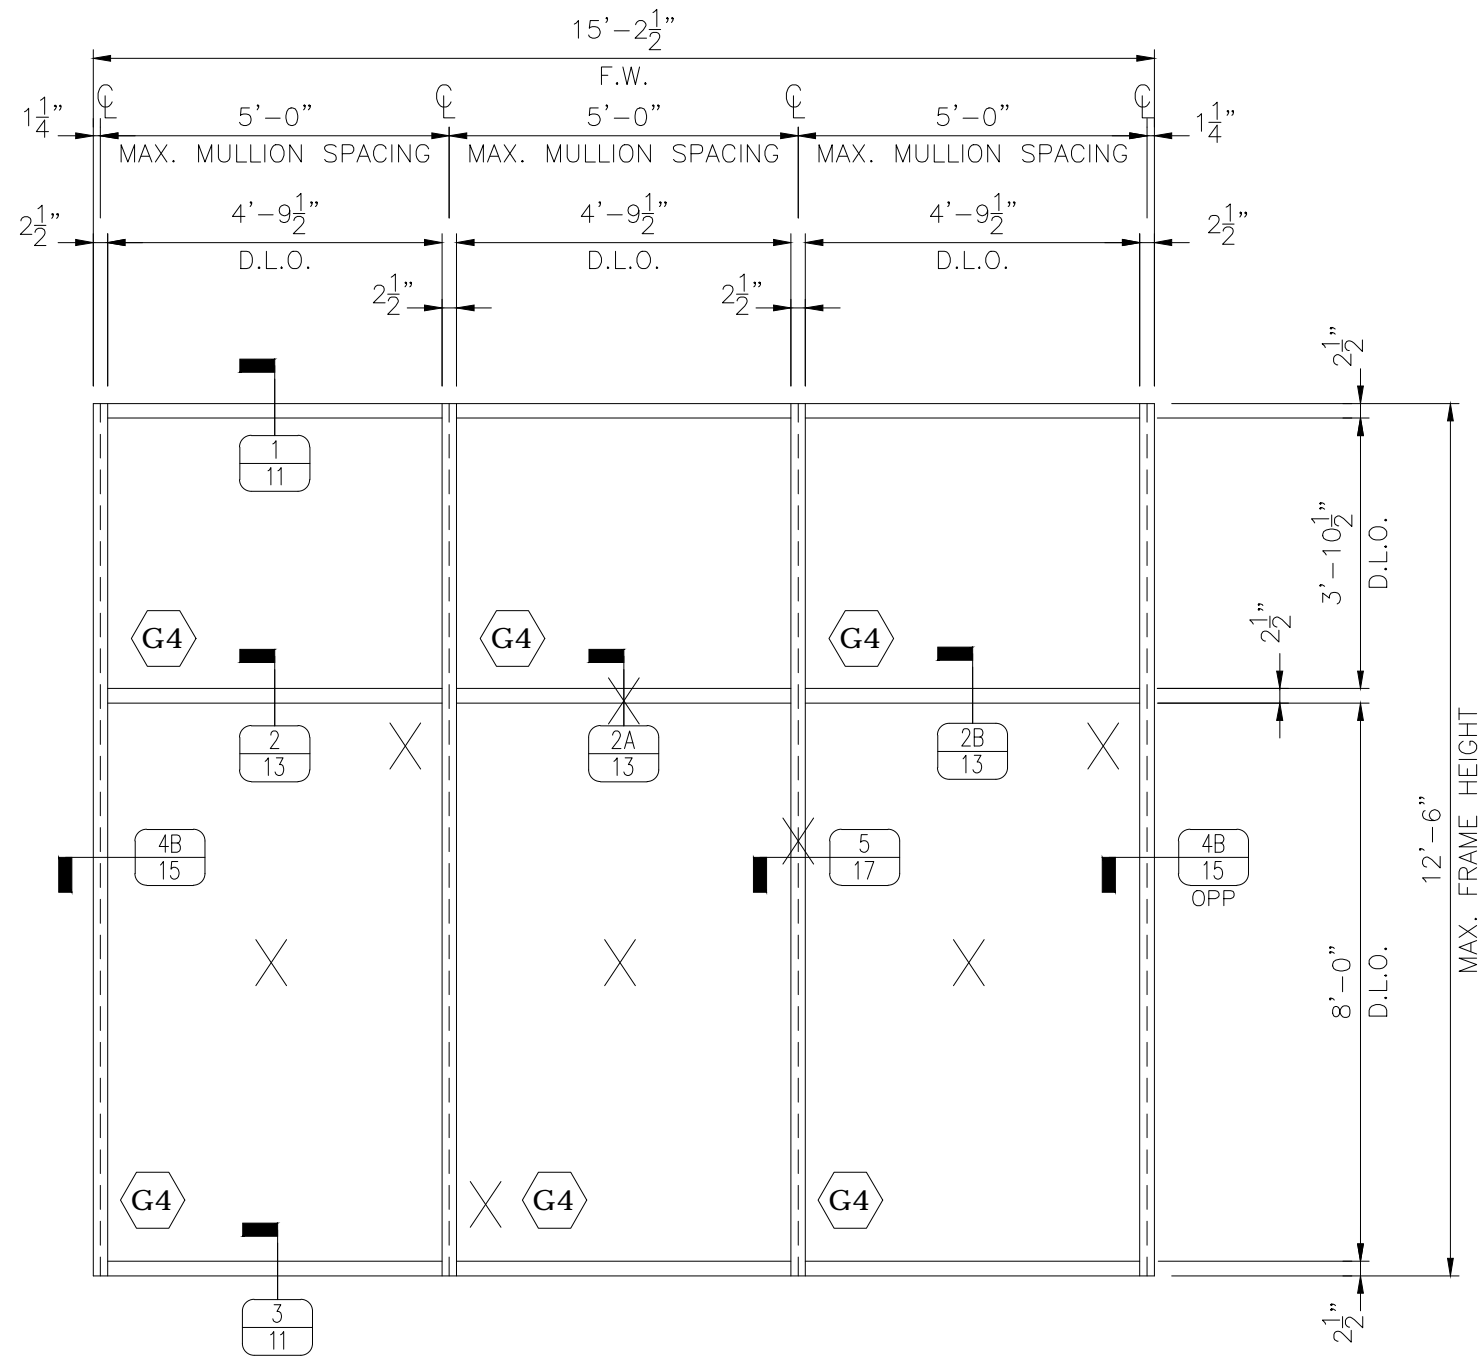
SHT 2 OF 39

- PERIMETER SEALANT: GE SCS 2000
- GLAZING POCKET SEALANT: GE SSG 4600 CTG
- JAMB ANCHORING DETAILS: SHEET 25
- MULLION ANCHORING DETAILS: SHEET 29

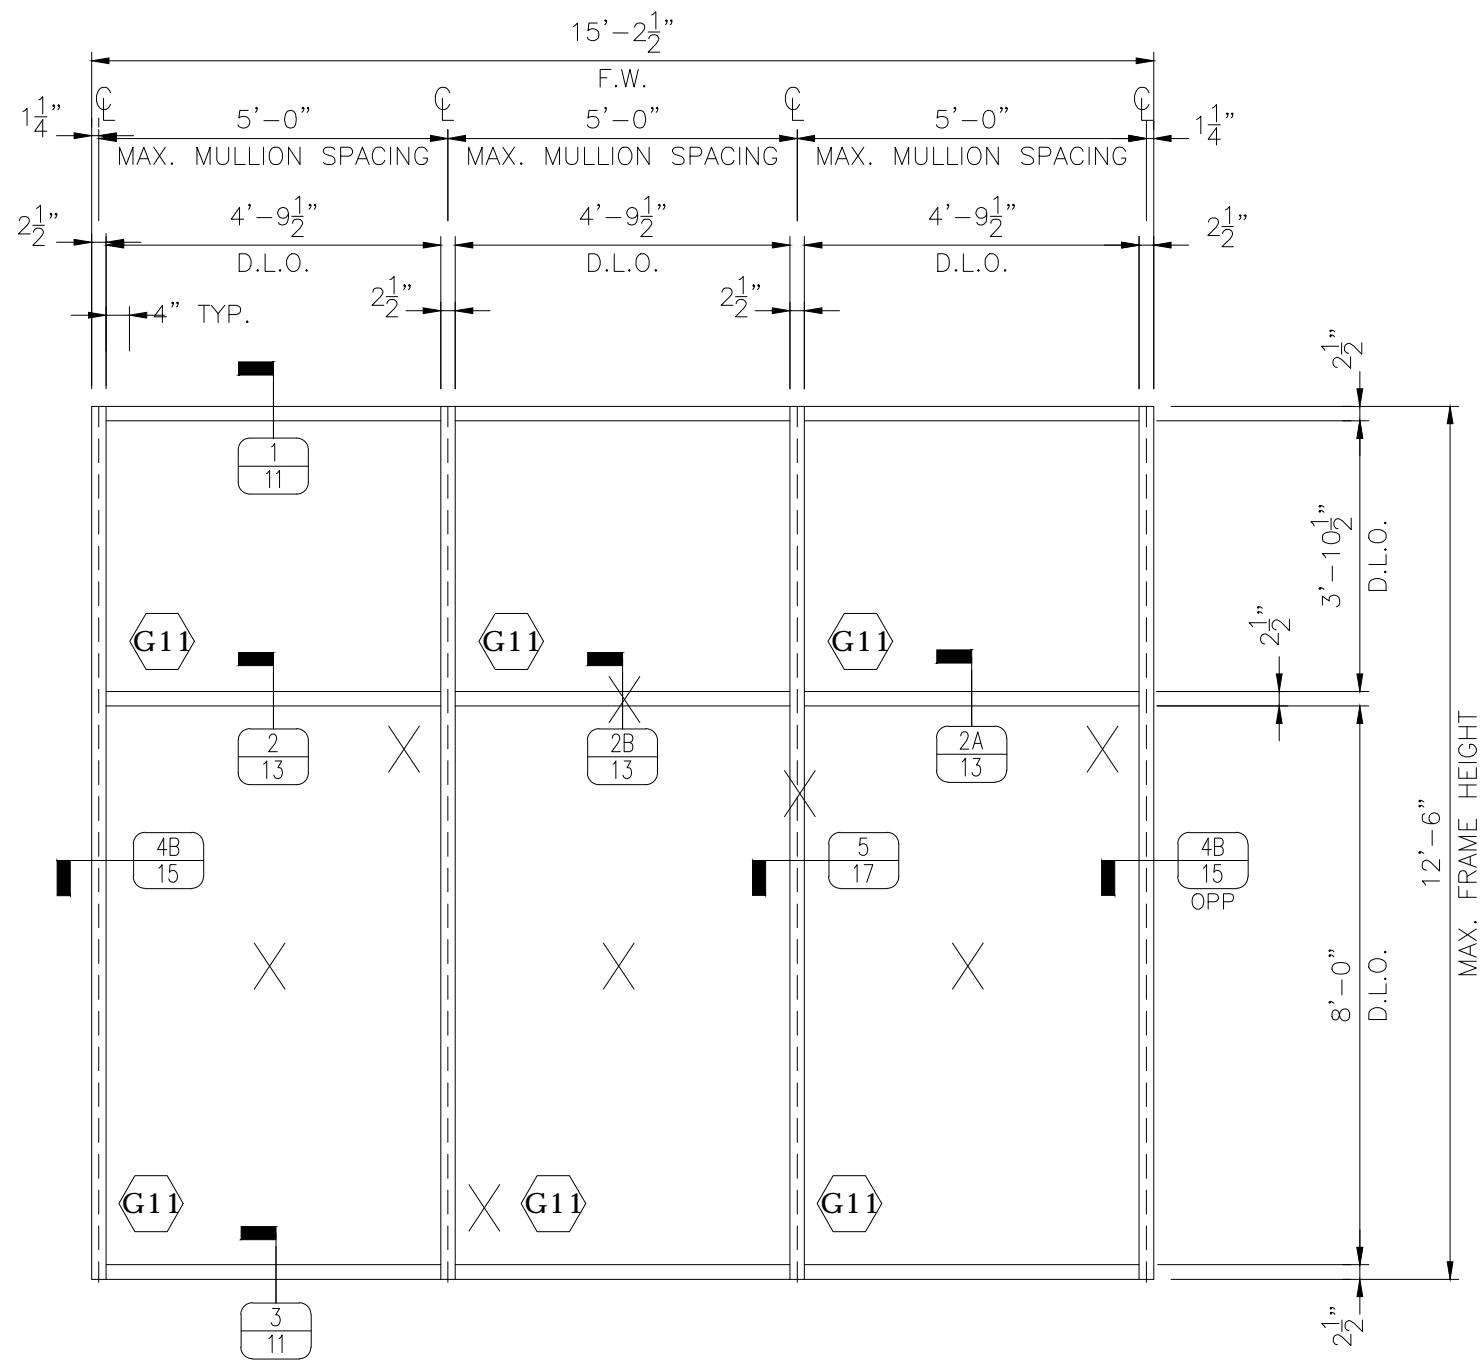
SHT 3 OF 39

- PERIMETER SEALANT: DOW 795
- GLAZING POCKET SEALANT: DOW 995
- JAMB ANCHORING DETAILS: SHEET 25
- MULLION ANCHORING DETAILS: SHEET 29

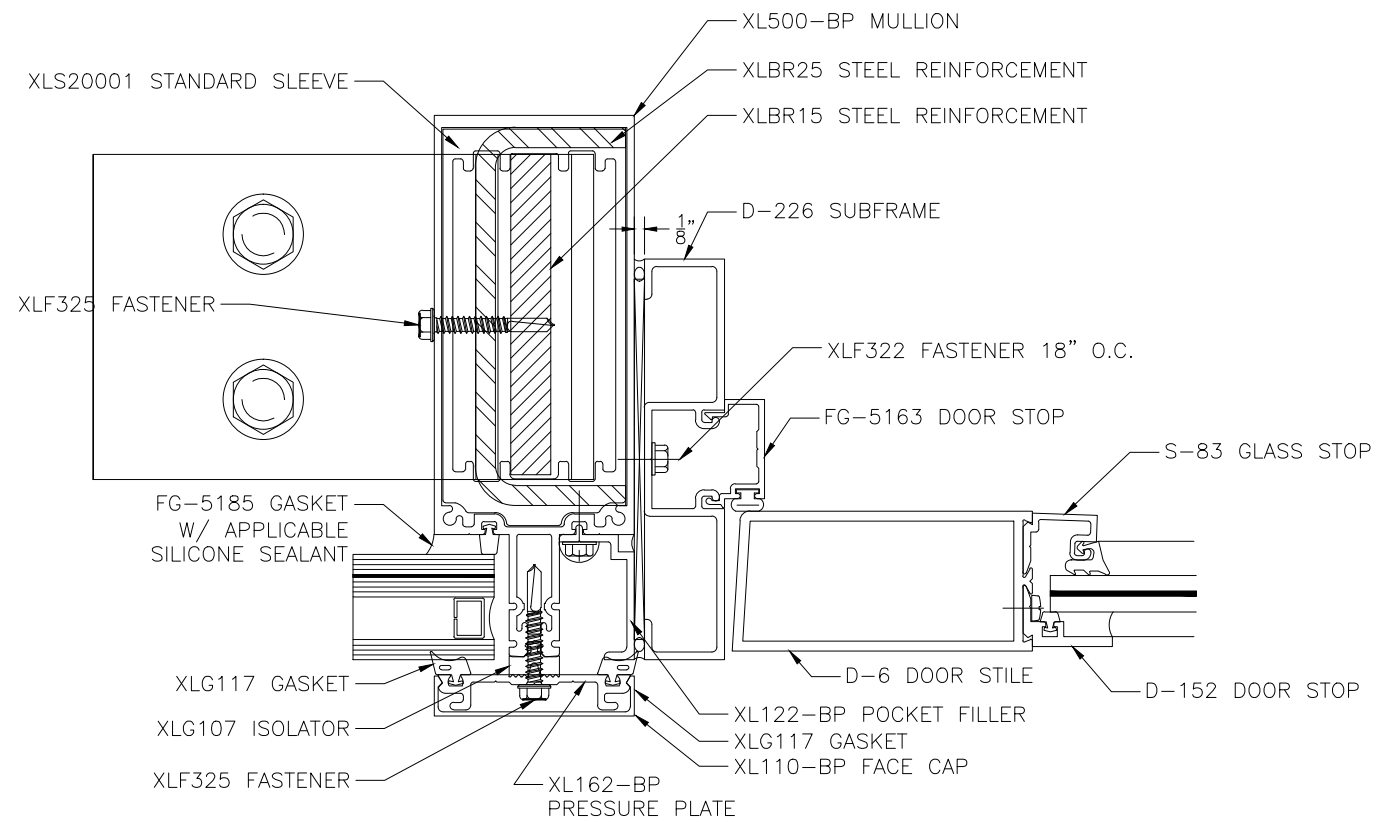
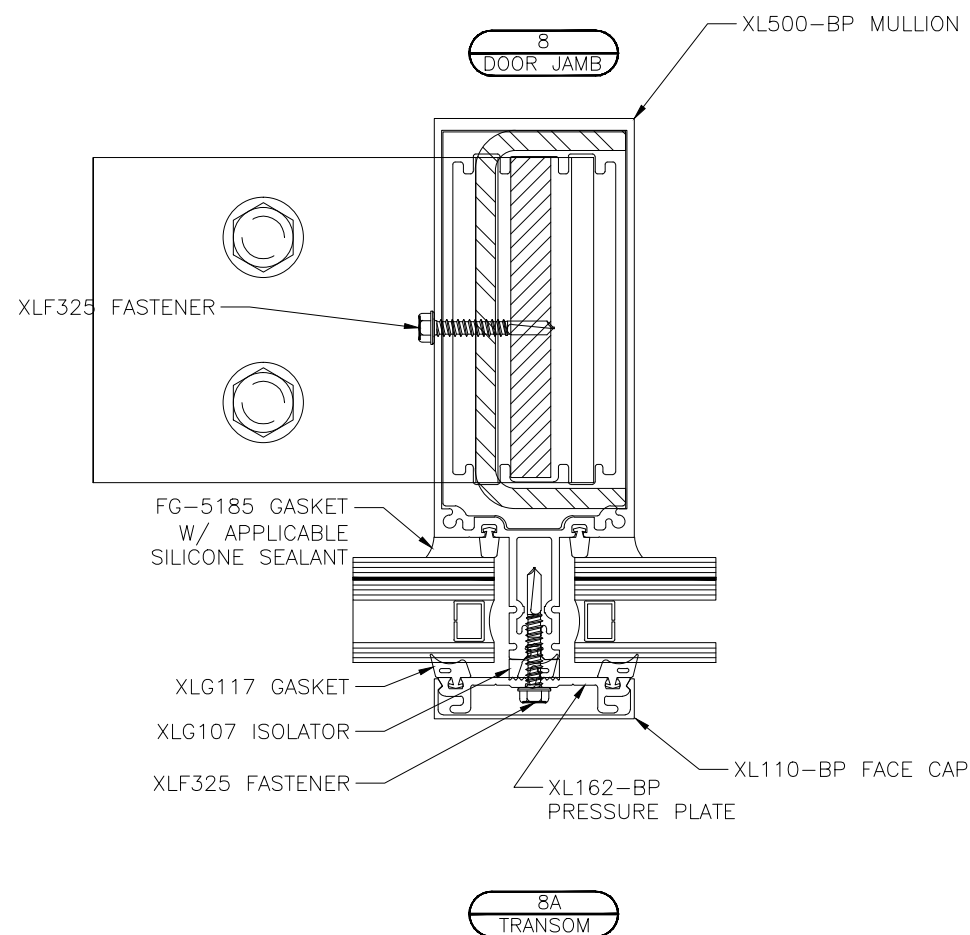
ONE DOOR PANEL DOOR STOP TESTED REVERSED
