PERFORMANCE TEST REPORT

Report No.: A8744.04-801-18

C.R. Laurence Co., INC.
Los Angeles, California

PRODUCT TYPE: Curtain Wall Systems
SERIES/MODEL: StormWall®XL

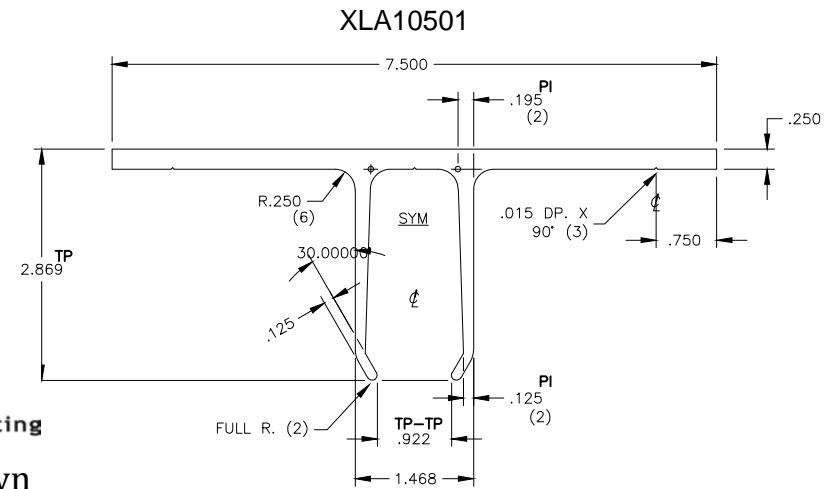
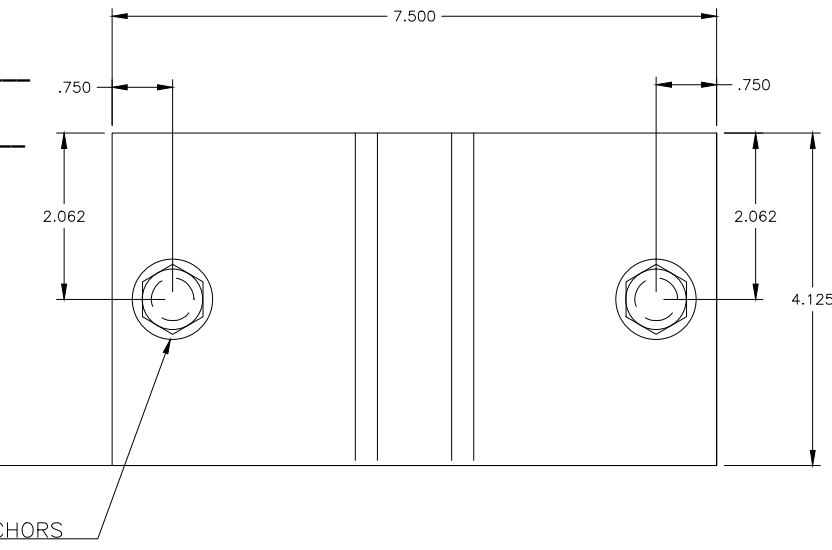
1/2" TYPE 'F' ANCHORS

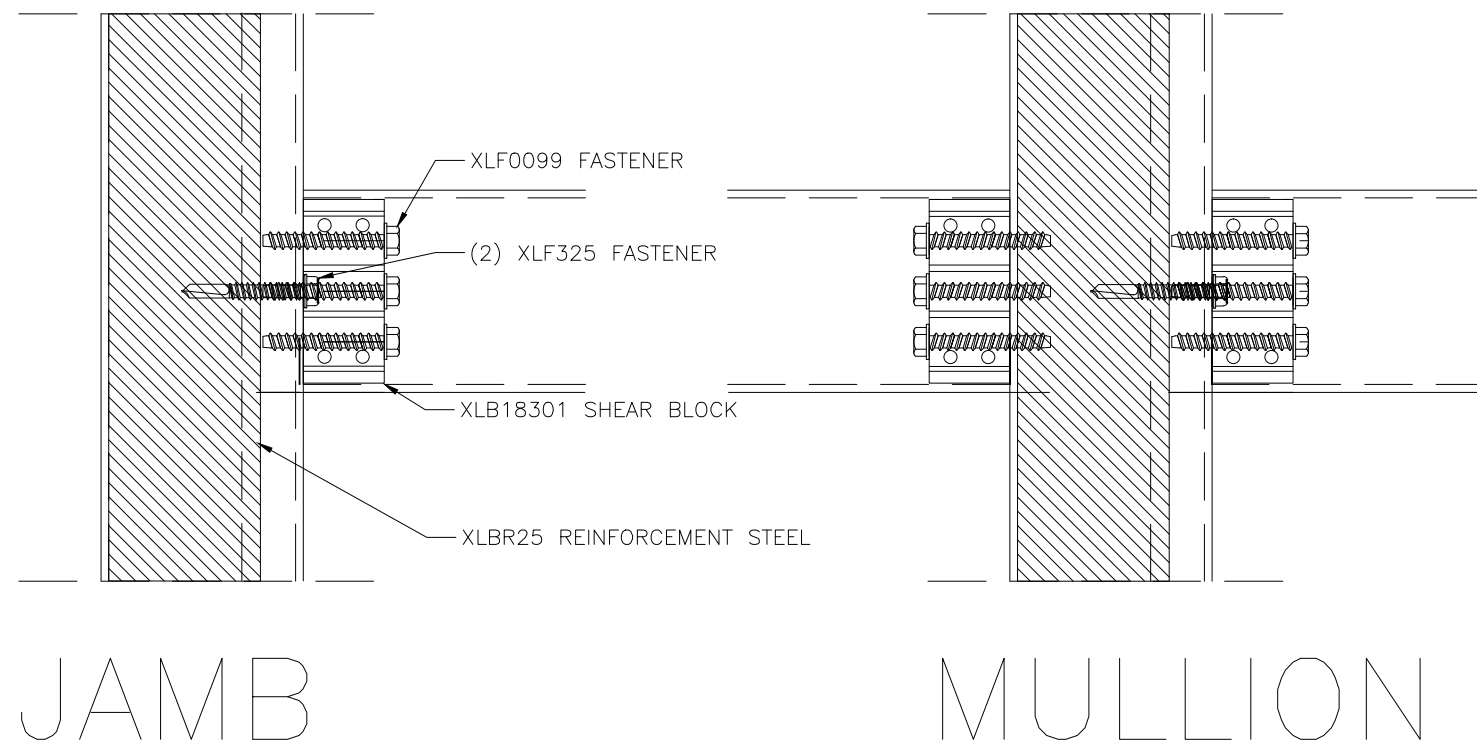
STEEL ATTACHMENT AT HORIZONTAL

ATTACH STEEL AT HORIZONTAL
