TEST REPORT:

AAMA 501-05 Performance and ASTM E 1996-09 and
ASTM E 1886-05 Impact and Cyclic Test Report

Series: StormWall®XL

REPORT #CCLI-11-226

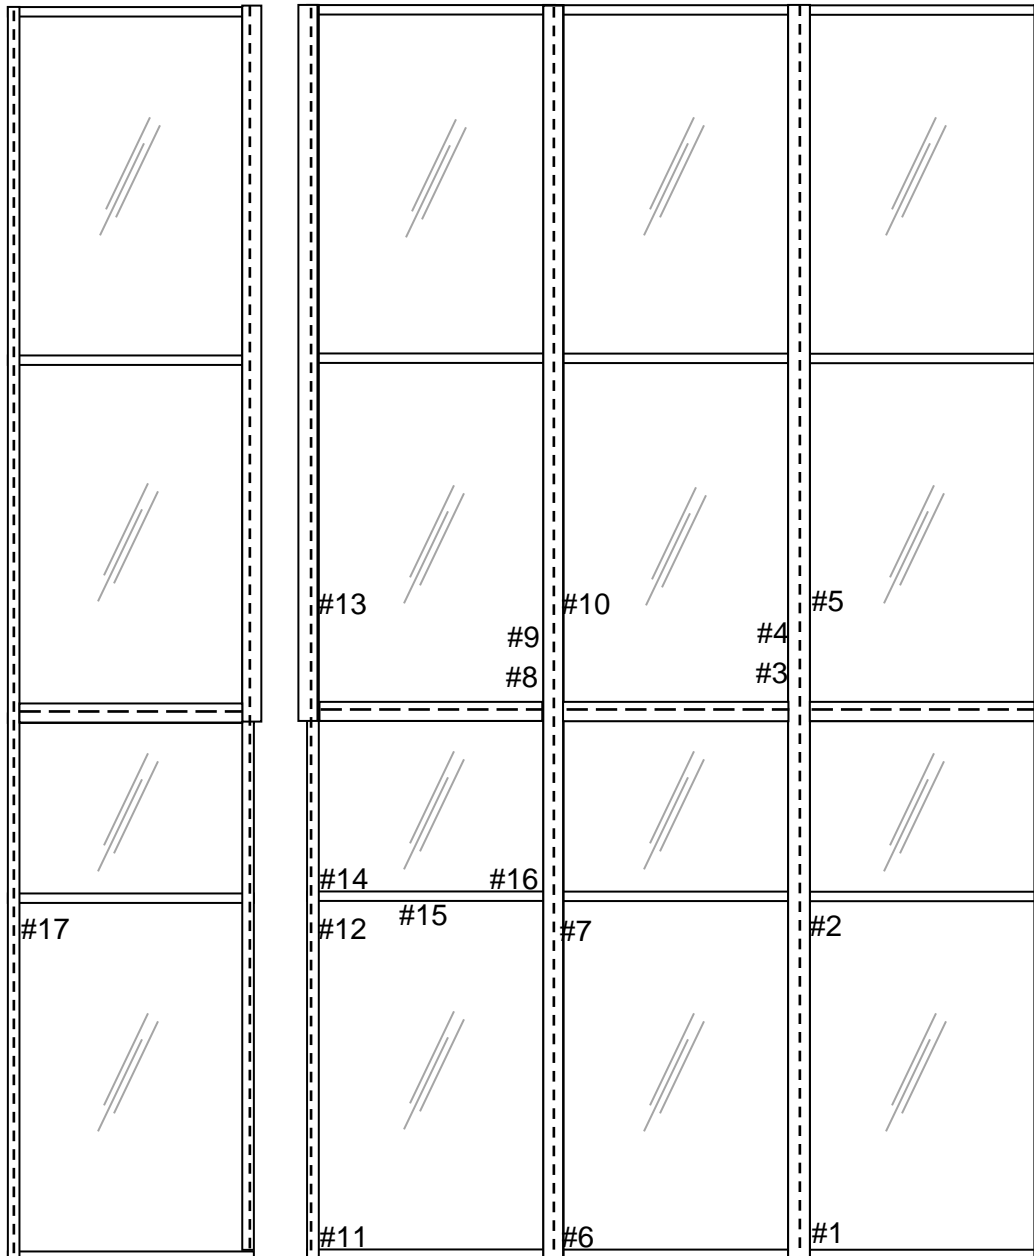
DIAL INDICATOR LOCATION DIAGRAM

Dial indicators were installed to measure deflection and residuals at ends and mid-span of typical horizontal and vertical members.

Results: All the positive and negative net deflections were below the allowable, for indicator locations, **See Indicator Location Plan View, Appendix B.**

Results: All the positive and negative net deflections were below the allowable, for indicator locations, **see Indicator Location Plan View, Appendix B.**

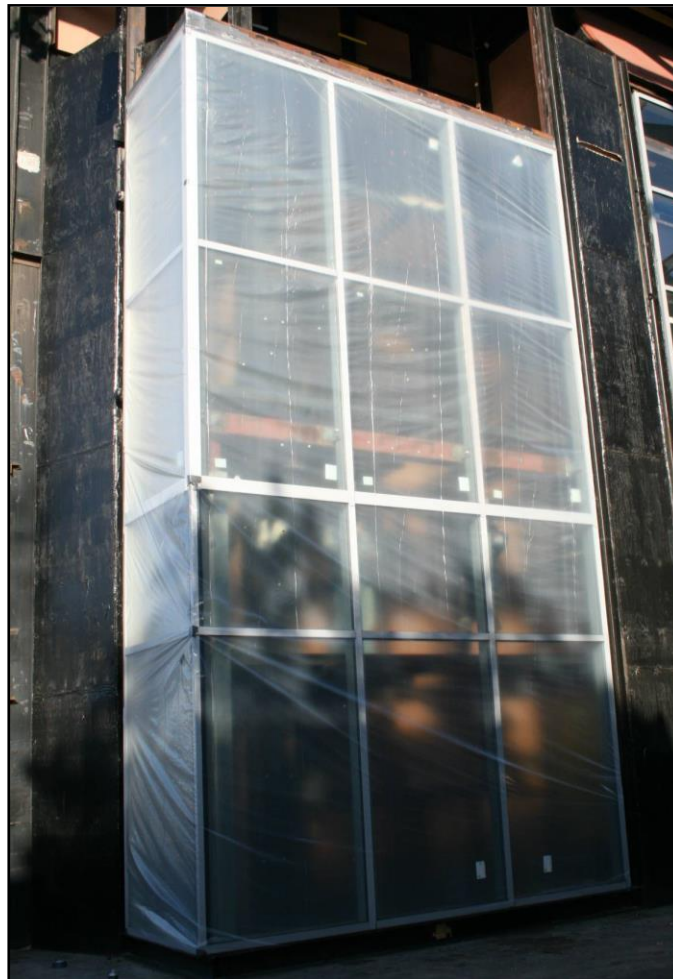
Photograph 2

Static Pressure Air Infiltration Test @ 300 Pa (6.24psf) per ASTM E283-04

The specimen and perimeter sealant joints were completely covered with 4-mil sheet plastic material and sealed with duct tape to the chamber perimeter, thus allowing no movement of air through the specimen. The exterior face of the specimen was subjected to a positive pressure differential of 300 Pa (6.24 psf) to obtain a leakage rate for the test chamber. The plastic bag was removed and the chamber again pressurized to a positive 6.24 Psf to measure total air infiltration. The chamber infiltration was subtracted from the total air infiltration resulting in the infiltration rate of the test specimen.

Chamber	Specimen & Chamber	Cfm	Cfm/ Ft ²	L/s m ²	Total CFM Allowable
45.42 Cfm	48.6.01 Cfm	3.01	>0.01	>.05	33.59 Cfm / 167.95 L/s

The specimen and perimeter sealant joints were completely covered with 4-mil sheet plastic material and sealed with duct tape to the chamber perimeter, thus allowing no movement of air through the specimen. The exterior face of the specimen was subjected to a positive pressure differential of 300 Pa (6.24 psf) to obtain a leakage rate for the test chamber. The plastic bag was removed and the chamber again pressurized to a positive 6.24 Psf to measure total air infiltration. The chamber infiltration was subtracted from the total air infiltration resulting in the infiltration rate of the test specimen, **Photograph 2, Appendix E.**

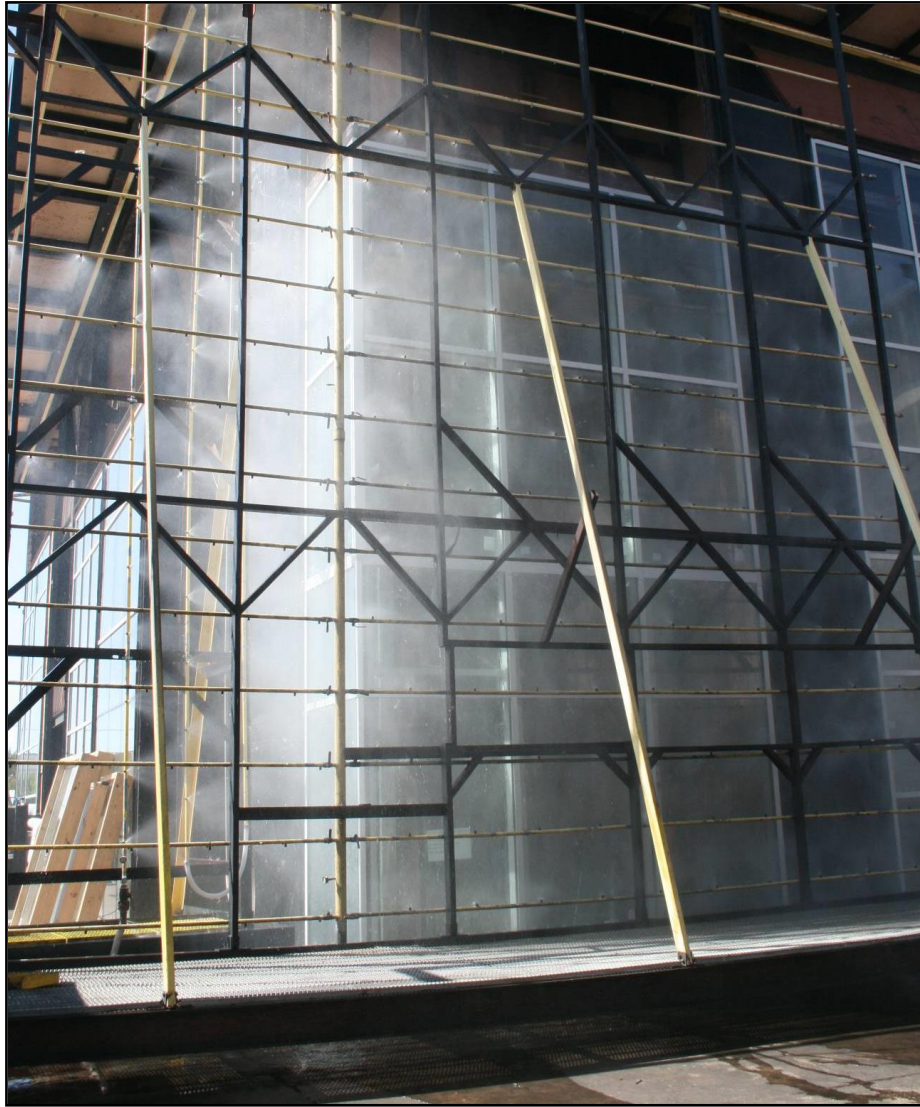
Photograph 3

Static Pressure Water Penetration Test @ 960 Pa (20.0psf) per ASTM E331-00

Water was applied to the exterior face of the specimen at a minimum rate of five (5) gallons per square foot per hour of wall area, in such a way as to continuously and completely cover the exterior face of the specimen. Simultaneously, a positive **inward** differential static pressure of **960 Pa (20.0 psf)** was applied against the face. The application of pressure and water was maintained for a period of fifteen (15) minutes, with observers inside the chamber checking for water penetration.

Results: No water penetration observed.

Water was applied to the exterior face of the specimen at a minimum rate of five (5) gallons per square foot per hour of wall area, in such a way as to continuously and completely cover the exterior face of the specimen. Simultaneously, a positive **inward** differential static pressure of **960 Pa (20.0 psf)** was applied against the face. The application of pressure and water was maintained for a period of fifteen (15) minutes, with observers inside the chamber checking for water penetration, **Photograph 3, Appendix E.**

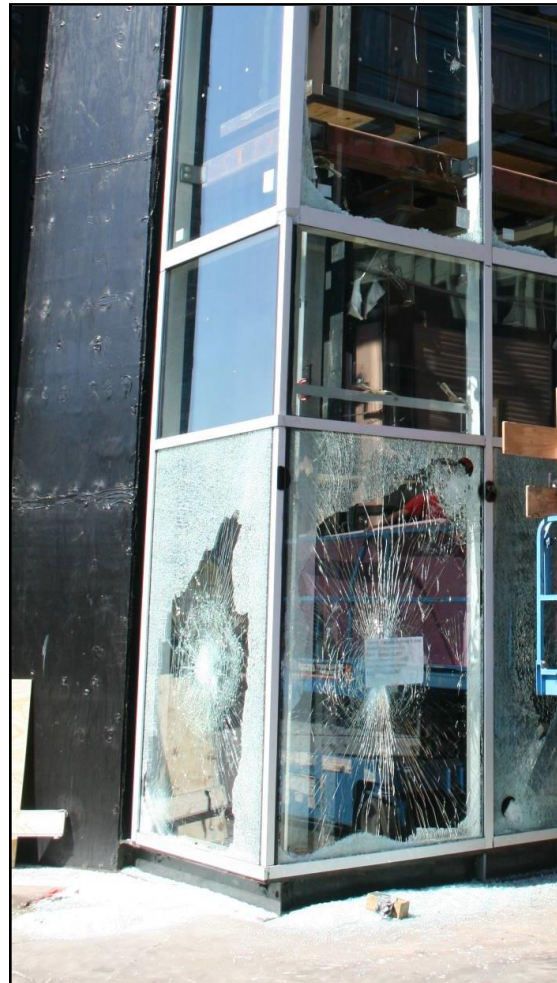
Photograph 4

The specimen was Type D Large Missile impacted with a #2 yellow pine nominal 2" x 4" x 8' 2" length. Large Missile Impact locations on the mock-up were to the glazing, horizontal and vertical mullions below the mid-span anchor and mid-span of the upper mullion at the outside corner. The missile weight prior to testing was 9 Lbs 1 oz. Nominal impact speed set at 50 feet per second. Fifteen (15) total Large Missile Impacts were performed on the mock-up, for impact locations and speeds see

The specimen was Type A Small Missile impacted with Ten (10) 2-gram solid steel 5/16 diameter balls. Small Missile Impact locations on the mock-up were to the glazing only. Twenty one (21) small missile Impacts were performed on the mock-up, for impact locations see.

9.1. The specimen was Type D Large Missile impacted with a #2 yellow pine nominal 2" x 4" x 8' 2" length. Large Missile Impact locations on the mock-up were to the glazing, horizontal and vertical mullions below the mid-span anchor and mid-span of the upper mullion at the outside corner. The missile weight prior to testing was 9 Lbs 1 oz. Nominal impact speed set at 50 feet per second. Fifteen (15) total Large Missile Impacts were performed on the mock-up, for impact locations and speeds see **Impact Location Diagram, Appendix C, Photograph 4, Appendix E.**

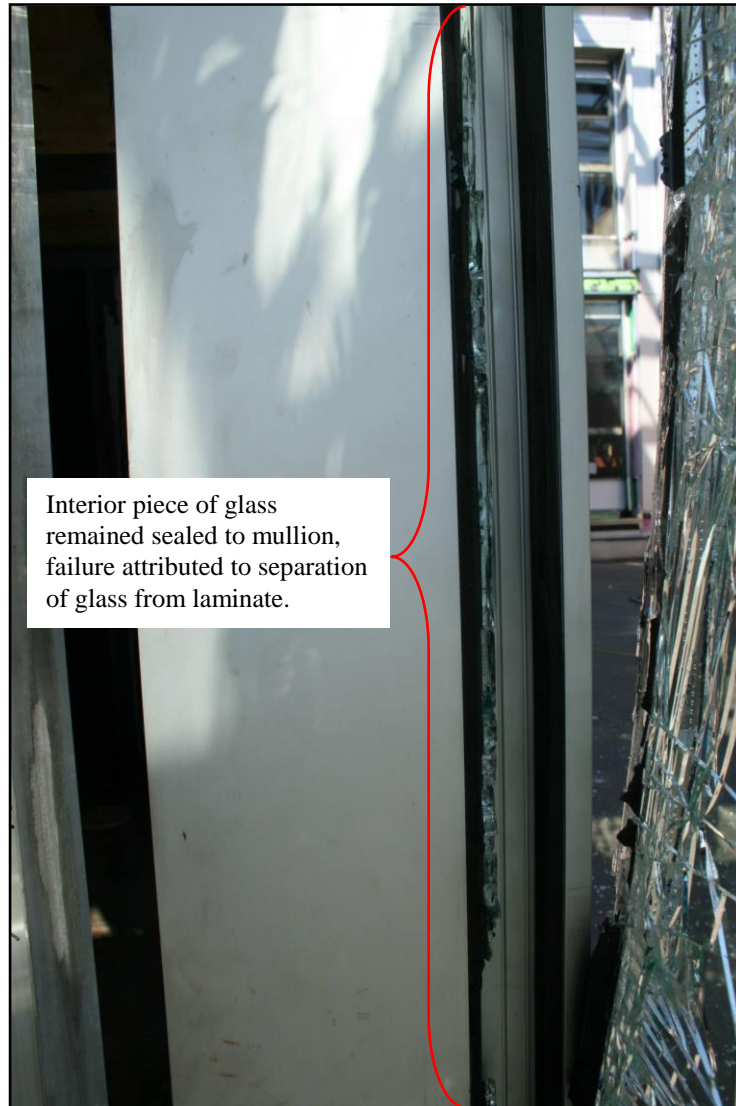
Photograph 5

Note: With 300 cycles remaining during Negative Cycle 2, the lower lite face of wall, adjacent to O.S. corner mullion deglazed from the intermediate mullion, **See Deglazed location Diagram, Appendix D.** Failure was attributed to separation of glass from laminate. Inspection revealed interior piece of glass remained glazed to the mullion. The opening was covered with plywood and sealed with duct tape to complete Cycle 2 and the remaining cycles

Note: With 300 cycles remaining during Negative Cycle 2, the lower lite face of wall, adjacent to O.S. corner mullion deglazed from the intermediate mullion, **See Deglazed location Diagram, Appendix D, Photograph 5, Appendix E.** Failure was attributed to separation of glass from air spacer. Inspection revealed interior pieces of glass remained glazed to the mullion. The opening was covered with plywood and sealed with duct tape to complete Cycle 2 and the remaining cycles.
