**ASTM E 90 SOUND TRANSMISSION LOSS  
TEST REPORT**

**C.R. LAURENCE CO., INC.**

**SERIES/MODEL: 8200**

**TYPE: Horizontal Sliding Window**

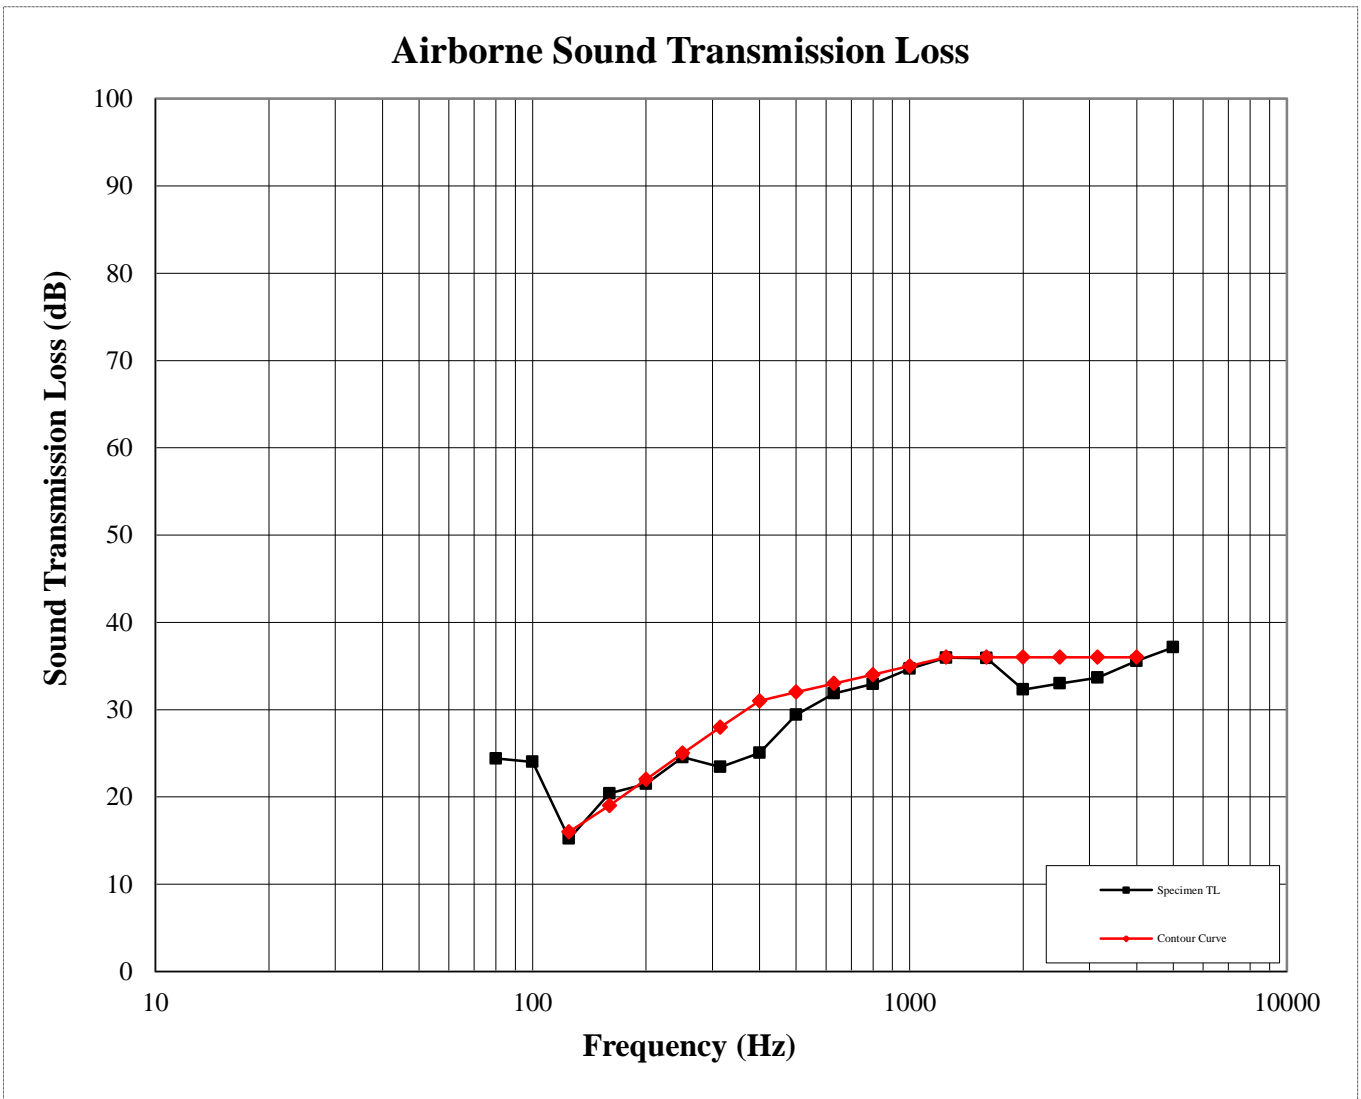
**STC Rating**            **32**            *(Sound Transmission Class)*  
**Deficiencies**            **27**            *(Sum of Deficiencies)*  
**OITC Rating**            **26**            *(Outdoor-Indoor Transmission Class)*

**AIRBORNE SOUND TRANSMISSION LOSS**  
ASTM E 90

| <b>Description</b> | Series/Model: 8200, Horizontal sliding window with 1" IG (1/4" tempered, 1/2" air space, 1/4" tempered) | | | | | |

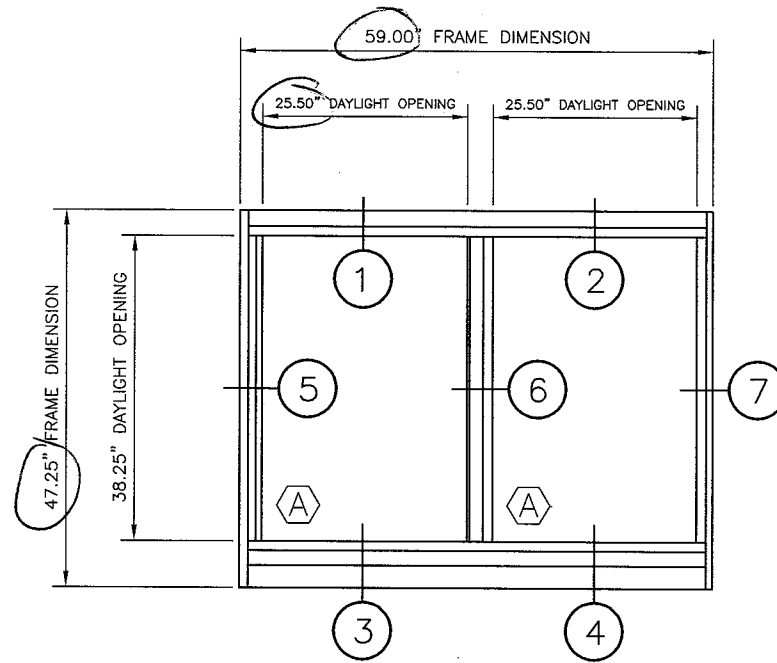
DRAWING NO.  
MU2014-178-02

Test sample complies with these details.  
Deviations are noted.

| SYMBOL KEY | | |
|---|---|---|
| (A) | 1" INSULATED GLASS 27.500 X 40.250<br>.250 CLR, TEMPERED<br>.500 MILL ALUM SPACER, AIR<br>.250 PPG SOLARBAN 70XL,<br>LOW-E #3 SURFACE, SILICONE | 2 |

TITLE:  
SOUND TRANSMISSION LOSS TEST  
ELEVATION  
PRODUCT: 8200 HORIZONTAL SLIDING WINDOW

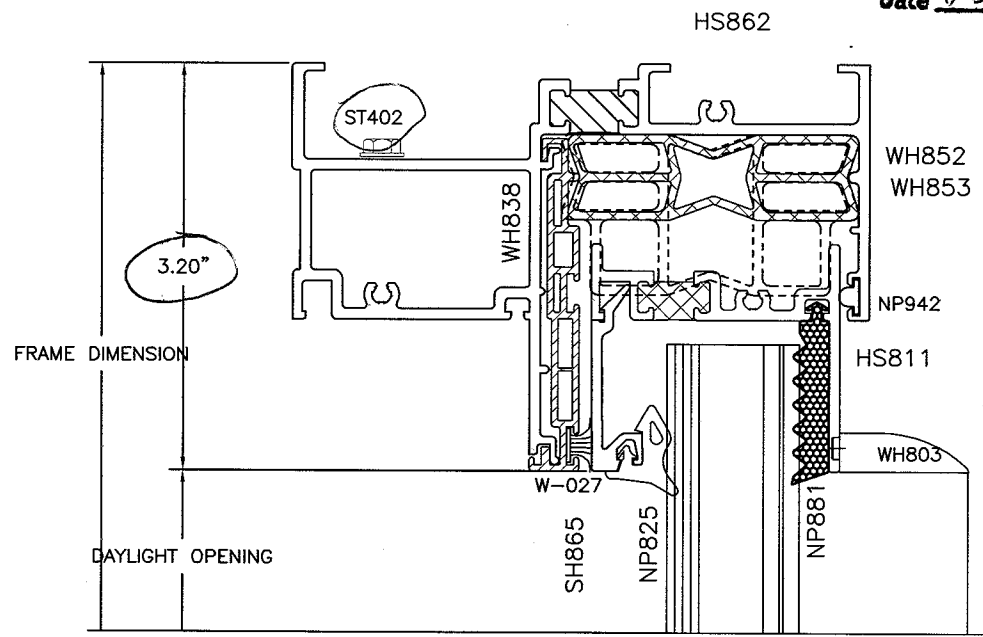
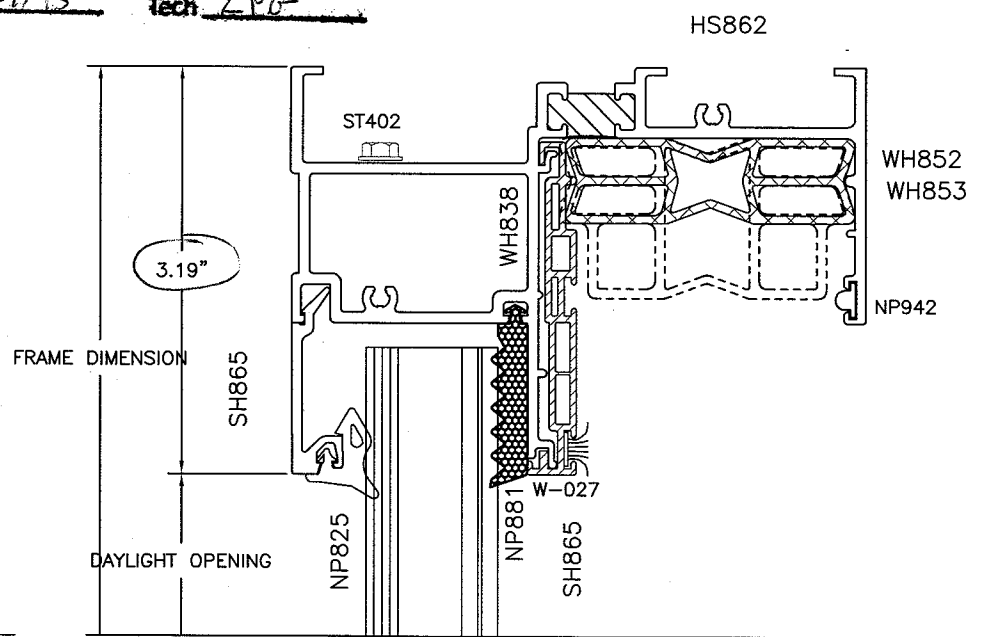
| | | | | DRAWN BY: GHK<br>DATE: 06.27.14 | TITLE:<br>SOUND TRANSMISSION LOSS TEST<br>HORIZONTAL SECTION<br>PRODUCT: 8200 HORIZONTAL SLIDING WINDOW | | |

Test sample complies with these details.  
Deviations are noted.

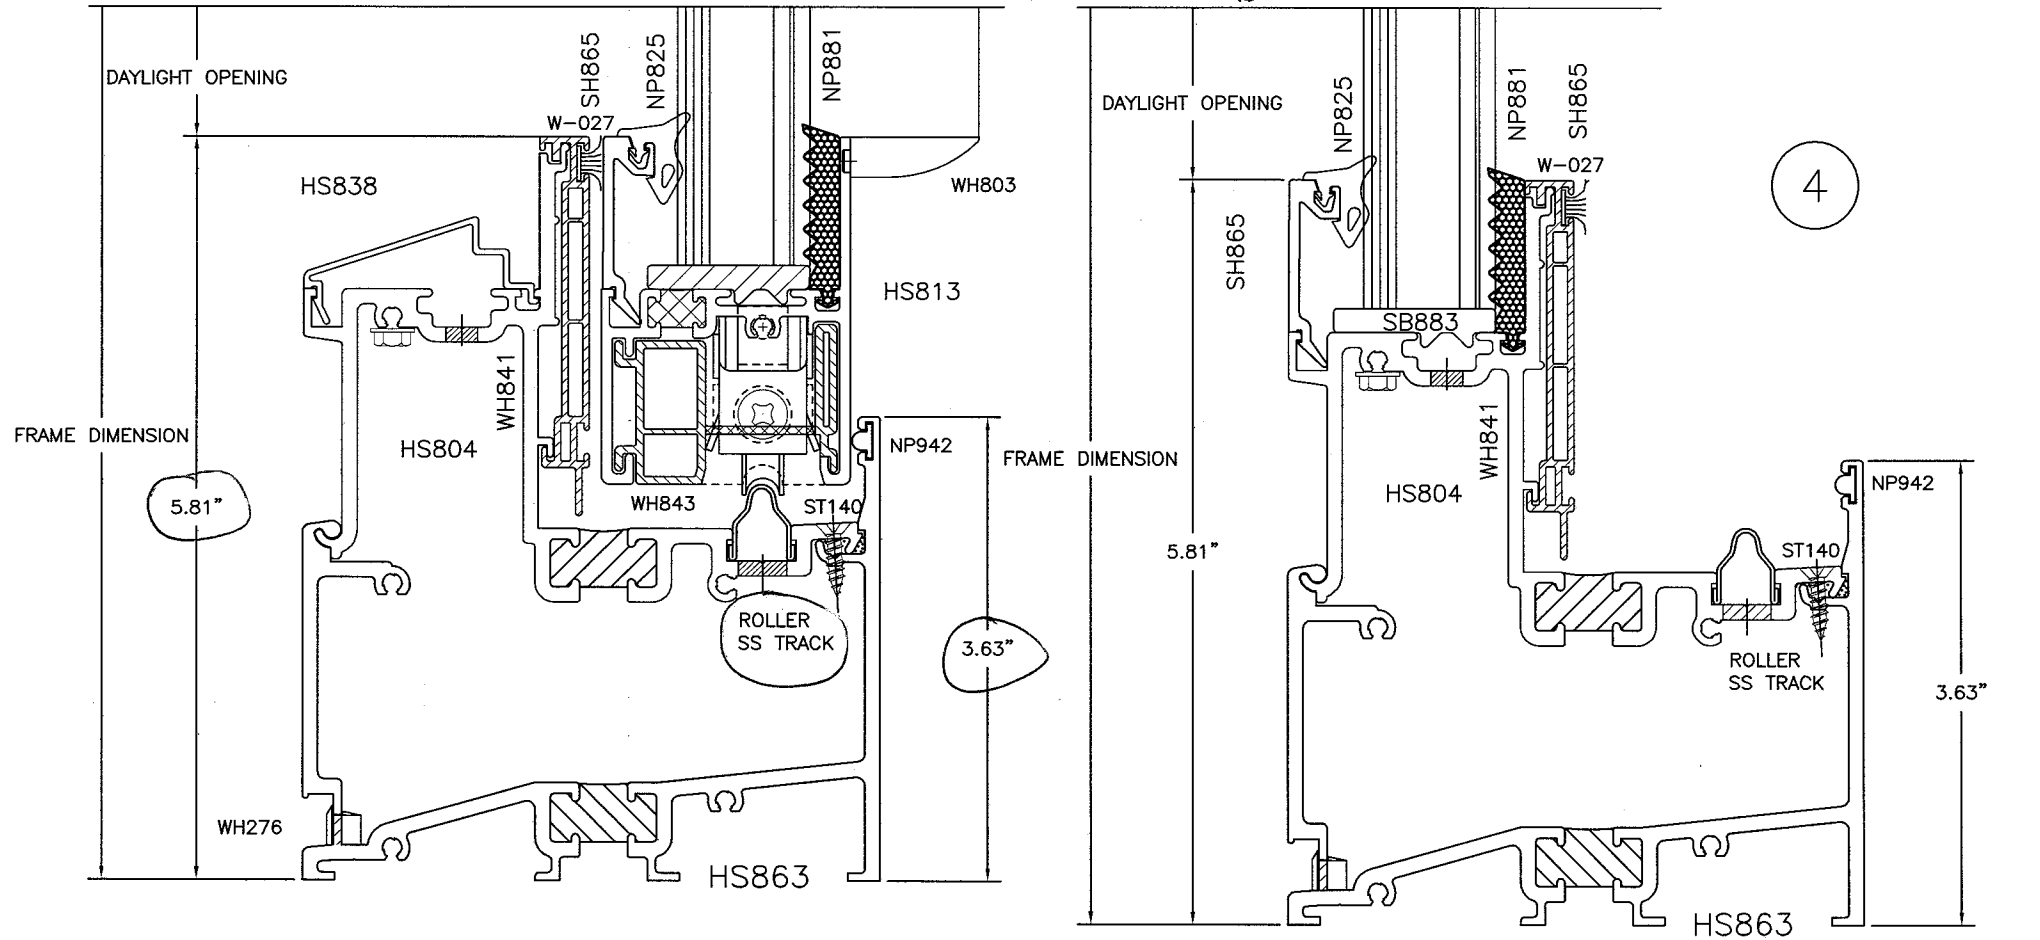
| | | | | DATE: 06.27.14 | SOUND TRANSMISSION LOSS TEST<br>VERTICAL SECTION<br>PRODUCT: 8200 HORIZONTAL SLIDING WINDOW | MU2014-178-02 | |

Test sample complies with these details.  
Deviations are noted.

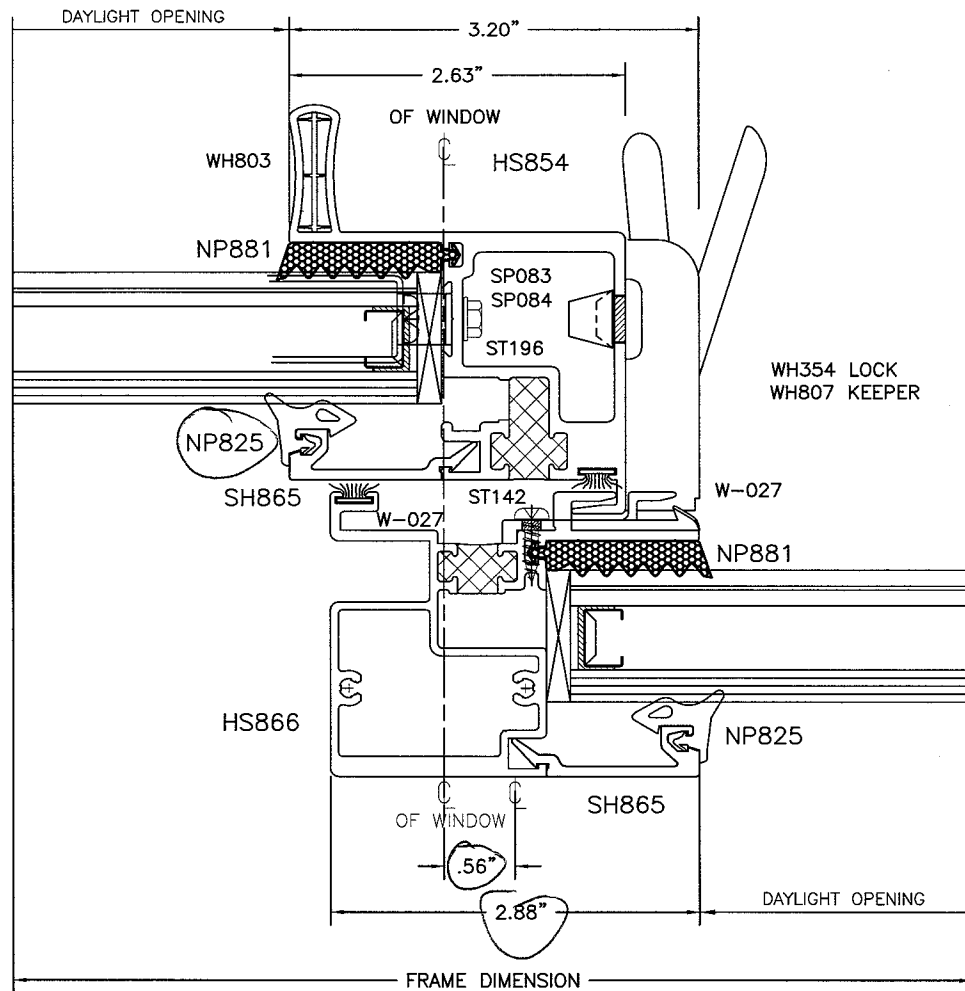
DRAWING NO.  
MU2014-178-02  
Sheet No. 5 of 6 Sheets

TITLE:  
SOUND TRANSMISSION LOSS TEST  
HORIZONTAL SECTION  
PRODUCT: 8200 HORIZONTAL SLIDING WINDOW

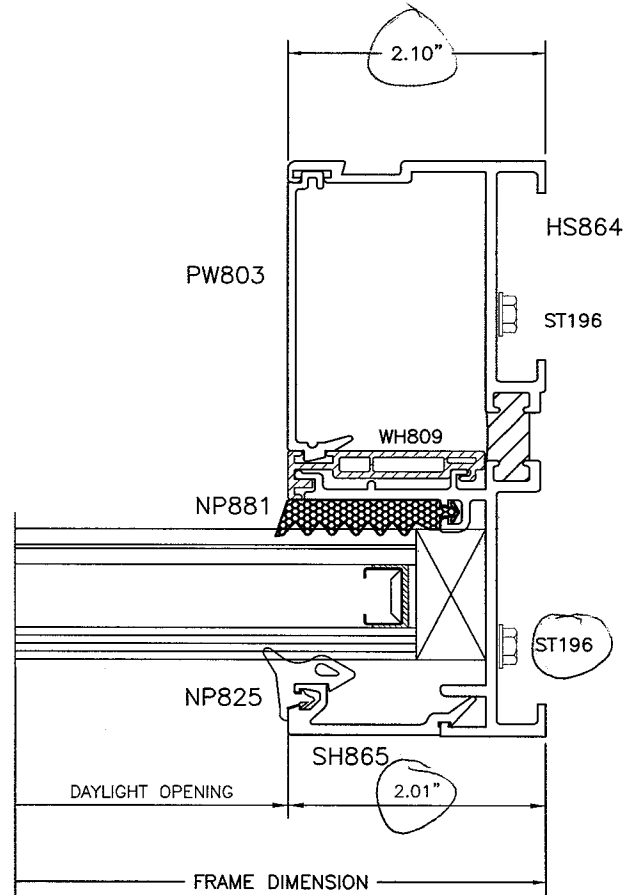
Test sample complies with these details.  
Deviations are noted.

| | | | | DRAWN BY: GHK<br>DATE: 06.27.14 | TITLE:<br>SOUND TRANSMISSION LOSS TEST<br>VERTICAL SECTION<br>PRODUCT: 8200 HORIZONTAL SLIDING WINDOW | | |

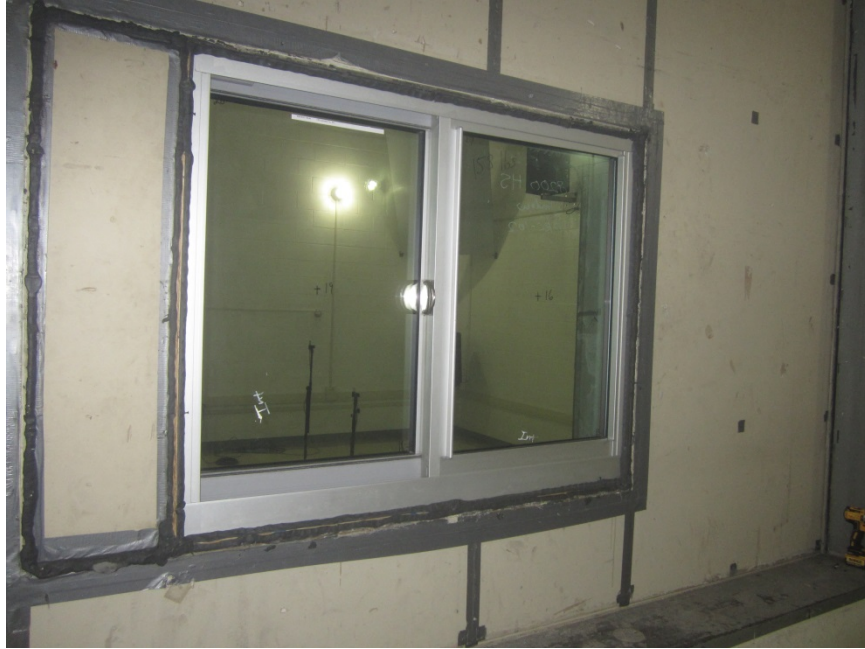
**Receive Room View of Installed Specimen**

**Sample Installation:** A double stud filler wall was constructed with 2-1/2" steel studs and 3-1/2" steel studs spaced 24" on center. Five layers of 5/8" Type "X" gypsum board were fastened to the receive side of the filler wall. Three layers of 1/2" cement board were fastened to the source side of the filler wall. The cavity was filled with two layers of R-13 fiberglass insulation. The perimeter and seams were sealed with acoustical sealant. A sound transmission loss test was then conducted on the filler wall. The filler wall achieved an STC rating of 71. The 60-1/2" by 48-1/2" filler wall plug was removed.

A filler wall-reducing element was built to adjust the test opening size to accommodate the test specimen. The reducing element consisted of a double 2x4 wood stud wall construction with three layers of 5/8" drywall on both sides. The stud cavities in the wall were insulated with two layers of R-13 fiberglass insulation. The window system was placed on isolation pads in the test opening. Duct seal was used to seal the perimeter of the test specimen to the test opening on both sides. The interior side of the test specimen, when installed, was approximately 1/4" from being flush with the receiving room side of the filler wall. A stethoscope was used to check for any abnormal air leaks around the test specimen prior to testing. The vent was opened and closed at least five times prior to testing.

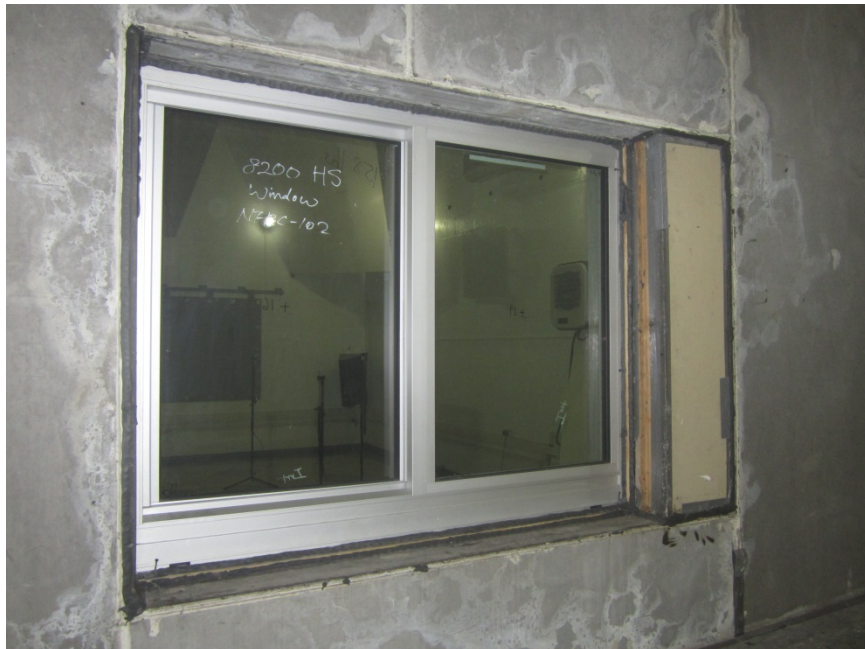
**Source Room View of Installed Specimen**
