**ASTM F1642-04/GSA TS01/UFC 4-010-01
TEST REPORT**

Report No.: C4837.02-801-12

UNITED STATES ALUMINUM
A Division of CR Laurence Co., Inc.
Vernon, CA

PRODUCT TYPE: Single Hung Window
SERIES/MODEL: 8000

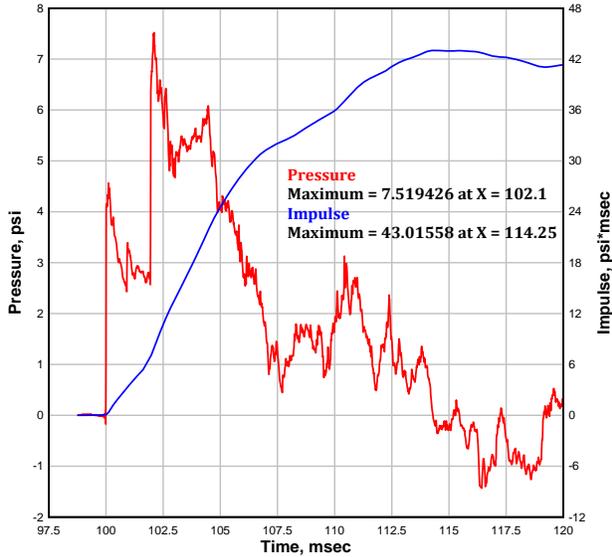
Reflected Air Blast Pressure
RPT #1

Top RPT

Peak Positive Pressure	
Top Pressure	7.519 psi
Right Pressure	8.953 psi
Shell Pressure	10.429 psi
Average Pressure	8.967 psi
Witness Chamber Pressure	0.255 psi

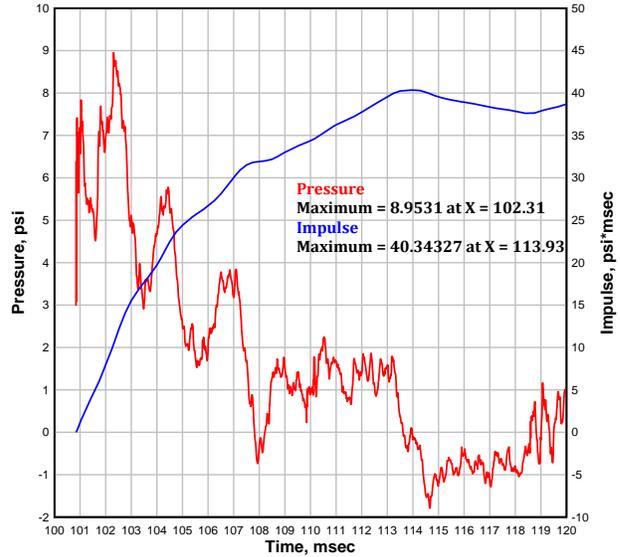
Reflected Air Blast Pressure
RPT #2

Right RPT

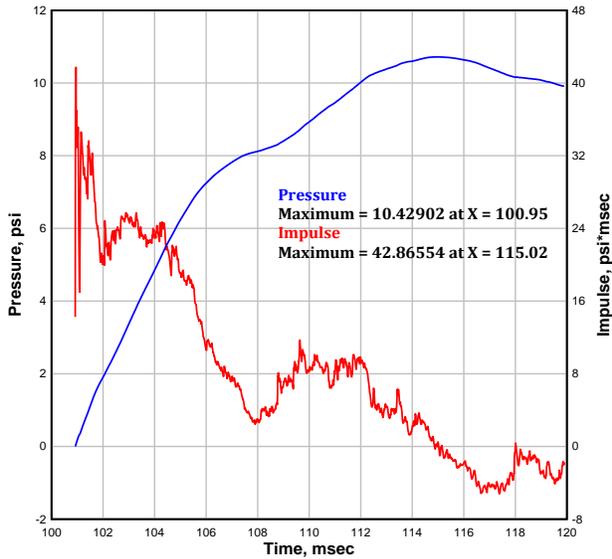
Reflected Air Blast Pressure
RPT #3

Shell RPT

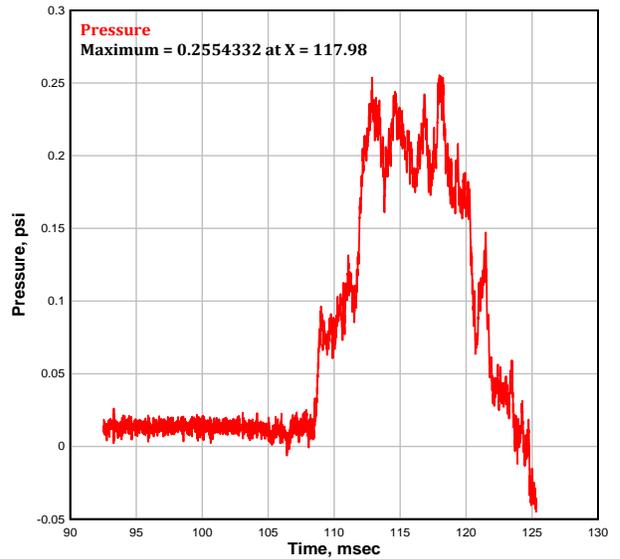
Internal Air Blast Pressure
IPT #1

Witness Chamber IPT

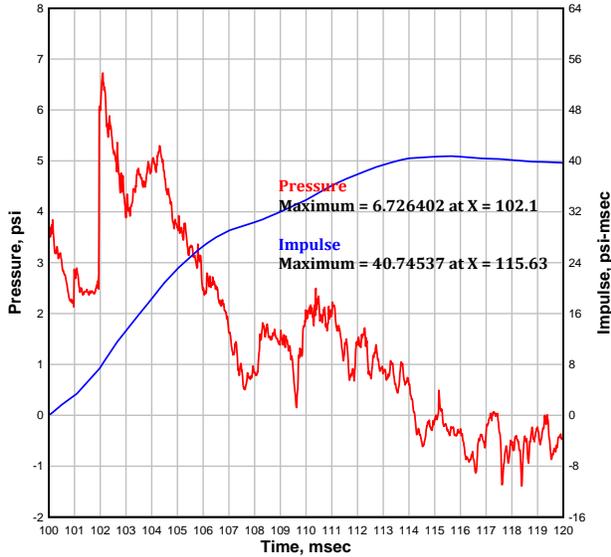
Reflected Air Blast Pressure
RPT #1

Top RPT

Peak Positive Pressure	
Top Pressure	6.726 psi
Right Pressure	7.467 psi
Shell Pressure	8.927 psi
Average Pressure	7.707 psi
Witness Chamber Pressure	0.268 psi

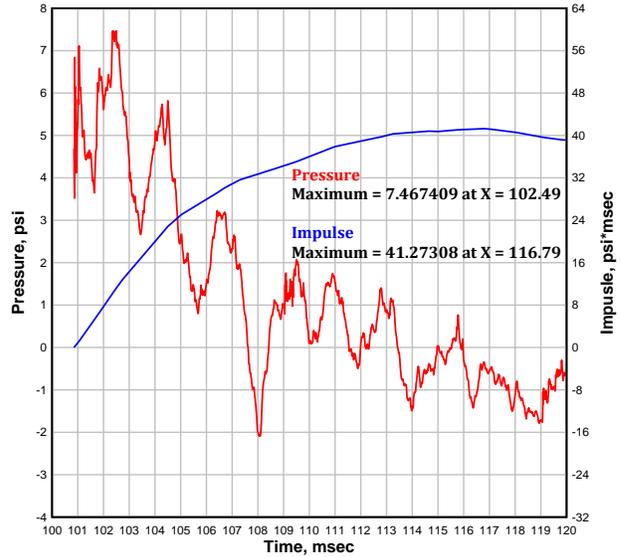
Reflected Air Blast Pressure
RPT #2

Right RPT

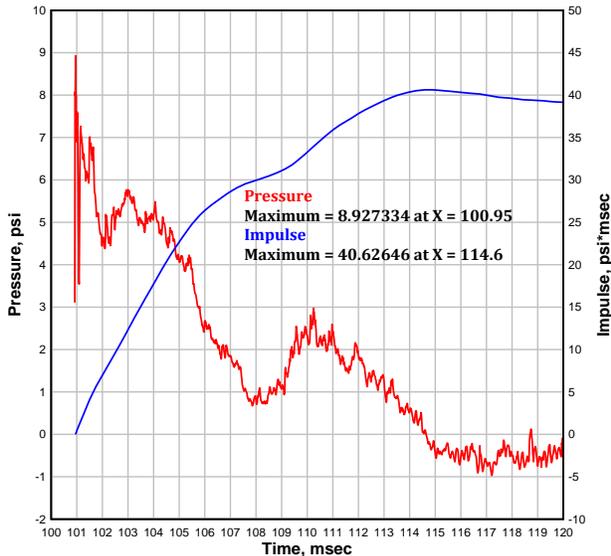
Reflected Air Blast Pressure
RPT #3

Shell RPT

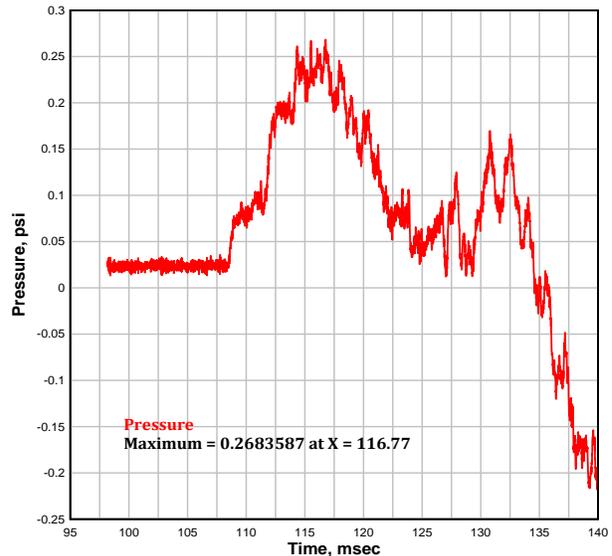
Internal Air Blast Pressure
IPT #1

Witness Chamber IPT

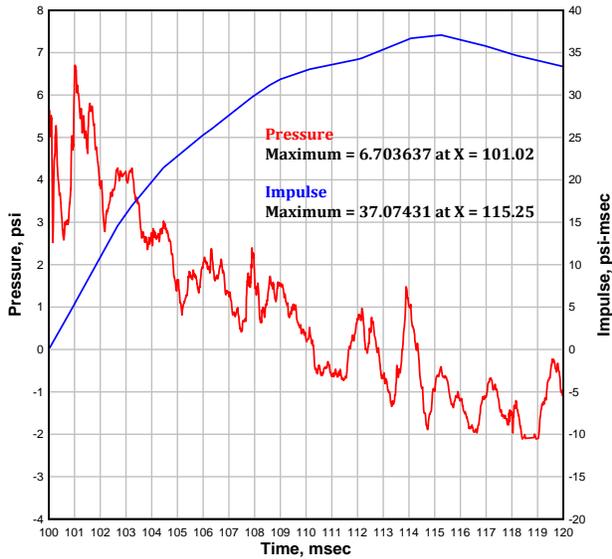
Reflected Air Blast Pressure
RPT #1

Top RPT

Peak Positive Pressure	
Top Pressure	6.703 psi
Right Pressure	8.049 psi
Shell Pressure	6.230 psi
Average Pressure	6.994 psi
Witness Chamber Pressure	0.402 psi

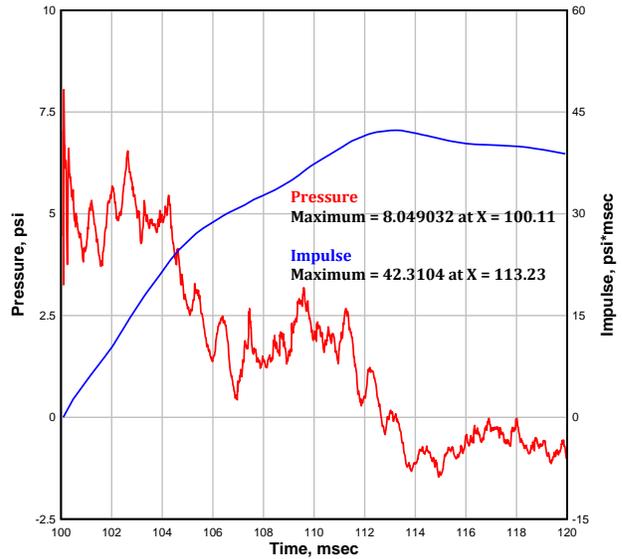
Reflected Air Blast Pressure
RPT #2

Right RPT

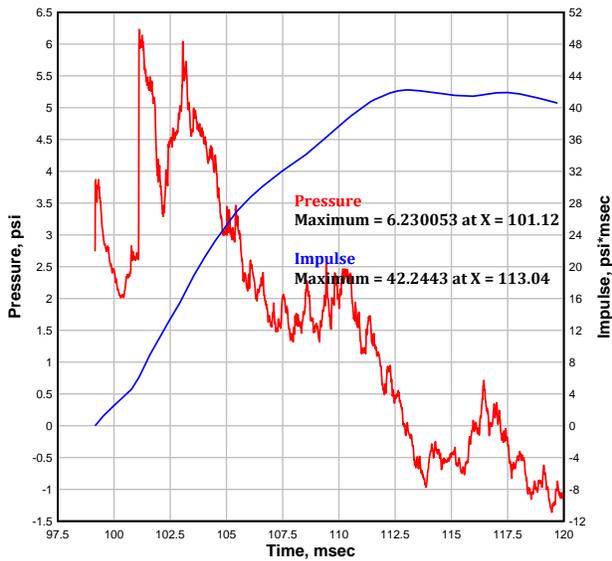
Reflected Air Blast Pressure
RPT #3

Shell RPT

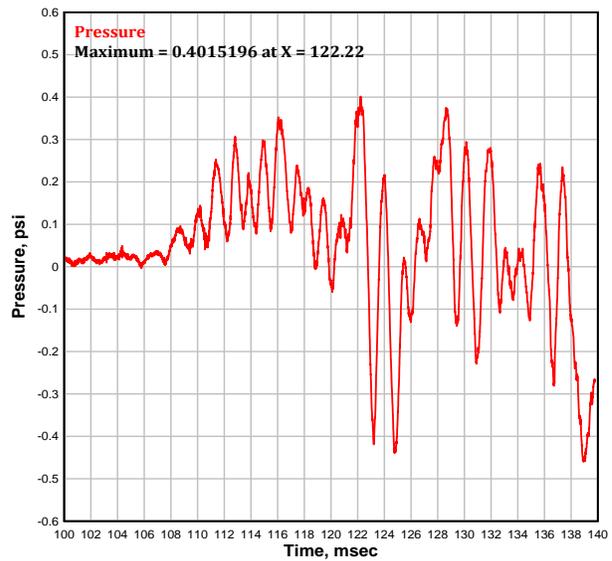
Internal Air Blast Pressure
IPT #1

Witness Chamber IPT

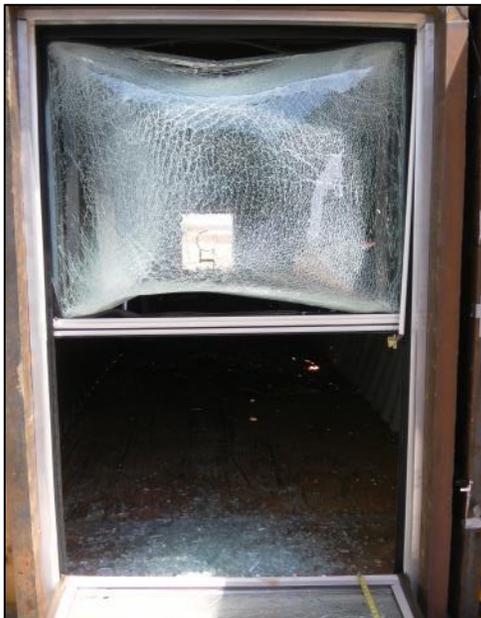
Photo No. 3
Post-test, Interior

Witness Chamber Results
The sash came out of the surrounding framing at the head and jambs then rotated to the floor with the head 45° from its original location. No glazing indents were located above 20" in the vertical witness panel.

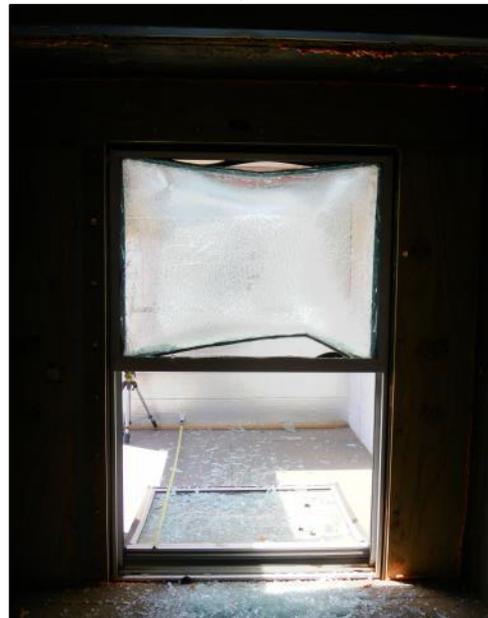
Photo No. 4
Post-test, Exterior

Glazing Response		
Lite	Operable	Fixed
Exterior Lite	Fractured	Fractured
Interior Lite	Fractured	Fractured
Glazing Pullout Length	> 20% of DLO Perimeter	> 20% of DLO Perimeter
Glazing Tearing	None	None

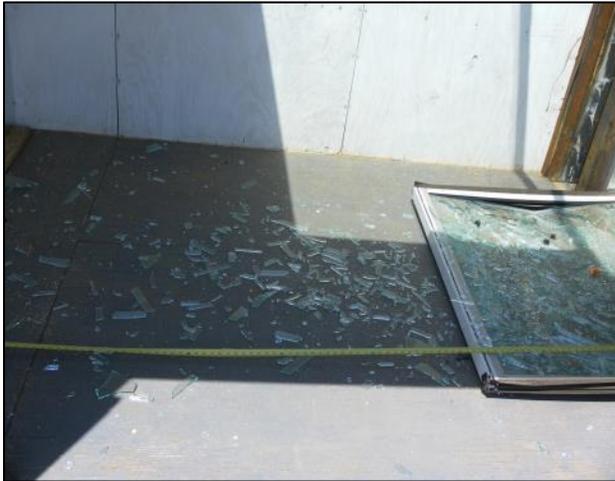
Photo No. 5
Post-test, Fragment

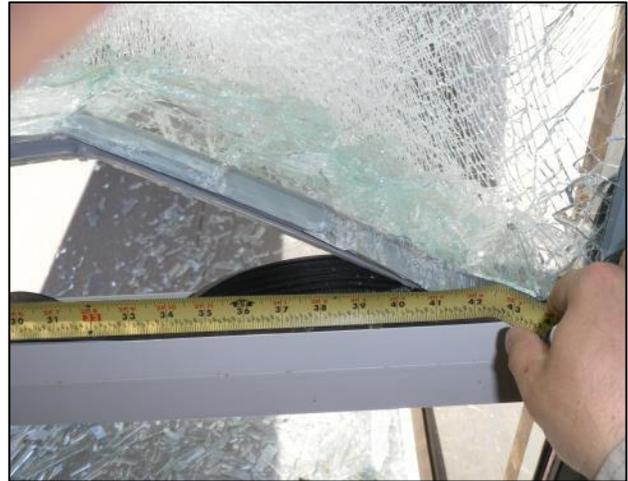
Photo No. 6
Post-test, Glazing Pull-out

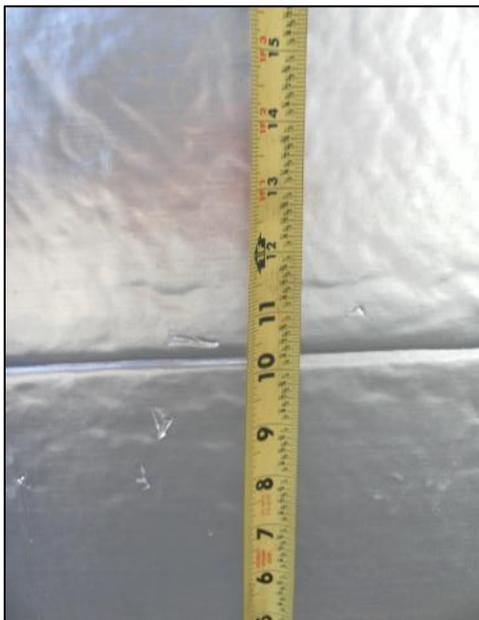
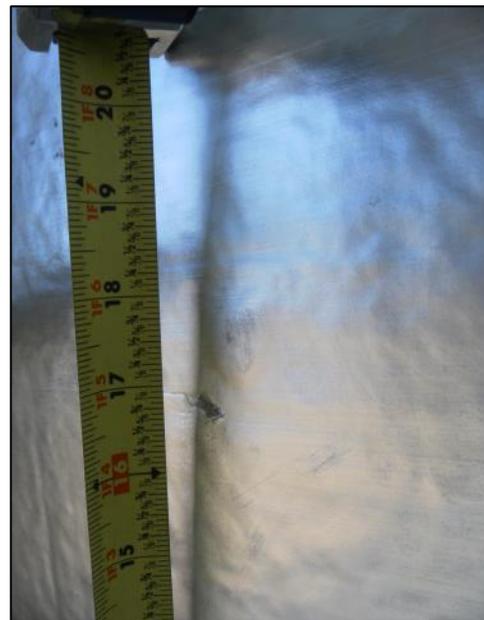
Photo No. 7
Post-test, Witness Panel Impact

Photo No. 8
Post-test, Witness Panel Impact

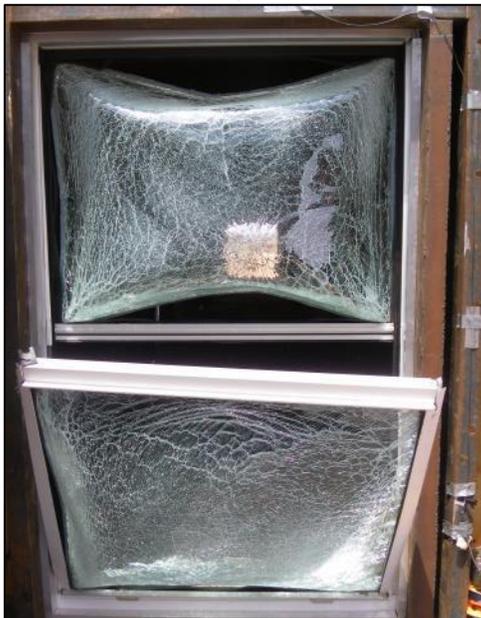
Photo No. 3
Post-test, Interior

Witness Chamber Results
The sash came out of the surrounding framing at the head and jambs then rotated to about a 45° angle from its original location. Two (2) fragments were located greater than 40" from the interior face of the specimen and no glazing indents were located anywhere in the vertical witness panel.

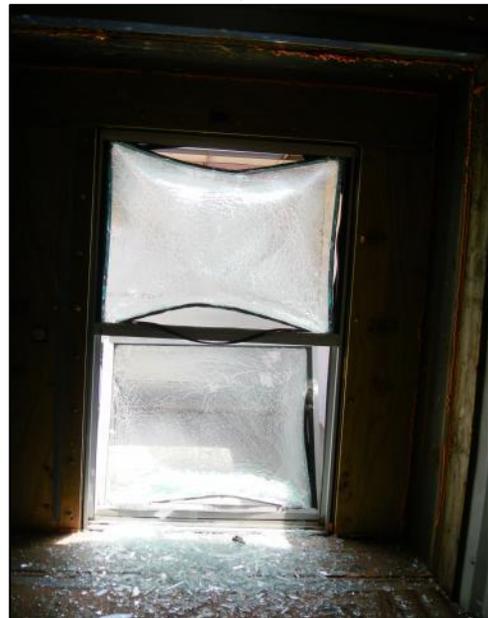
Photo No. 4
Post-test, Exterior

Glazing Response		
Lite	Operable	Fixed
Exterior Lite	Fractured	Fractured
Interior Lite	Fractured	Fractured
Glazing Pullout Length	> 20% of DLO Perimeter	> 20% of DLO Perimeter
Glazing Tearing	None	None

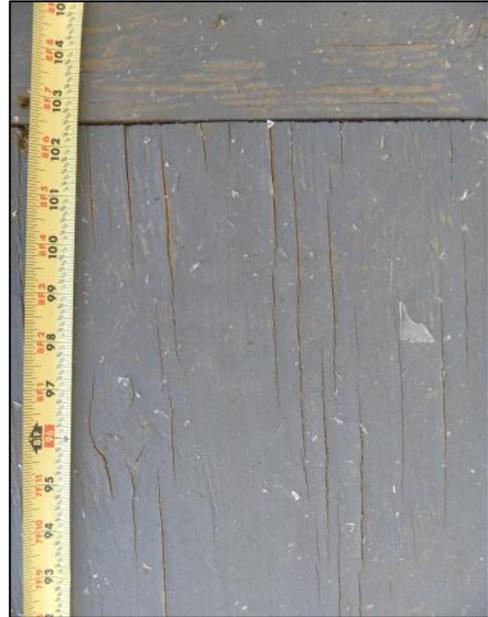
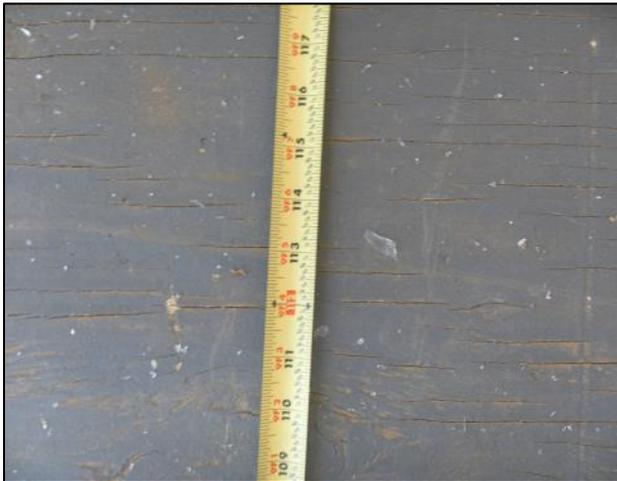
Photo No. 6
Post-test, Fragment

Photo No. 7
Post-test, Fragment

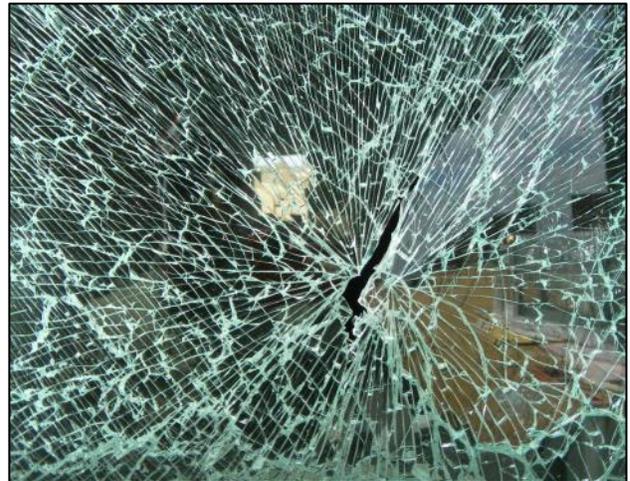
Photo No. 8
Post-test, Glazing Tear

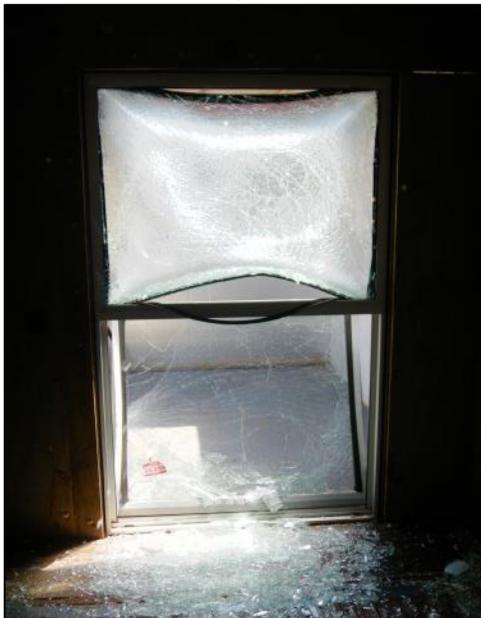
Photo No. 3
Post-test, Interior

Witness Chamber Results
The sash came out of the surrounding framing at the head and jambs then rotated to about a 20° angle from its original location. One (1) fragment was located greater than 40" from the interior face of the specimen and no glazing indents were located anywhere in the vertical witness panel.

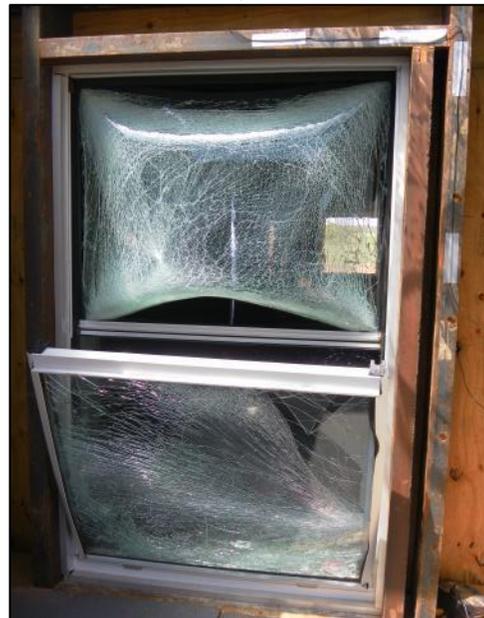
Photo No. 4
Post-test, Exterior

Glazing Response		
Lite	Operable	Fixed
Exterior Lite	Fractured	Fractured
Interior Lite	Fractured	Fractured
Glazing Pullout Length	> 20% of DLO Perimeter	> 20% of DLO Perimeter
Glazing Tearing	None	None

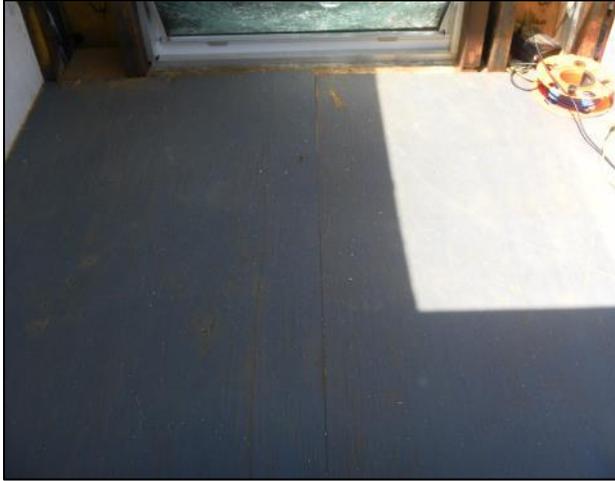
Photo No. 5
Post-test, Fragment

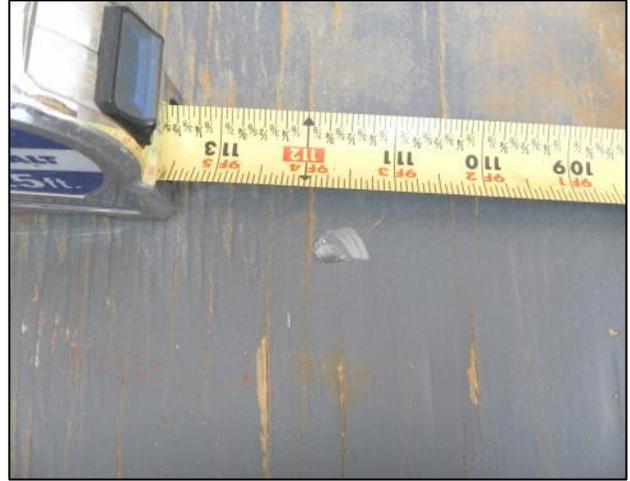
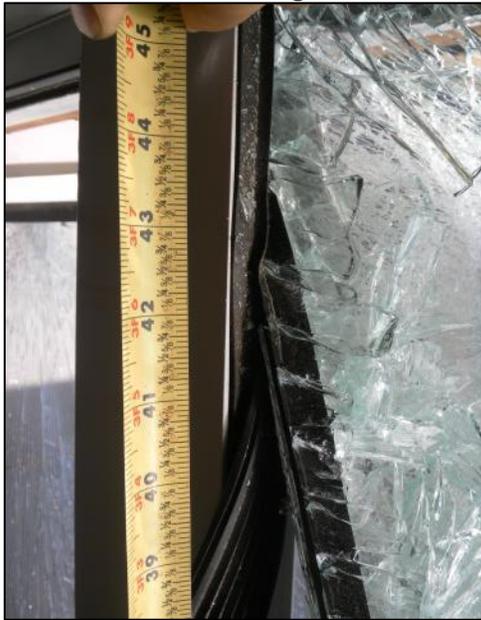
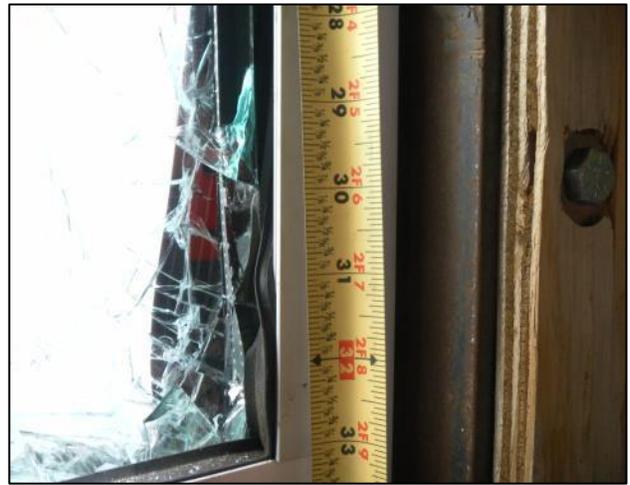
Photo No. 6
Post-test, Witness Panel Impact

Photo No. 7
Post-test, Witness Panel Impact

Photo No. 8
Post-test, Witness Panel Impact

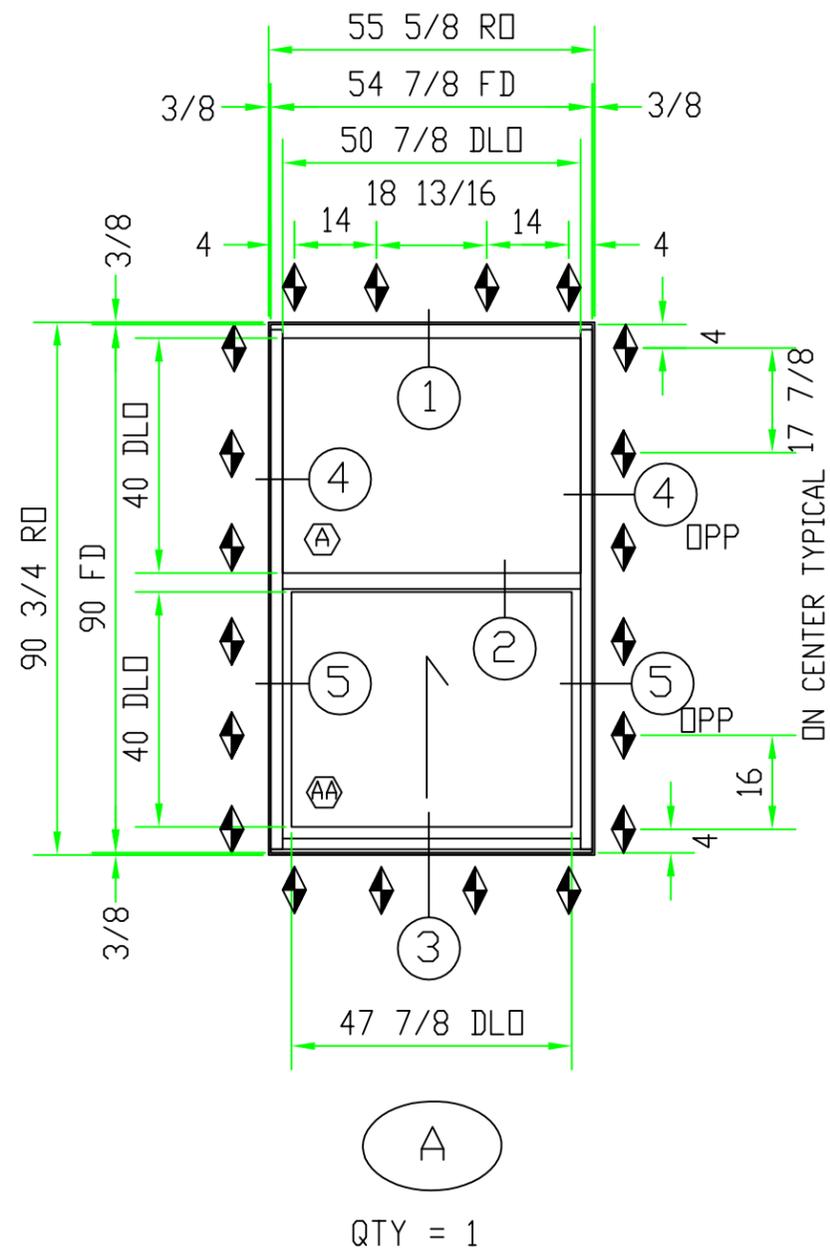
SYMBOL KEY			
SYMBOL	DESCRIPTION	QTY	COMMENTS
⬡	52.875 X 42.000	1	1' INS = 1/4' CLR, 1/2' AIR, LAMI 1/8"HS,030,1/8"HS BUT/PVB
⬢	49.875 X 42.000	1	1' INS = 1/4' CLR, 1/2' AIR, LAMI 1/8"HS,030,1/8"HS BUT/PVB
◆	ANCHOR POINT

1 PSI - 4 PSI - 6 PSI

SERIES_8000_SINGLE_HUNG

The specimen was installed into a steel C-channel buck. The specimen was anchored to the surrounding steel buck using 1/4-20 x 1-1/8" TEK screws. See Drawing MU2012-019-00 in Appendix C for anchor spacing and location.

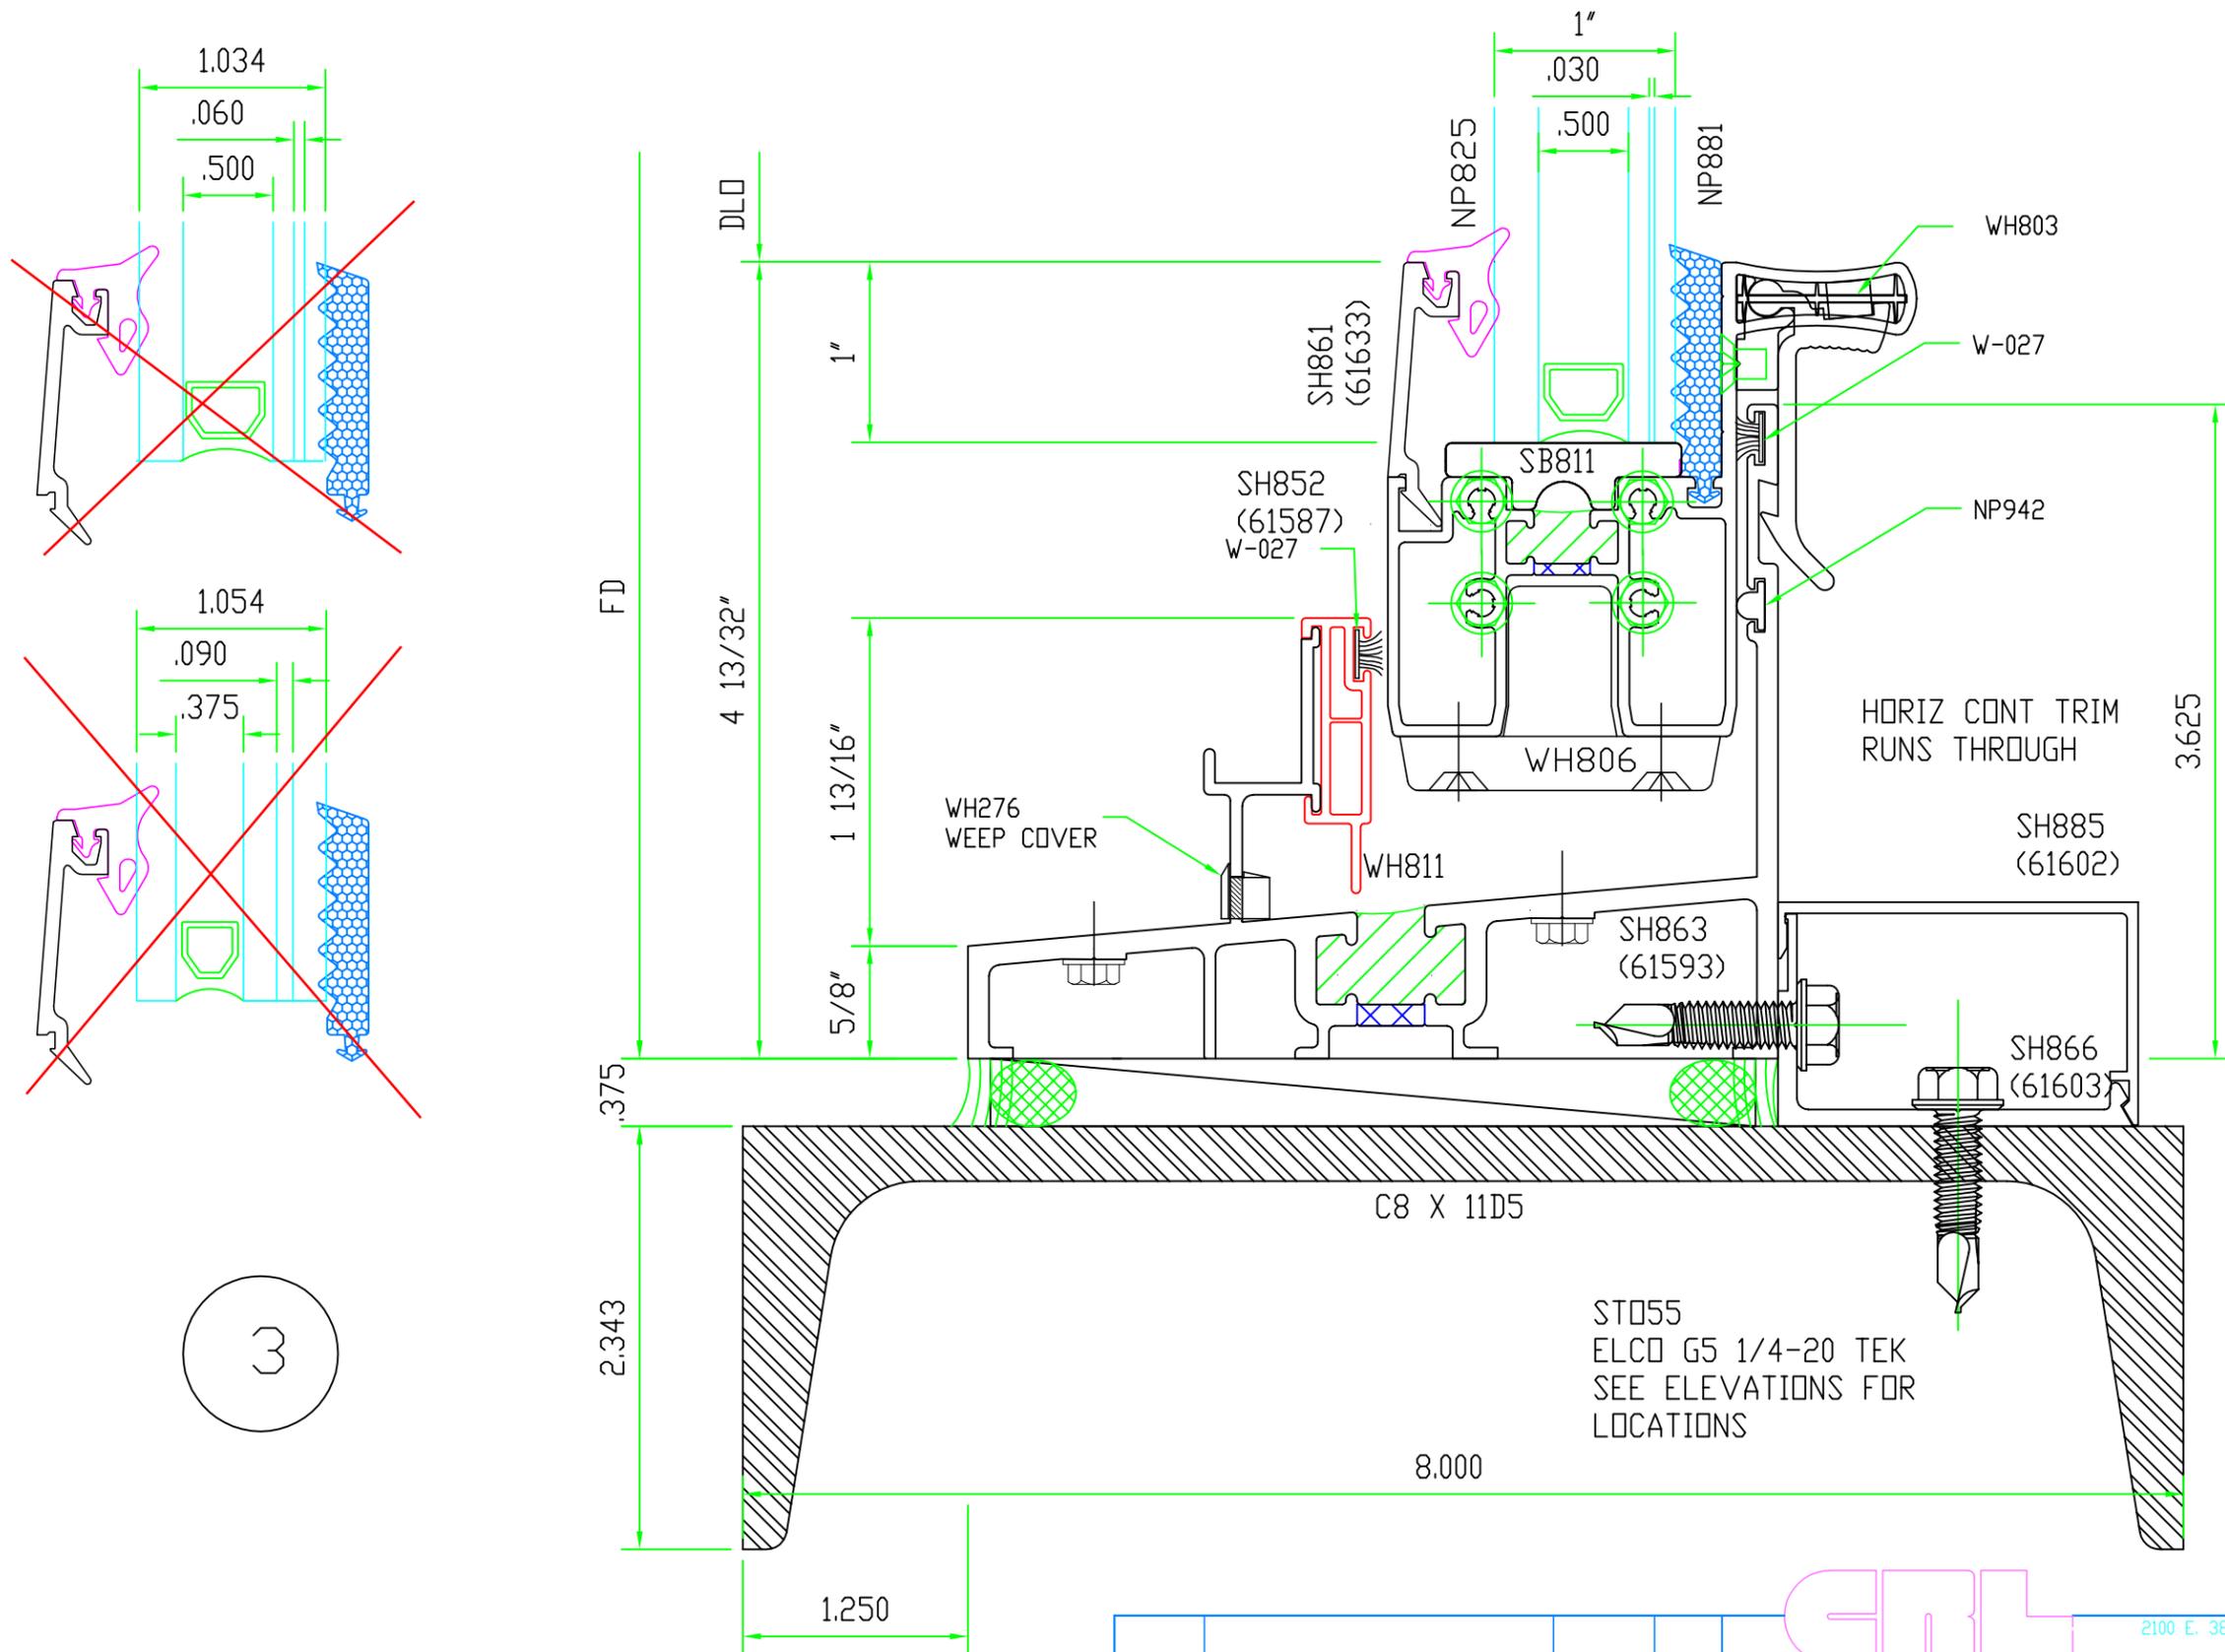
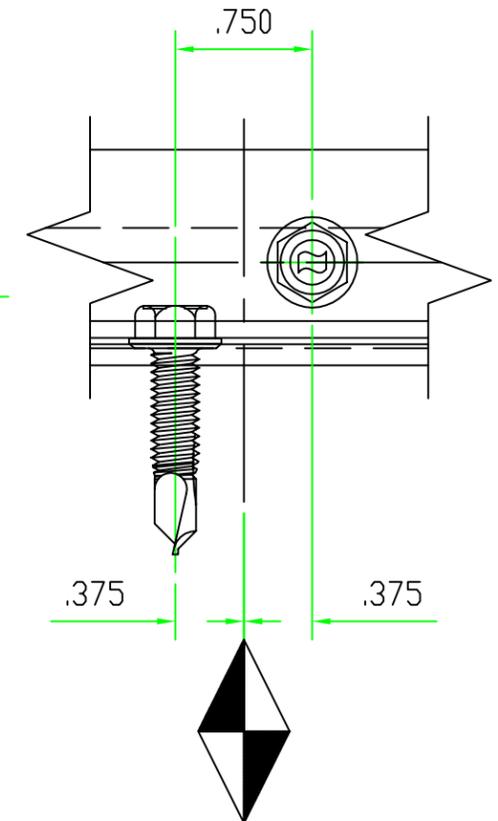
TYPICAL FASTENER OFFSET FOR INSTALLATION
