CR LAURENCE CO., MIAMI-DADE TEST REPORT

SCOPE OF WORK TAS 201 AND TAS 203 TESTING ON IW8000/SINGLE HUNG (LMI)

REPORT NUMBER J2604.01-303-18 R0

Product Type: Single hung window (LMI) Series/Model: IW8000

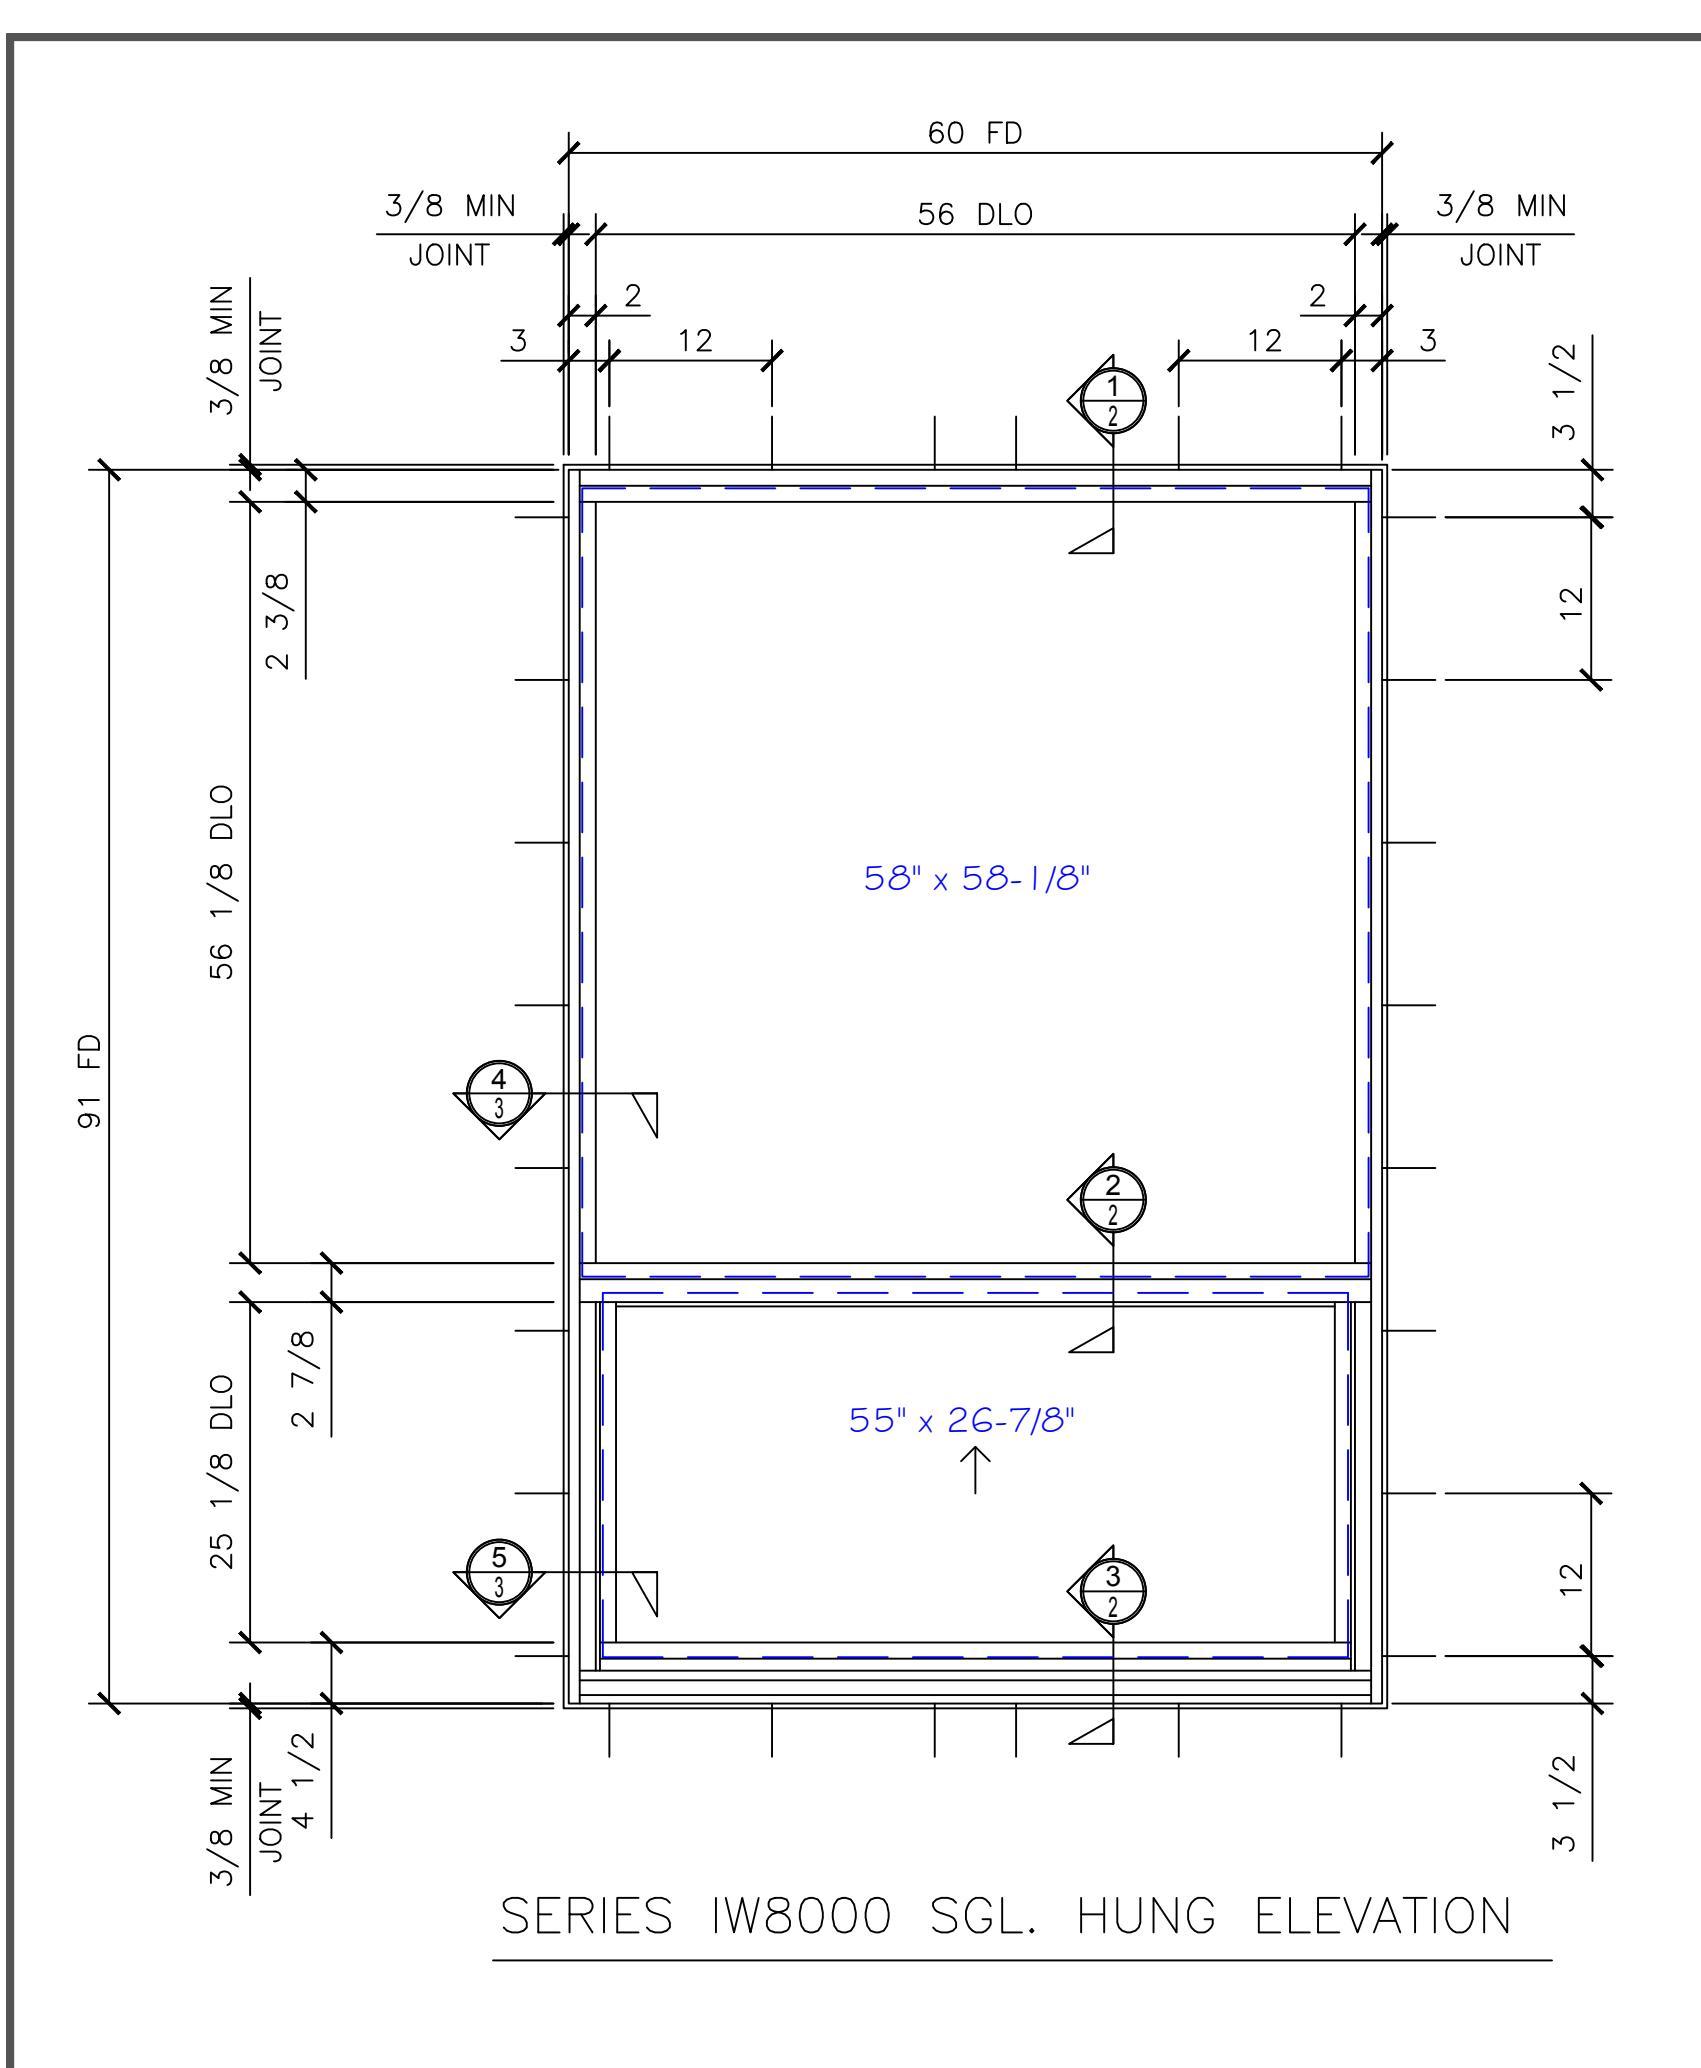
The test specimen drawings have been reviewed by Intertek B&C and are representative of the test specimen(s) reported herein. Test specimen construction was verified by Intertek B&C per the drawings included in this report. Any deviations are documented herein or on the drawings.

ITEM		<u>PT. NO.</u>	
C1		SH812	HEAD EXTRUSION
C2		SH814	JAMB EXTRUSION
C3		SH852	VENT EXTRUSION
C4		SH866	VENT EXTRUSION
C5		WH808	HEAD THERMAL ISOLATOR
C6	NTS	SH855	VENT STILE
C7	ONE	SH854	VENT HEAD EXTRUSION
C8	MP(SH813	SILL EXTRUSION
C9	CO	SH884	GLAZING STOP
C10	HS	WH811	ISOLATOR STRUT
C11	k SA	WH809	ISOLATOR STRUT
C12	AE 8	SH858	INTERLOCK
	RAN		
	ш		
G1			1/4" HS X 1/2" AIF INSULATED GLASS
62		NP881	SPONGE GASKET-EDPM
G3	U	WH416	WEDGE GASKET-EDPM
G4	NIZ	NP942	PC GUIDE
65	ILA.	SB811	SETTING BLOCK
60	G	W-027	
67		SB882	SETTING BLOCK
			SETTING BEGOR
Н1		10X1HWSMS	#10 X 1" HEX WASHER H
H2		10X212FHPWS	#10 X 2-1/2" FLAT HFA
H.3	щ	K29095K	AMESBURY - BALANCE H
H4	VAF	WH3807	KEEPER
H5	ND8	WH276	WEEP HOLE COVER
	IAR		
	<u> </u>		
C1		EF12C	CRL 3/8" CLOSED CELL I
\$2		795BL	DOW CORNING-795 SILICO
			1

FRAME MEMBER	MATERIAL	DESCRIPTION
Head	Aluminum	Part No. SH812, See attached Drawings Section 10.
Jambs	Aluminum	Part No. SH814, See attached Drawings Section 10.
Sill	Aluminum	Part No. SH813, See attached Drawings Section 10.
Fixed Interlock	Aluminum	Part No. SH866, Secured through frame jambs with two #8 x 1" Phillip Hex Head fasteners into screw bosses. See Attached Drawings Section 10
Sill	PVC	Part No. WH811, snapped onto center leg. See attached Drawings Section 10.
Jambs	PVC	Part No. WH809 snapped onto jambs. See Attached drawings Section 10.

SASH MEMBER	MATERIAL	DESCRIPTION
Interlock	Aluminum	Part No. SH854, See Attached Drawings Section 10
Stiles	Aluminum	Part No. SH855, See attached Drawings Section 10.
Bottom rail	Aluminum	Part No. SH852, See attached Drawings Section 10.
Interlock	Aluminum	Part No. SH858, See attached Drawings Section 10.
	JOINERY TYPE	DETAIL
All Corners	Coped	Secured through the stiles with four #8 x 1" Phillip Hex Head fasteners into screw bosses through balance catch clip.
