CR LAURENCE CO. INC. ACOUSTICAL PERFORMANCE TEST REPORT

ASTM E90 SOUND TRANSMISSION LOSS TESTING ON AN OST451, WINDOW WALL/STOREFRONT

K4603.02-303-11-R1

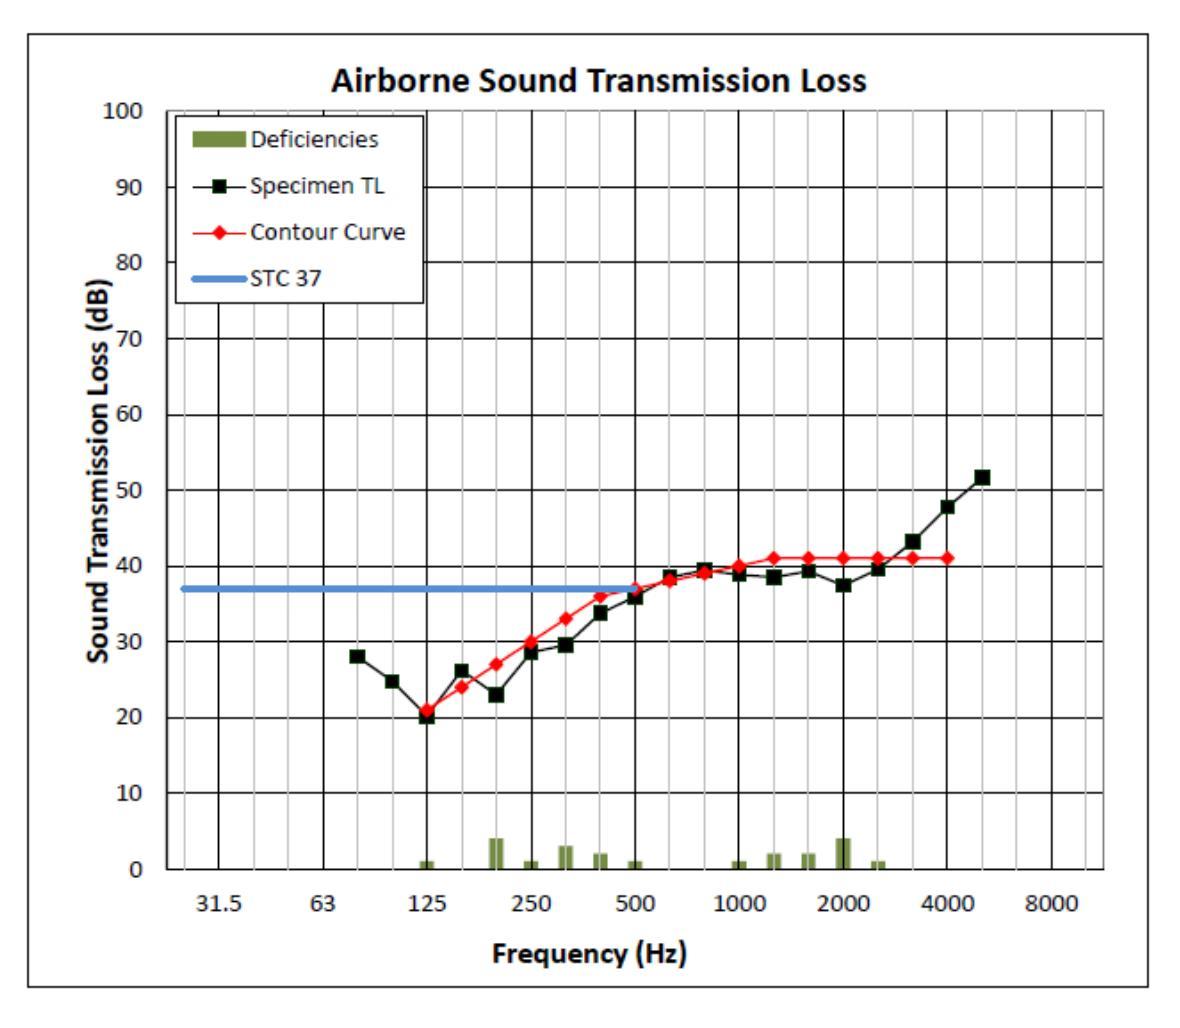
ASTM E90 AIRBORNE SOUND TRANSMISSION LOSS

TEST DATE	11/22/19					
DATA FILE NO.	K4603.01B	ACCREDITED				
CLIENT	CR Laurence	Testing Laboratory				
DESCRIPTION	Series/Model: OST451 Window Wall/Storefront with 1-1/8" IG (1/4" Tempered Exterior, 1/2" Air Space, 3/8" Laminated Interior) Glass temperature 75F					
SPECIMEN AREA	4.00 m ²	RECEIVE TEMP.	17.0 °C	SOURCE TEMP	19.4 °C	
TECHNICIAN	Marco T Sant	RECEIVE HUMIDITY	46%	SOURCE HUMIDIT	46%

FREQ	BACKGROUND	ABSORPTION	SOURCE	RECEIVE	SPECIMEN	95%	NUMBER
	SPL		SPL	SPL	TL	CONFIDENCE	OF
(Hz)	(dB)	(m²)	(dB)	(dB)	(dB)	LIMIT	DEFICIENCIES
80	38.6	4.6	104	75	28	1.91	-
100	33.4	4.3	102	78	25	1.41	-
125	39.2	5.1	102	81	20	1.17	1
160	42.1	5.2	102	75	26	0.95	0
200	36.7	6.4	106	81	23	0.78	4
250	27.2	7.1	107	75	29	0.76	1
315	29.2	7.0	106	74	30	0.38	3
400	34.0	5.9	105	70	34	0.32	2
500	20.9	5.3	106	69	36	0.71	1
630	18.6	5.6	106	66	39	0.45	0
800	22.4	5.7	105	65	39	0.27	0
1000	13.9	5.9	107	66	39	0.34	1
1250	12.0	6.1	105	65	39	0.23	2
1600	6.2	6.7	103	62	39	0.35	2
2000	4.4	7.8	101	61	37	0.19	4
2500	4.1	8.9	101	58	40	0.19	1
3150	4.2	10.3	100	53	43	0.22	0
4000	4.8	12.8	97	44	48	0.14	0
5000	5.5	16.8	93	35	52	0.34	-
STC RATING		37	(Sound Transmission Class)				
DEFICIENC	CIES	22	(Sum of Deficiencies)				
OITC RATING		31	(Outdoor-Indoor Transmission Class)

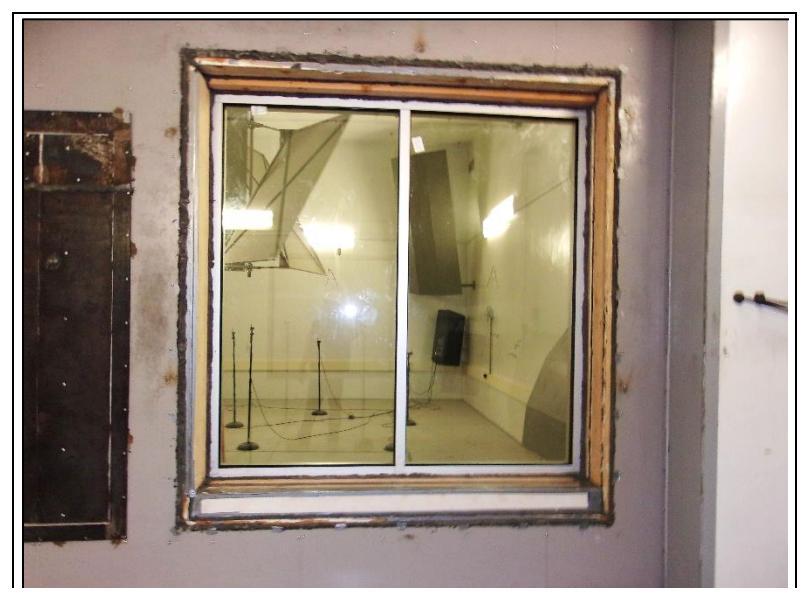
Photo No. 1 Source Room View of Test Specimen

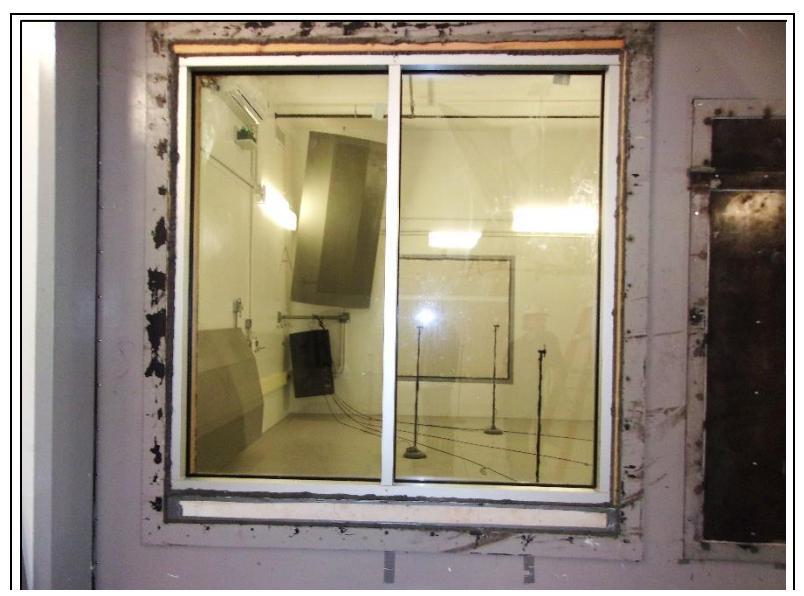
Photo No. 2 Receive Room View of Test Specimen

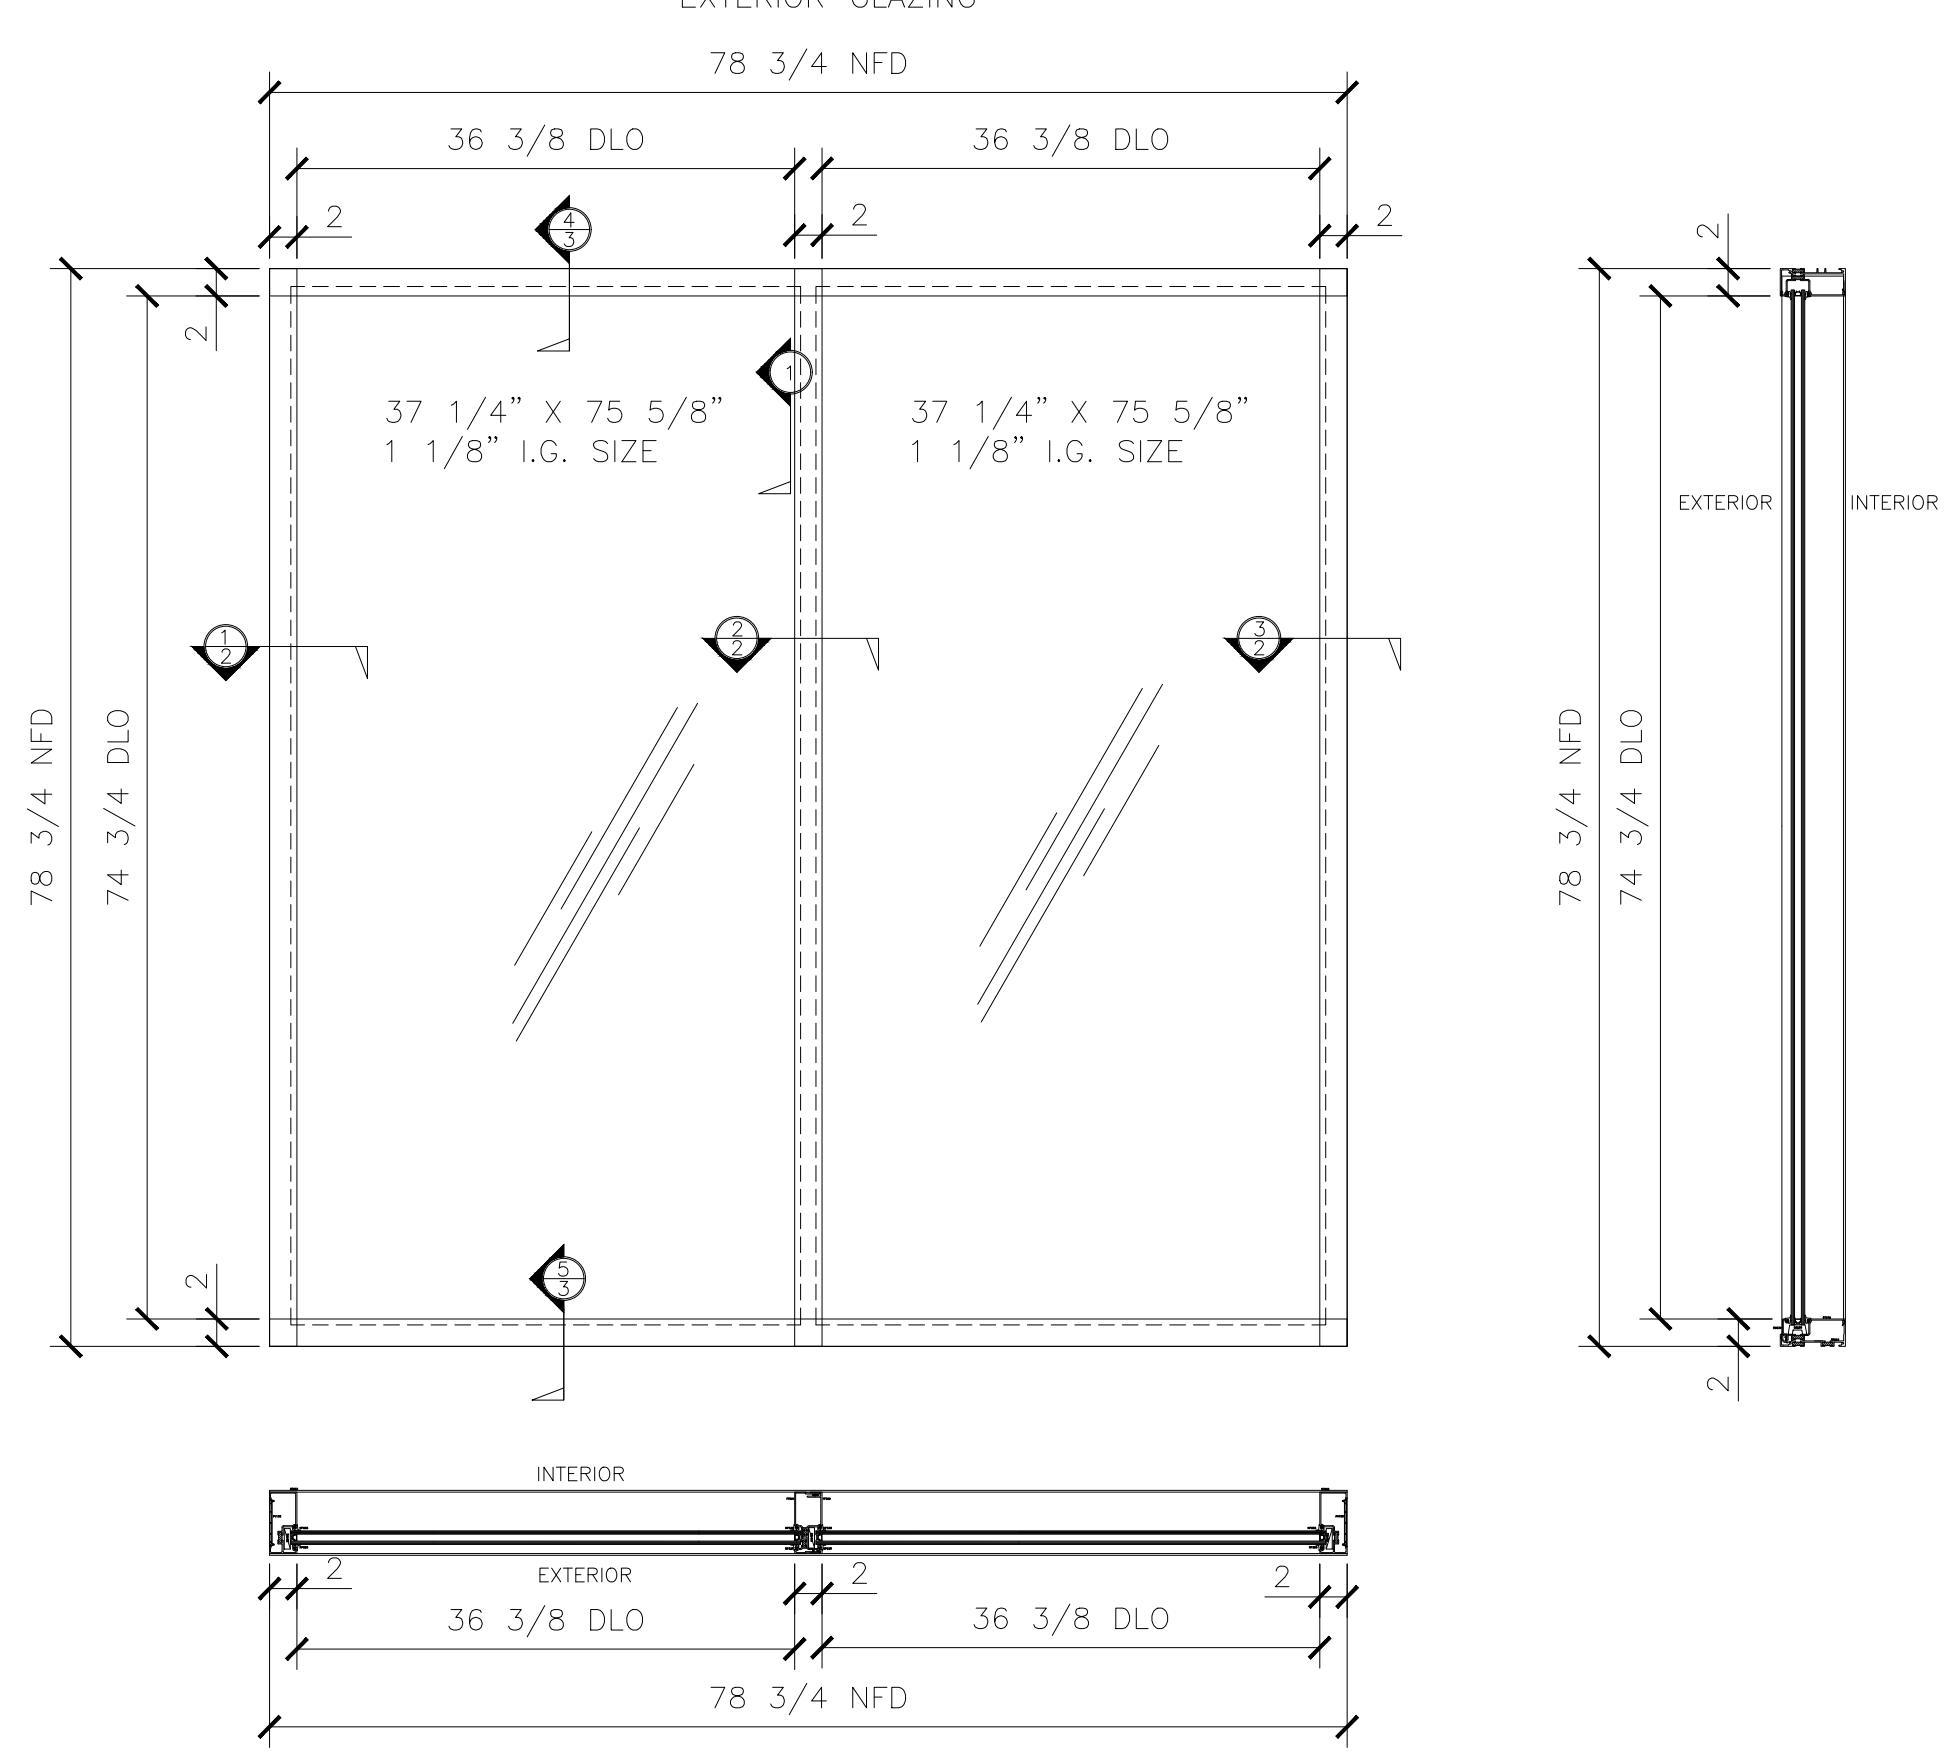
EXTERIOR GLAZING

FRAME
SIZE	78-3/4" by 78-3/4"
THICKNESS	4-3/4"
CORNERS	Coped
FASTENERS	Screws
SEAL METHOD	N/A
MATERIAL	Aluminum
REINFORCEMENT	N/A
THERMAL BREAK MATERIAL	Insulbar
DAYLIGHT OPENING SIZE (X2)	36-1/4" by 74-1/2"

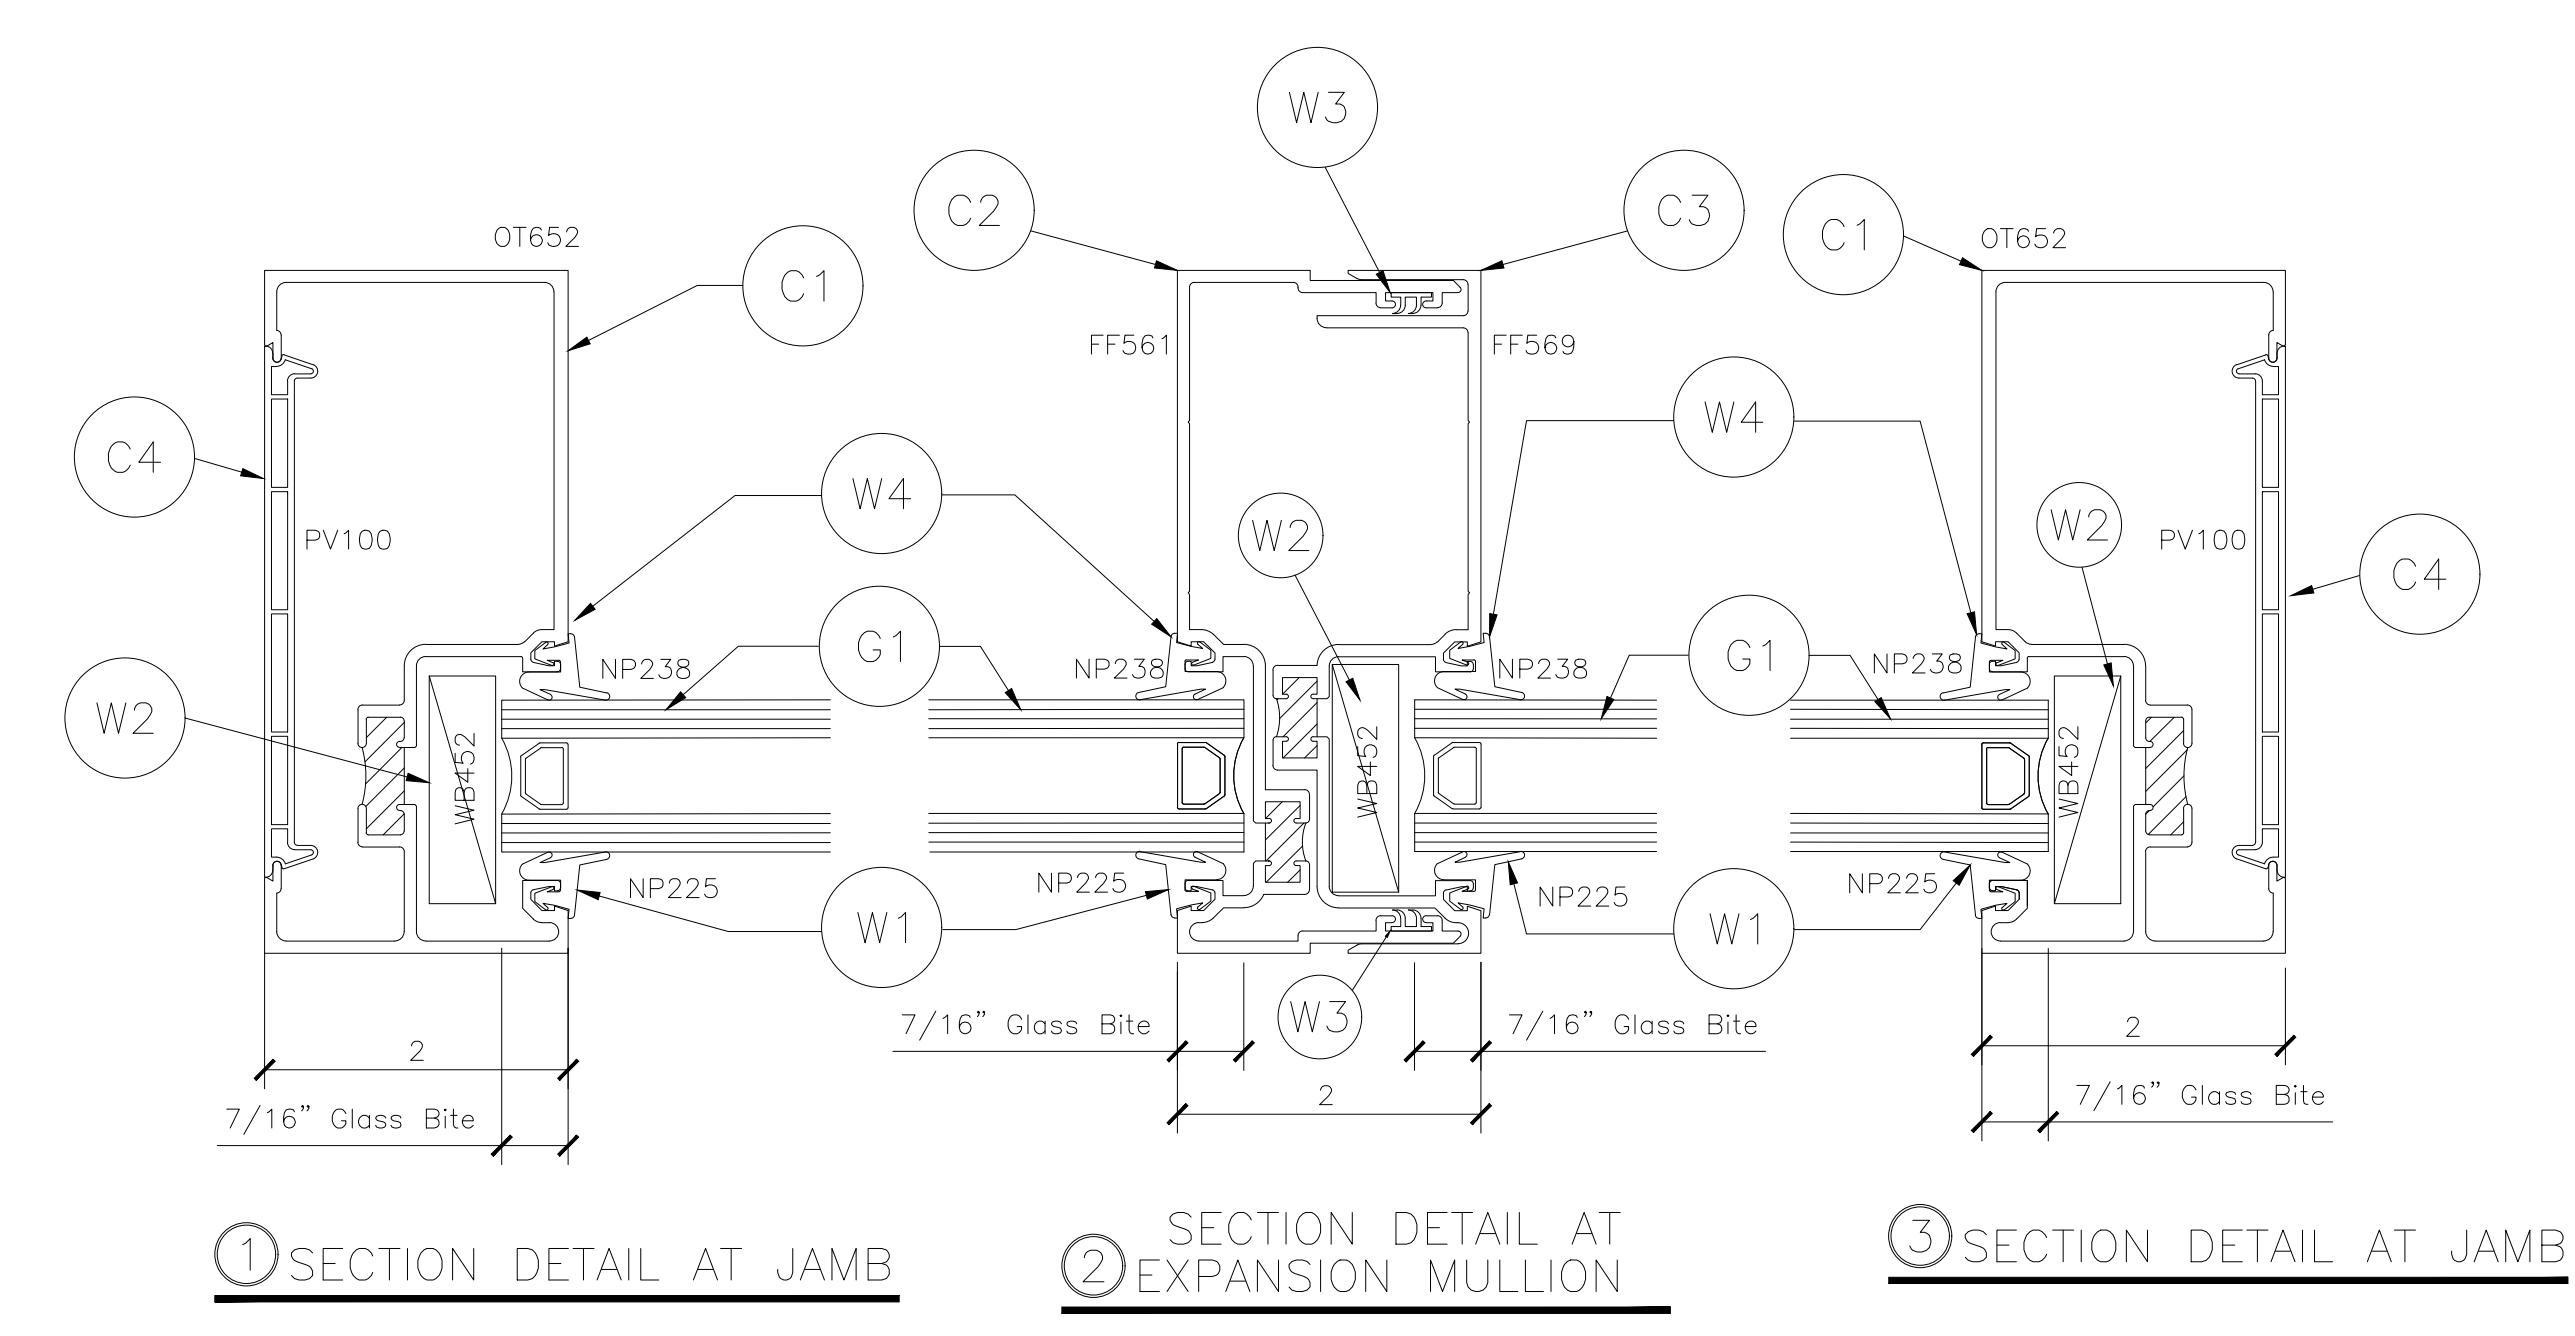
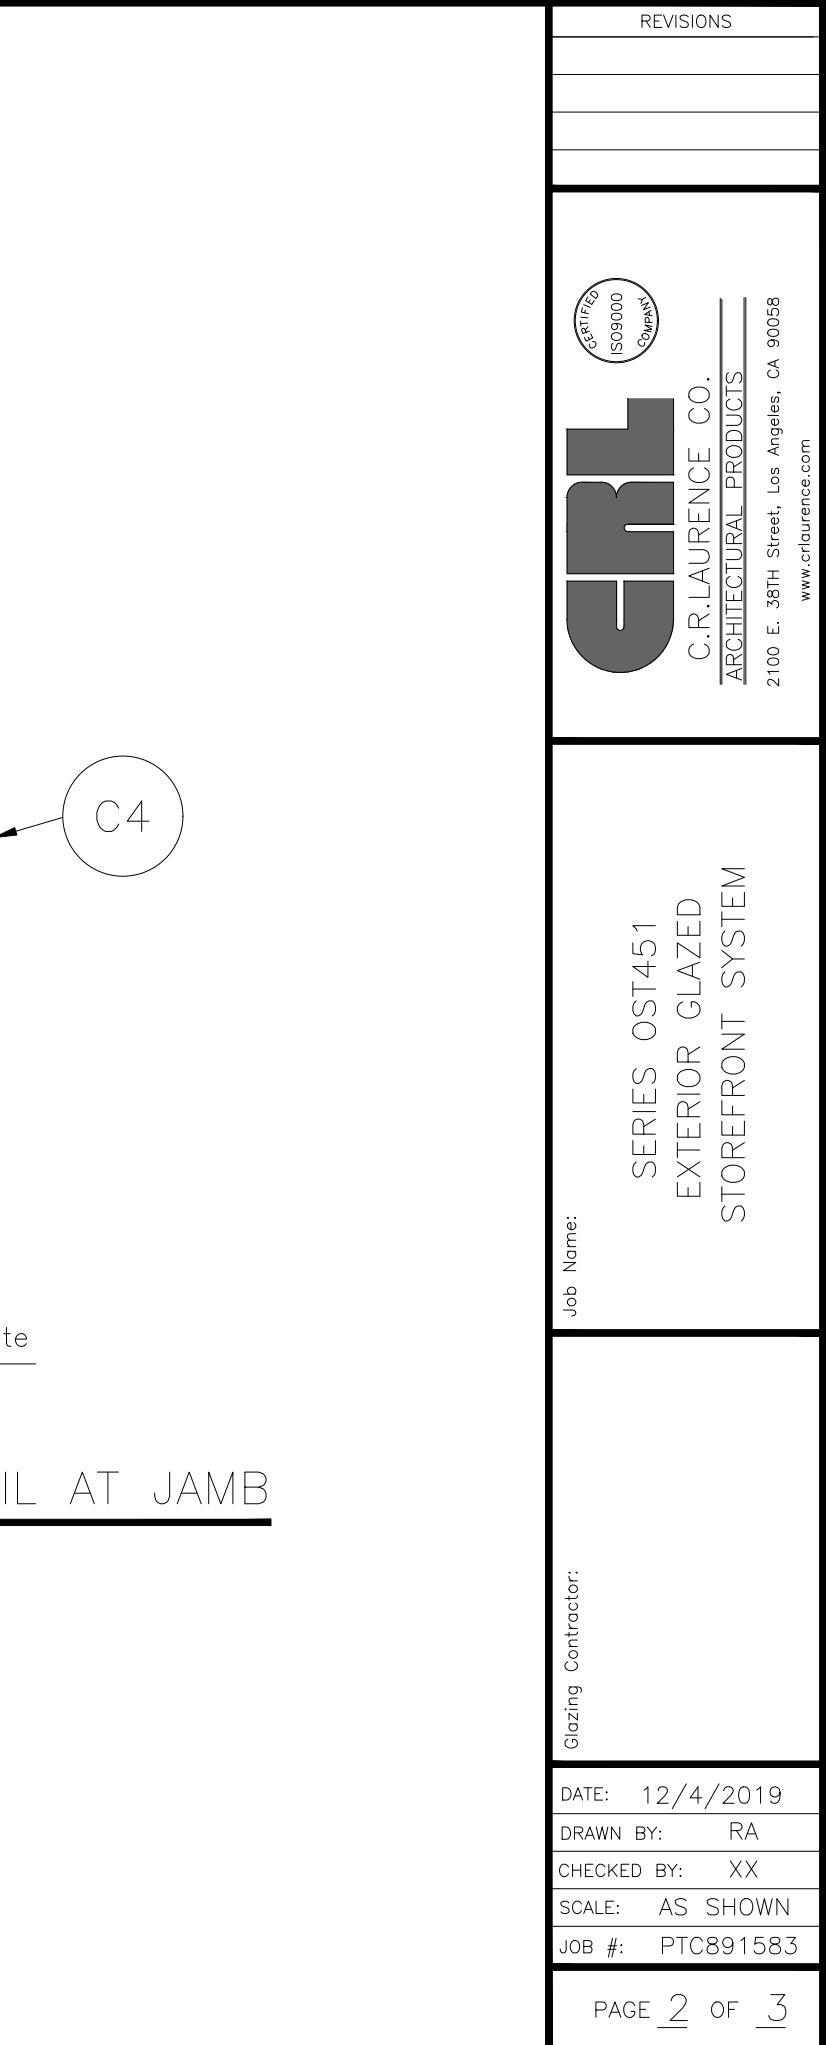
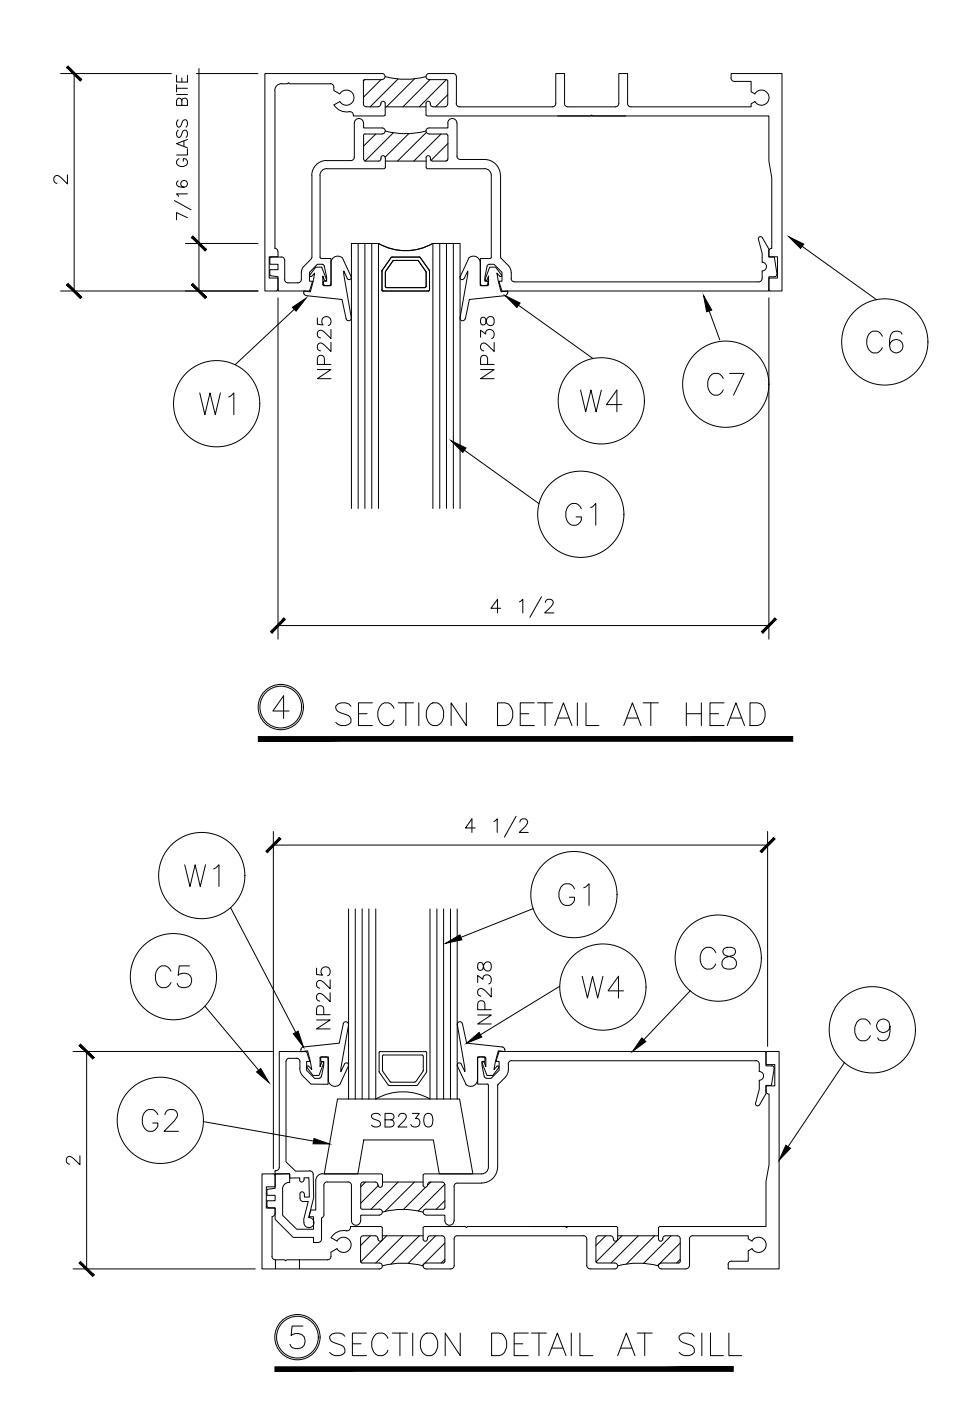
ITEM		<u>PT. NO.</u>	PART DESCRIPTION	
C1	S	0T652	WALL JAMB	
C2	L	FF561	MALE EXPANSION MULLION	
C3	ONE	FF569	FEMALE EXPANSION MULLION	
C4	MP	PV100	PVC JAMB FILLER	
C5	8	0G539	SILL FACE PLATE	
C6	ASH	0T668	HEAD CHANNEL (EXT. GLAZE)	
C7	8 8	0T666	HEAD INSERT (EXT. GLAZE)	
C8	ME	0T676	SILL INSERT (EXT. GLAZE)	
C9	FRA	0T662	SILL CHANNEL (EXT. GLAZE)	
	E E			
W 1	STI	NP225	GASKET	
W2	ER	WB452	"W" EDGE BLOCK	
W3	I H	VS200		
W4	VE/	NP238	GASKET	
G1	AZING		1/4" TEMPERED GLASS - 1/2" AIR FILLED ALUM SPACER -	
G2	GL	SB230	SETTING BLOCK SILL	
]

3/8" LAMINATED GLAS	5
